**HISTORIC BUILDING INVENTORY**

SITE NO.: 5ME8315

HISTORIC BUILDING NAME: The house at 227 Belford Avenue

PROJECT NAME: Grand Junction Historic Resources Survey, Phase 2

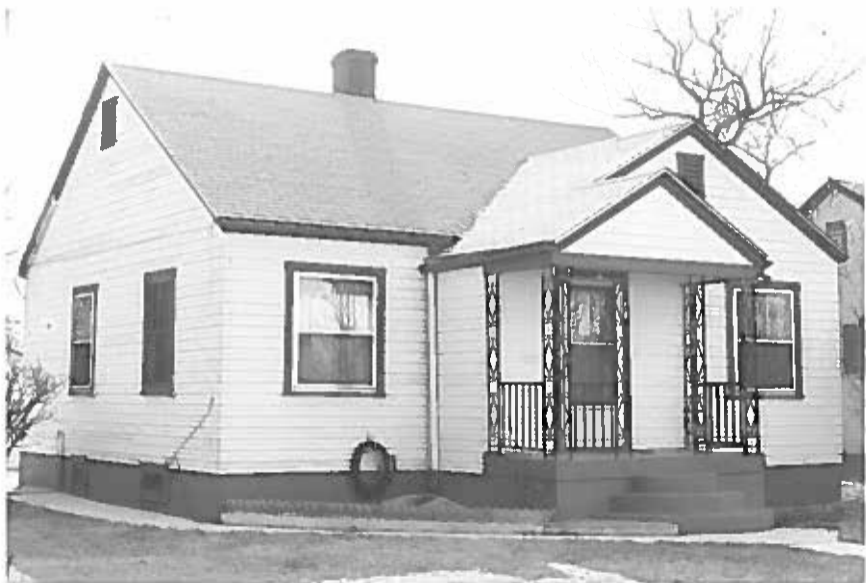
Roll 29 Frame 6 View N Dir S/SW

**ARCHITECTURAL DESCRIPTION:** One story with cross gables. Gabled wing extends across 2/3 of facade. Curved concrete steps lead to open porch with pedimented gable roof in center of facade. Full height wrought iron porch posts with iron railing. Metal storm door. Front door is paneled with three vertical lights. Windows around house are double hung wood sash, with four and six vertical lights over one, and have storm windows. Concrete basement with small single pane windows on east and west elevations. White false bevel wood siding. Porch steps, front door, window surrounds, cornices and raking cornices are brown. Brown composition shingle roof with close to the wall. Brick chimney in ridge.  
Lawn and trees in front yard. Paved walk leads to porch and continues around east elevation to rear of house. Large shrub on west side of facade. Several small shrubs and small flower bed on east side of lawn. A tall, horizontal wood plank fence separates front and back yard on east side of lot. Single car garage in rear with front gable, cedar shingle roof, and wide lapped siding painted white.

227 Belford Ave., Grand Junction, Mesa Co, CO

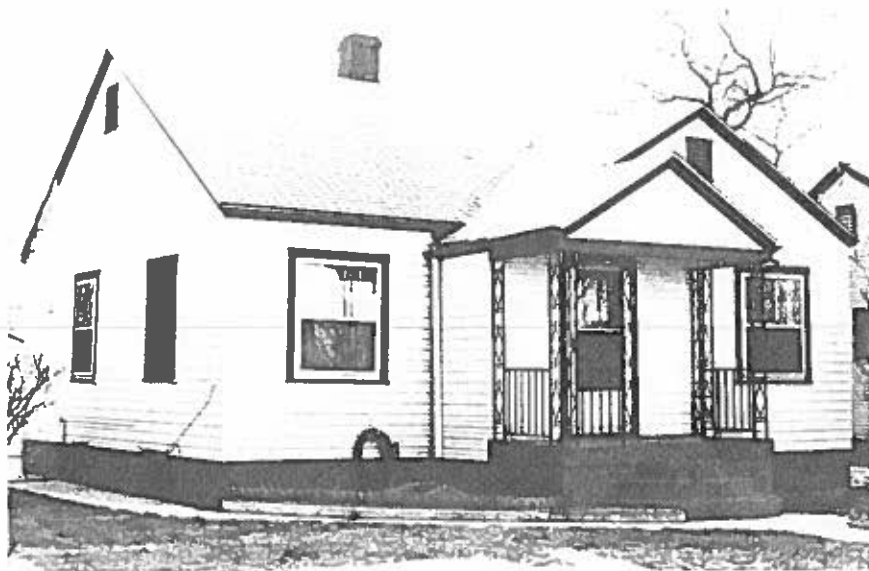
227 Belford Ave. , Grand Junction, Mesa Co, CO  
2945-142-11-004 02/07/1996  
Roll 29 Frame 6 View N Dir S/SW  
SMF 8315
