COLORADO HISTORICAL SOCIETY Office of Archaeology and Historic Preservation		SITE NO.: 5ME8330
1300 Broadway Denver, CO 80203 HISTORIC BUILDING INVENTORY		Eligible for National Register  yesno    dateinitials     CriteriaABCD D    Contributes to a potential National Register district
COUNTY: Mesa	Сіту: Grand Junction	_ Eligible for State Registeryesno date Initials Criteriaabcde Areas of significance:
HISTORIC BUILDING NAME: The house at 833 N. 4th Street		Period of significance
CURRENT BUILDING NAME: Marquardt Residence		LOCAL LANDMARK DESIGNATION: [ ] yes [X] no
ADDRESS: 833 N. 4th St., Grand Junction, CO 81501-2521		Date of designation: N/A Designating authority: N/A
		P.M.: UTE township: 1S range:1W NE ¼ of SE ¼ of NW¼ of NW¼ of section 14
OWNER NAME & ADDRESS: Matthew M. Marquardt, 833 N. 4th St., Grand Junction, CO 81501-2521		UTM REFERENCE-12 Easting: 710560 Northing: 4327740
		USGS QUAD NAME: Grand Junction

INVENTORY COMPLETED BY: Museum Group Staff	DATE: 5/31/96
AFFILIATION: Museum of Western Colorado	PHONE: (970) 241-9117
Address: PO Box 20000-5020, Grand Junction, Colorado 81502-5020	PROJECT NAME: Grand Junction Historic Resources Survey, Phase 2

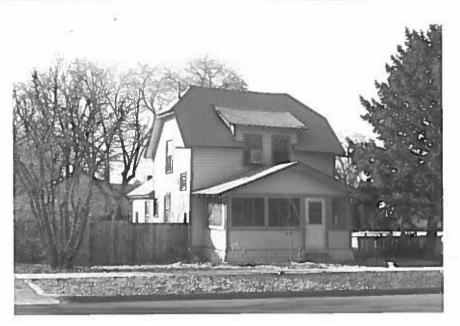
833 N. 4th St., Grand Junction, Mesa Co, CO 2945-142-15-006 02/06/1996 Roll 28 Frame 12 View E Dir NW Sm∈ 8330

ARCHITECTURAL DESCRIPTION: Two story with hip on gable roof. Concrete steps lead to sunporch/entry with gable roof that extends across most of facade. Narrow vertical siding is on the half-wall. Full height, squared porch posts on corners and frame porch door. Glazing consists of ribbons of six pane casement windows. Wood framed screens cover porch windows. Porch has metal storm door and French door. Windows around house are double hung wood sash. Shed roof wall dormer in center of facade has two windows. Gable wing in rear with sliding, wood frame, window. Beige simple drop wood siding. Porch half wall siding, wood shingles in porch gable face, and exposed rafter ends are beige. Window frames and surrounds, porch posts, raking cornices and corner boards are navy blue. Porch screen frames are light blue. Gray composition shingle roof. Small lawn. Large pine tree, shrubs and raised garden bed in front yard. Low wood fence partially enclosed north side of lot with several small saplings. South side of lot partially enclosed by tall wood fence. The parking has gray rocks and gravel.
