COLORADO HISTORICAL SOCIETY Office of Archaeology and Historic Preservation 1300 Broadway Denver, CO 80203 HISTORIC BUILDING INVENTORY		SITE NO.: 5ME8372
		Eligible for National Registeryesno date initials CriteriaABCD Contributes to a potential National Register district
		yesno district name:
COUNTY: Mesa	Crry: Grand Junction	Eligible for State Register
HISTORIC BUILDING NAME: Jacques, Anna, House		Period of significance Needs data date initials
CURRENT BUILDING NAME: Knauer Residence		LOCAL LANDMARK DESIGNATION: [] yes [X] no Date of designation: N/A Designating authority: N/A
ADDRESS: 1117 Hill Ave., Grand Junction, CO 81501-3236		
		P.M.: UTE township: 1S range:1W SW 1/2 of SE 1/4 of NE1/4 of NE1/4 of section 14
OWNER NAME & ADDRESS: Helen B. Knauer, 1117 Hill Ave., Grand Junction, CO 81501-3238		UTM REFERENCE-12 Easting: 711685 Northing: 4327720
		USGS QUAD NAME: Grand Junction
		Year: 1962; photorevised 1973 [X] 7.5' [] 15'

VENTORY COMPLETED BY: Museum Group Staff		DATE: 5/31/96
FILIATION: Museum of Western Colorado		PHONE: (970) 241-9117
ODRESS: PO Box 20000-5020, Grand Junction, Colorado 81502-5020		PROJECT NAME: Grand Junction Historic Resources Survey, Phase 2

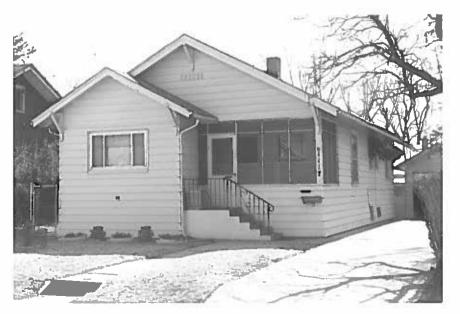
1117 Hill Ave., Grand Junction, Mesa Co, CO 2945-141-19-003 02/29/1996 Roll 32 Frame 24 View N Dir S/SE 5ME 3372

ARCHITECTURAL DESCRIPTION: One story with front gable roof. Gable wing projecting from east half of facade. Concrete steps with wrought iron railing arranged parallel to the street, leads to a screened porch integral in the west half of facade. Porch half-wall is sided with aluminum clapboard siding down to ground level. Single, full height, squared corner porch post. Ribbons of wood frame screens with screened transoms around both sides of porch. Wood framed porch screen door. Main door is glazed. Windows are varied. Large mull window in facade. Remaining windows are sash and sliding windows. All windows have metal frames and storm windows. Projecting bay with gable roof and knee braces on east elevation. Gray composition shingle roof with overhanging eaves with knee braces and exposed rafters. White aluminum clapboard siding. Screened porch door, steps, porch screen frames, porch posts, knee braces, exposed rafters and bargeboards are white. Brick chimney on west slope.
