HISTORIC BUILDING INVENTORY

SITE NO.: 5ME8379

HISTORIC BUILDING NAME: Farmer, William, House

PROJECT NAME: Grand Junction Historic Resources Survey, Phase 2

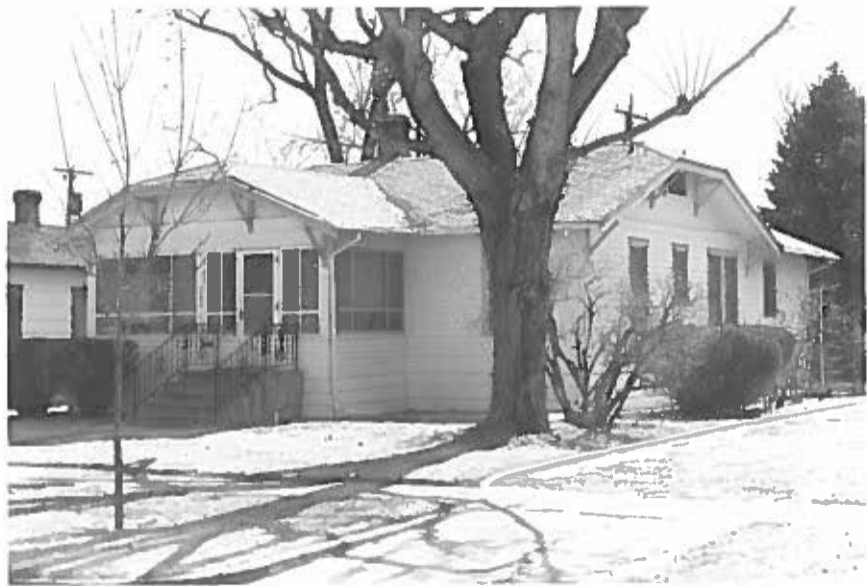
1135 Hill Ave. , Grand Junction, Mesa Co, CO
2945-141-19-005 02/29/1996
Roll 33 Frame 0 View N Dir S/SE
SME 8379

ARCHITECTURAL DESCRIPTION: One story with hipped gable roof. Battered foundation. Concrete steps and stoop with wrought iron railings lead to sunporch/entry with hipped gable roof extending across east two-thirds of facade. Cedar shingle on half-wall. Three squared, half height porch posts. Porch glazed with ribbons of metal frame windows. A course of narrow sliding windows is below the large upper lights. Metal storm porch door. French front door. Windows around house are double hung wood sash, one-over-one. Large sash picture window, six over one, in facade enclosed by porch, and on east elevation. White narrow lapped clapboards in gables. Siding of house is white cedar shingles. The battered foundation is sided with white, wide pressed wood clapboards. Basement, French front door and picture window frames are white. Remaining windows have black frames with green surrounds. Raking cornices and knee braces are green. Gray composition shingle roof. Brick chimney on ridge.
