PROJECT NAME: Grand Junction Historic Resources Survey, Phase 2

757 Hill Ave., Grand Junction, Mesa Co, CO
2945-141-23-006 02/05/1996
Roll 23 Frame 15 View N Dir SW

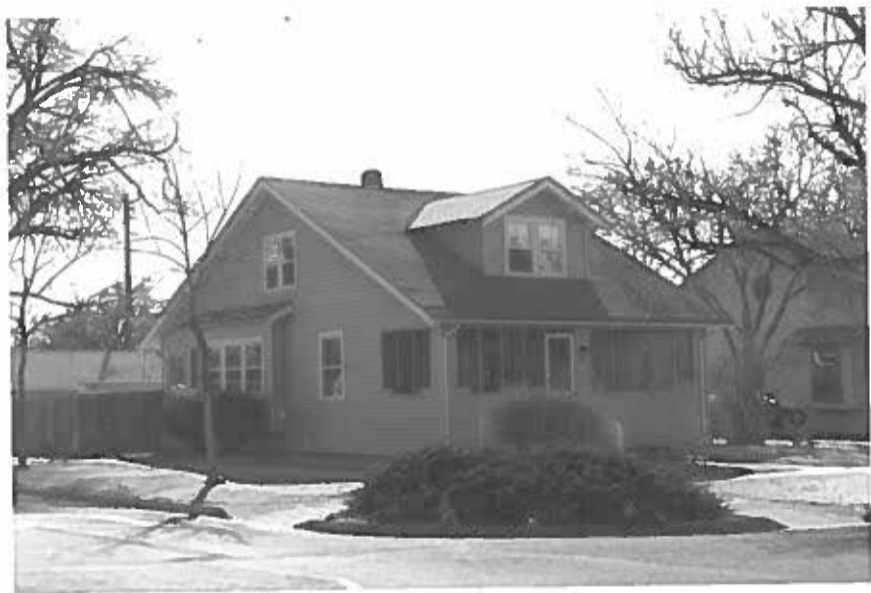
ARCHITECTURAL DESCRIPTION: One and a half story with side gable roof. Concrete steps and concrete piers lead to integral screened porch extending across the entire facade. Porch half-wall of clapboard aluminum siding extends to the ground. Ribbons of thin, wood frame screens on all three sides of porch. Porch has wood screen door. Main door is paneled with large light. Squared, corner porch piers covered with clapboard aluminum siding. Windows around house are double hung, wood sash, one-over-one, with white vinyl storm windows. Large gable dormer on the facade with bargeboards and exposed rafter ends has pair of sash windows. Shallow squared bay with shed roof, bargeboards and exposed rafter ends on east elevation, has triple sash windows. Gray clapboard aluminum siding. Window surrounds and frames, porch screen door and screen frames, concrete piers of porch steps, exposed rafter ends and bargeboards are russet. Brick chimney on south slope.
