HISTORIC BUILDING INVENTORY

SITE NO.: 5ME8446

HISTORIC BUILDING NAME: Matson, Andrew, House

PROJECT NAME: Grand Junction Historic Resources Survey, Phase 2

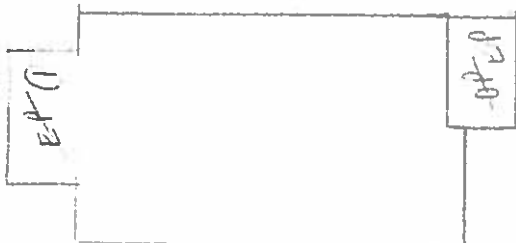
PLAN SHAPE:

ARCHITECTURAL DESCRIPTION: One story with hip roof. Concrete block foundation. Concrete steps lead up to enclosed porch with hip roof on the east half of the facade. Simple drop siding on porch. Windows around porch are small pairs of sliding, metal frame, single lights. Metal frame storm door on the porch. Front door is paneled with a large light. Windows around house are double hung, wood sash, one-over-one, with metal frame storm windows. Ocher narrow lapped wood siding. Porch and gable face also are ocher. Window and door surrounds, corner boards, cornices are dark brown. Brown composition shingle roof. Boxed eaves have cornices. Short wing on west half of the facade has pedimented gable with a kick. Gable face has diamond wood shingles and small window with three vertical lights. Simple drop siding on enclosed lean-to porch across the rear.
