COLORADO HISTORICAL SOCIETY Office of Archaeology and Historic Preservation 1300 Broadway Denver, CO 80203		SITE NO.: 5ME8427		
		Eligible for National Registeryesno dateinitials		
HISTORIC BUILDING INVENTORY		CriteriaABCD  Contributes to a potential National Register districtyesno district name:		
COUNTY: Mesa	CITY: Grand Junction	Eligible for State Registeryesno date initials Criteriaabcde Areas of significance:		
HISTORIC BUILDING NAME: The building at 102	Period of significance  Needs data date initials			
CURRENT BUILDING NAME: Mesa County Farm	LOCAL LANDMARK DESIGNATION: [ ] yes [X] no  Date of designation: N/A  Designating authority: N/A			
ADDRESS: 1025 N. 4th St., Grand Junction,				
	P.M.: UTE township: 1S range:1W NE ¼ of NE ¼ of NW¼ of NW¼ of section 14			
OWNER NAME & ADDRESS: 1025 N. 4th St., Grand Junction, CO 81501-7502		UTM REFERENCE-12 Easting: 710560 Northing: 4327970		
	USGS QUAD NAME: Grand Junction

PROJECT NAME: Grand Junction Historic Resources Survey, Phase 2

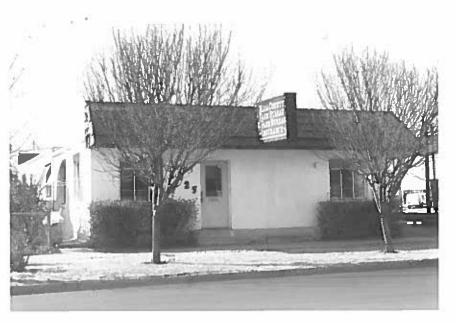
1025 N. 4th St., Grand Junction, Mesa Co, CO 02/07/1996 2945-142-03-006 Roll 30 Frame 0 View E Dir N/NW

ARCHITECTURAL DESCRIPTION: One story flat roof. Concrete foundation. The facade is close to the sidewalk. Wide concrete steps. Door paneled with a large light. Two windows on the facade are steel casement, three sections wide and four lights in height. The center casement is fixed, the outer two swing. Other windows around the building are also steel casement, in pairs or threes. South facing windows have steel awnings. Buff walls are stuccoed. All window trim is buff. Door is gray. On the facade and along the east half of the north elevation is a visor roof with rough split shake shingling. Sign says "Farm Bureau Insurance."
