HISTORIC BUILDING INVENTORY

SITE NO.: 5ME8487

HISTORIC BUILDING NAME: Vickery, Roy, House

PROJECT NAME: Grand Junction Historic Resources Survey, Phase 2

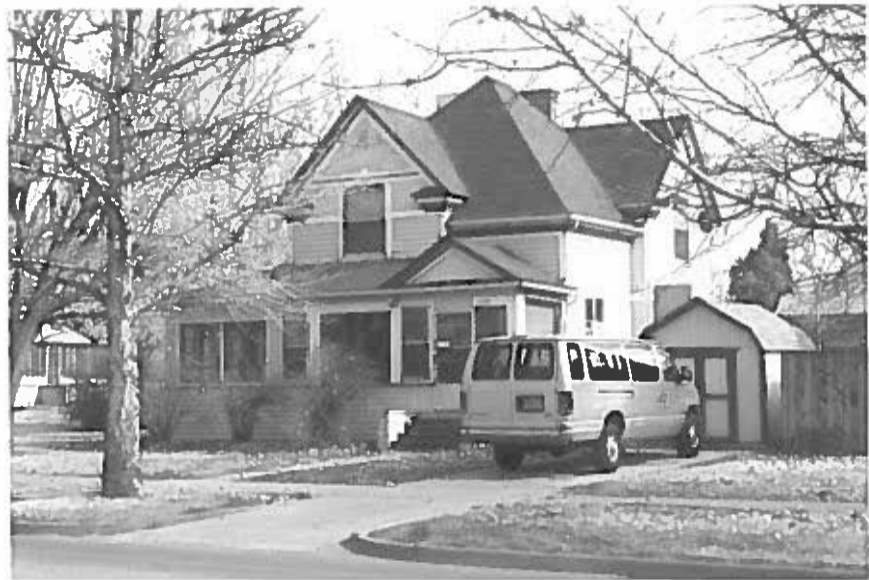
Roll 26 Frame 4 View W Dir NE

ARCHITECTURAL DESCRIPTION: Two story with pyramidal hip roof and two story gable wings extending from each elevation. Wood steps, with battered wood piers covered with cedar shingles, lead to a large, enclosed, wrap-around sunporch with hip roof, and pedimented gable over entrance. Half-wall of lapped wood siding extends to ground level. Metal storm door and French main door. Porch glazing is varied. Flanking the porch door is a double hung wood sash and tall, fixed pane window. Large fixed pane picture windows appear in the facade and south elevation of the porch. Wrapping around the northwest corner are ribbons of wood frame casement windows divided into four horizontal lights. Majority of windows around house are large, double hung, wood sash, one-over-one, with metal frame storms and screens. Gray lapped board siding. Window frames and surrounds and corner boards are white. Porch steps, cornices, raking cornices and cornice returns are dark gray with red molding strips. Dark brown composition shingle roof with boxed eaves. Sunburst pattern in facade gable is gray. Lattice-like decoration in gable of north elevation is gray. Wide brick chimney on north slope.

STATEMENT OF SIGNIFICANCE (briefly justify the significance checked above): The porch glazing is uncoordinated. The mass of the house is original, with details emphasized by contrasting paint. Although not eligible for the National Register, this house may contribute to a local register.
