HISTORIC BUILDING INVENTORY

HISTORIC BUILDING NAME: Chelius, Peter, House

ADDRESS: 328 Gunnison Ave., Grand Junction, CO 81501

PROJECT NAME: Grand Junction Historic Resources Survey, Phase 2

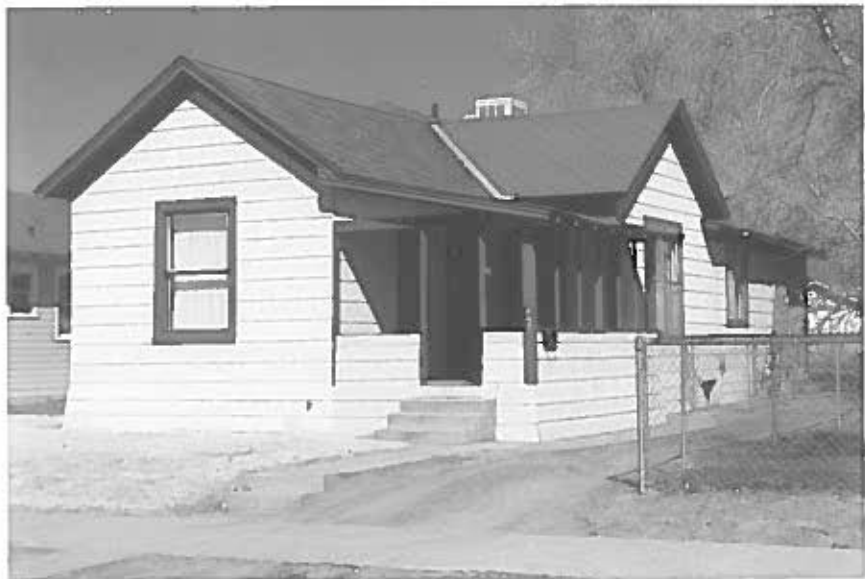
328 Gunnison Ave., Grand Junction, Mesa Co, CO
2945-142-22-012 03/11/1996
Roll 37 Frame 8 View S Dir N/NW
5mE8491

ARCHITECTURAL DESCRIPTION: One story with cross gable roof. Battered foundation skirted with shake shingles. Concrete steps lead to open shed roof porch situated in the southeast corner of house. Shake shingles on porch half-wall extend down to the ground. Two squared half-height corner posts. Rows of 2x4 and 2x2 posts are possibly for screen panels. Wood screen door and flush main door. Windows around house are double hung, wood sash, one-over-one, some with metal storms. Tan asbestos shingle siding. Porch posts, window frames and surrounds and raking cornices are dark brown. Green composition shingle roof with boxed eaves and fascia boards.
