COLORADO HISTORICAL SOCIETY		SITE NO.: 5ME8500	
Office of Archaeology and Historic Preservation		Elizible for National Register yes no	
1300 Broadway Denver, CO 80203		Eligible for National Registeryesno date initials	
		Criteria A B C D	
		Contributes to a potential National Register district	
HISTORIC BUILDING INVENTORY		yesno district name:	
	[Eligible for State Registervesno	
COUNTY: Mesa	CITY: Grand Junction	date initials Criteriaabcde	
		Areas of significance:	
	<u> </u>		
HISTORIC BUILDING NAME: Lang, J.W., House			
		Period of significance initials	
CURRENT BUILDING NAME:	LOCAL LANDMARK DESIGNATION: [] yes [X] no		
	Date of designation: N/A		
ADDRESS 719 N. 4th St., Grand Junction,	Designating authority: N/A		
	P.M.: UTE township: 1S range:1W		
		NE ¼ of NE ¼ of SW¼ of NW¼ of section 14	
OWNER NAME & ADDRESS: Elva M. Conrow, 3125 Cloverdale Ct., Grand Junction CO		UTM REFERENCE-12	
81506-1952		Easting: 710560

INVENTORY COMPLETED BY: Museum Group Staff	DATE: 5/31/96	
AFFILIATION: Museum of Western Colorado	Рноке: (970) 241-9117	
ADDRESS: PO Box 20000-5020, Grand Junction, Colorado 81502-5020	PROJECT NAME: Grand Junction Historic Resources Survey, Phase 2

719 N. 4th St., Gr

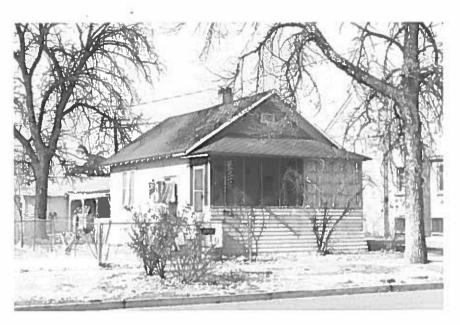
Roll 26 Frame 13 View E Dir NW

ARCHITECTURAL DESCRIPTION: One story with front gable roof. Gable wing extends from the north elevation. Battered foundation skined with gray shake shingles. Concrete steps on south elevation lead to partially screened porch with hipped roof extending across three-quarters-of facade. Shake shingle siding on half-wall extends down to ground level. Metal screen door. Thin, wood screen frames. Squared half-height corner post. Front door is paneled and has a large single light. A set of narrow French doors with transom leads to sunporch on northern half of porch. Sunroom-glazed with ribbons of narrow, eight light casement windows. Windows are varied. A pair of double hung, wood sash, one-over-one, windows with wood screens on the south elevation. Two large, wood framed sliding windows on the north elevation. Gray false bevel siding. Window frames and surrounds, wood screens and corner boards are gray. Raking cornices, fascia and exposed rafter ends are white. Red octagon composition shingle roof with overhanging eaves and exposed rafter ends.
