<b>COLORADO HISTORICAL SOCIETY</b> Office of Archaeology and Historic Preservation 1300 Broadway Denver, CO 80203		SITE NO.: SME8536
<b>HISTORIC BUILDING INVENTORY</b>		Eligible for National Register <input type="checkbox"/> yes <input type="checkbox"/> no date _____ initials _____ Criteria <input type="checkbox"/> A <input type="checkbox"/> B <input type="checkbox"/> C <input type="checkbox"/> D Contributes to a potential National Register district <input type="checkbox"/> yes <input type="checkbox"/> no district name: _____
COUNTY: Mesa	CITY: Grand Junction	Eligible for State Register <input type="checkbox"/> yes <input type="checkbox"/> no date _____ initials _____ Criteria <input type="checkbox"/> a <input type="checkbox"/> b <input type="checkbox"/> c <input type="checkbox"/> d <input type="checkbox"/> e Areas of significance: _____
HISTORIC BUILDING NAME: McCarell, J.F., House		Period of significance _____ Needs data <input type="checkbox"/> date _____ initials _____

CURRENT BUILDING NAME: Lehman Residence		LOCAL LANDMARK DESIGNATION: <input type="checkbox"/> yes <input checked="" type="checkbox"/> no Date of designation: N/A Designating authority: N/A
ADDRESS: 402 Belford A

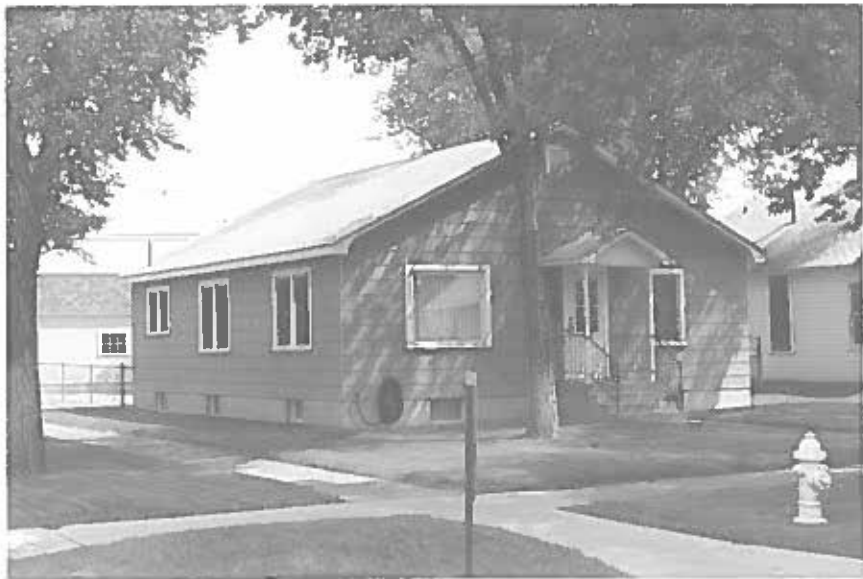
Roll 45 Frame 12 View S Dir NE

**ARCHITECTURAL DESCRIPTION:** One story with front gable roof. Concrete basement with small, single pane windows with white wood frames around house. Concrete steps, with wrought iron railings, lead to small entrance porch in center of facade. Porch has small gable roof supported by two full height 6 x 6 posts. Pediment of porch gable has decorative, scalloped base. Front door is flush with diagonal arrangement of diamond lights. Metal frame storm door. Windows around house are double hung, wood sash, one-over-one. Large fixed pane picture window on west side of facade. Green asbestos shingle siding. Porch posts and pediment, window frames and surrounds, cornices and raking cornices, and storm door are white. Gray composition shingle roof with boxed eaves.

402 Belford Ave., Grand Junction, Mesa Co, CO
