COLORADO HISTORICAL SOCIETY Office of Archaeology and Historic Preservation 1300 Broadway Denver, CO 80203 HISTORIC BUILDING INVENTORY		SITE NO.: 5ME8555 Eligible for National Register <input type="checkbox"/> yes <input type="checkbox"/> no date _____ initials _____ Criteria <input type="checkbox"/> A <input type="checkbox"/> B <input type="checkbox"/> C <input type="checkbox"/> D Contributes to a potential National Register district <input type="checkbox"/> yes <input type="checkbox"/> no district name: _____ Eligible for State Register <input type="checkbox"/> yes <input type="checkbox"/> no date _____ initials _____ Criteria <input type="checkbox"/> a <input type="checkbox"/> b <input type="checkbox"/> c <input type="checkbox"/> d <input type="checkbox"/> e Areas of significance: _____ Period of significance _____ Needs data <input type="checkbox"/> date _____ initials _____
COUNTY: Mesa	CITY: Grand Junction

HISTORIC BUILDING NAME: Moslander, Clyde, House		
CURRENT BUILDING NAME: Wilmer Residence		LOCAL LANDMARK DESIGNATION: <input type="checkbox"/> yes <input checked="" type="checkbox"/> no
ADDRESS: 1321 Main St., Grand Junction, CO 81501-4638		Date of designation: N/A Design

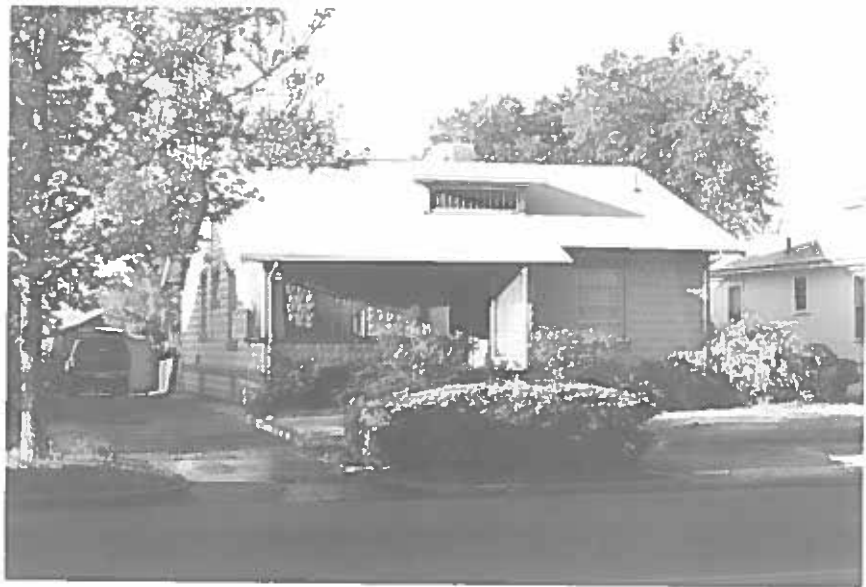
1321 Main St., Grand Junction, Mesa Co, CO
2945-133-14-011 05/14/1996
Roll 44 Frame 18 View N Dir SW

ARCHITECTURAL DESCRIPTION: One story, side gable roof. Yellow, rusticated concrete block basement with small, double light basement windows. Concrete steps with rusticated block piers on center of facade, lead to open porch extending across the east half of facade. Porch has continuous shed roof, half-wall of rusticated block with concrete coping, and two half height rusticated block corner piers. Glazed storm door. Front door is paneled and has three lights. Windows around house are double hung, wood sash, seven vertical over one, and have concrete headers and sills. Shed roof dormer on facade with narrow, twelve light wood frame window. Rusticated concrete block siding painted yellow. Gable faces have five rows of green, fishscale shingles, yellow wood shake shingles, and green fishscale shingles. Window frames and surrounds and water table are white. Porch posts are yellow with green capitals. Steps, coping, and barge boards are green. Light gray composition shingle roof with overhanging eaves. Brick chimney on north slope.

Landscaped yard with large, evergreen shrub next to street. Evergreen shrubs along facade. Backyard enclosed by chain-link fence. Mature evergreen tree in backyard.

Gravel driveway on the east side of lot leads to a one car garage in rear with front gable, gray composition shingle roof, and yellow, simple drop, siding.
