PROJECT NAME: Grand Junction Historic Resources Survey, Phase 2

305 Gunnison Ave. , Grand Junction, Mesa Co, CO

2945-142-27-001 02/28/1996

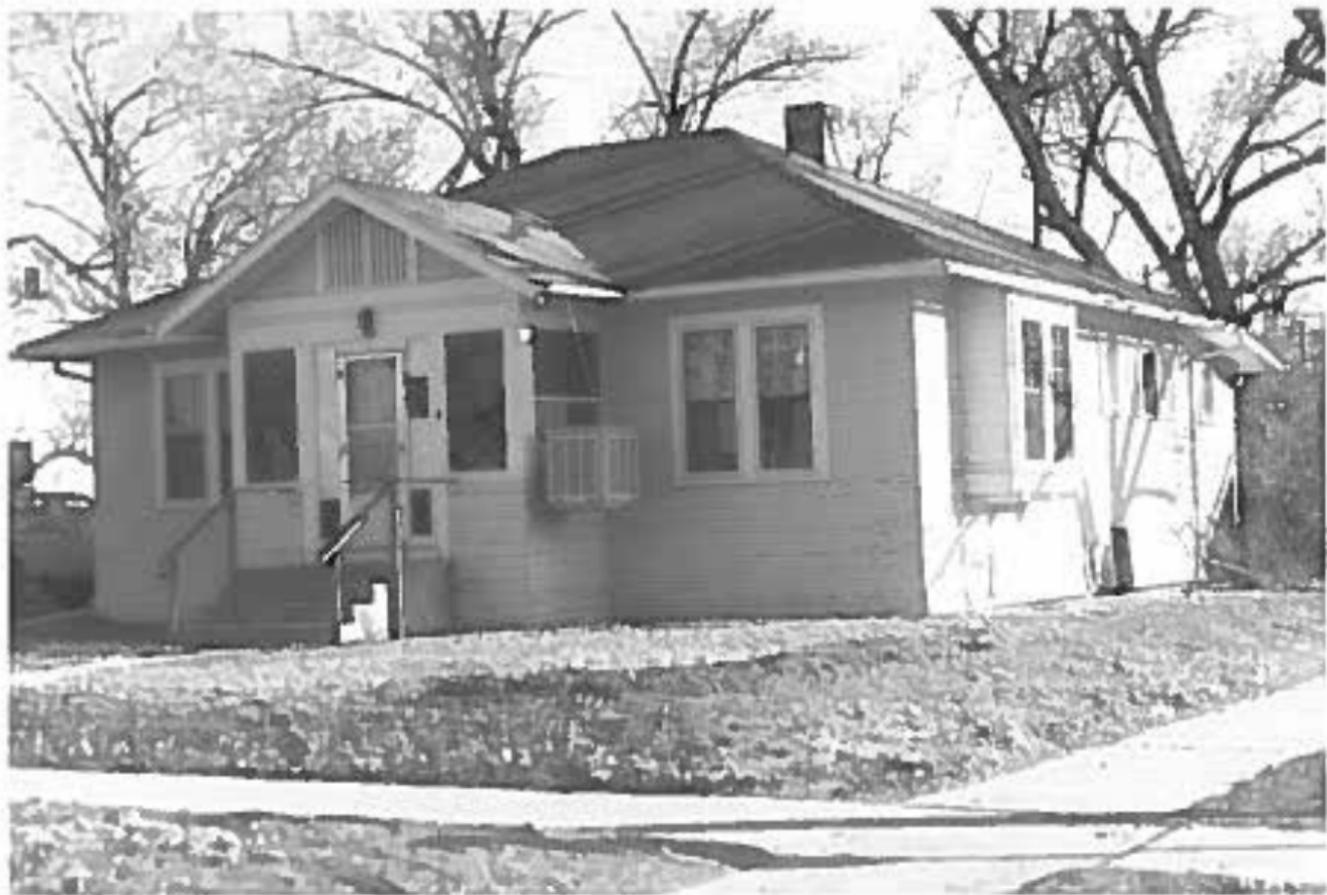
Roll 31 Frame 17 View N Dir S/SE

ARCHITECTURAL DESCRIPTION: One story with hip roof. Slightly flared foundation. Concrete steps and stoop have wood railings. Gabled sunporch/entry on the center third of facade. Siding on half-wall. Squared half height columns are on the porch corners. Two full height columns flank the porch door. Glazing is large single lights on the porch facade. Porch ends have single lights, two-over-two. The metal frame storm door is flanked by single light sidelights. The front door is paneled. Windows around the house are mostly double hung, wood sash, nine over one. Pairs of windows are on each side of the facade, and on the face of a projecting bay on west elevation. The eave is the roof of the bay. Two shed roof wings on east and west of rear have ribbons of eight light wood casement windows. Buff, false bevel wood siding. Door and window surrounds, columns, bargeboards and fascias are white.

Brown composition shingle roof. Porch gable face has a vertical slat wood ventilator filling the center third of the gable. Brick chimney on south slope. Lawn with high wood fence around backyard. Elm tree on east lawn. Ash and elm trees on parking area.

CONSTRUCTION HISTORY (include description and dates of major additions, alterations, or demolitions): Solar added to rear, enclosed front porch, 1993. Additional construction or modifications not noted in Assessor's records.
