HISTORIC BUILDING INVENTORY

SITE NO.: 5ME8637

HISTORIC BUILDING NAME: Claire's Auto Service

PROJECT NAME: Grand Junction Historic Resources Survey, Phase 2

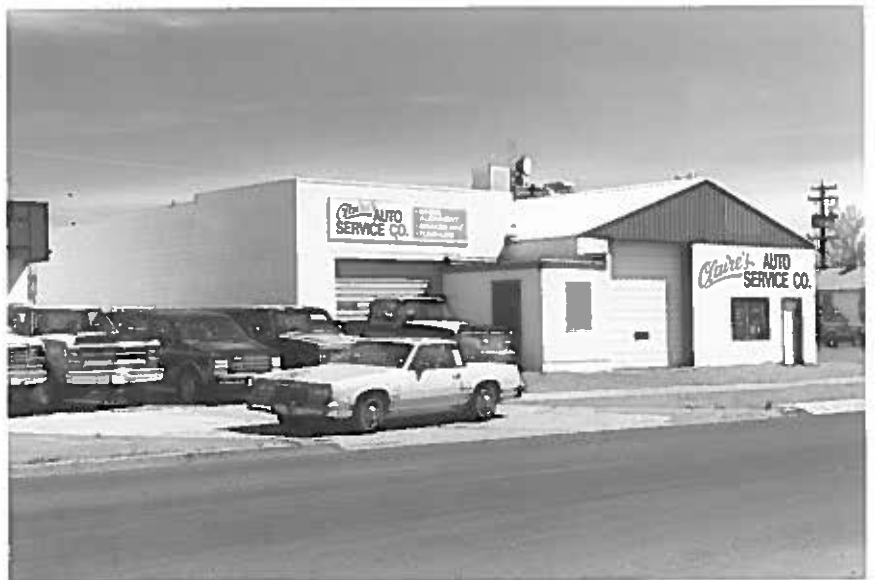
524 Pitkin Ave., Grand Junction, Mesa Co, CO
2945-143-32-009 04/29/1996
Roll 41 Frame 7 View S Dir NW •
(East half of building)
SME8637

ARCHITECTURAL DESCRIPTION: One story, front gable. Concrete foundation. Concrete stoop. A paneled metal door is near the east corner of the facade. West of the door is a pair of single light, fixed metal frame windows. On west half of the facade is a large high metal vehicle door with a slit window 4' above grade. On east elevation is a flush metal door and four metal eash windows with six lights. The sills are concrete. On the north elevation is a metal vehicle door. The concrete block walls are painted pale buff. Door frames, facade window frames, window sills and facade gable face are painted brown. The low pitch roof is ribbed metal. Gable faces are the same material as roof.
