PROJECT NAME: Grand Junction Historic Resources Survey, Phase 2

463 Gunnison Ave., Grand Junction, Mesa Co, CO
2945-142-28-010 02/05/1996
Roll 25 Frame 24 View N Dir S/SE
SME 8609

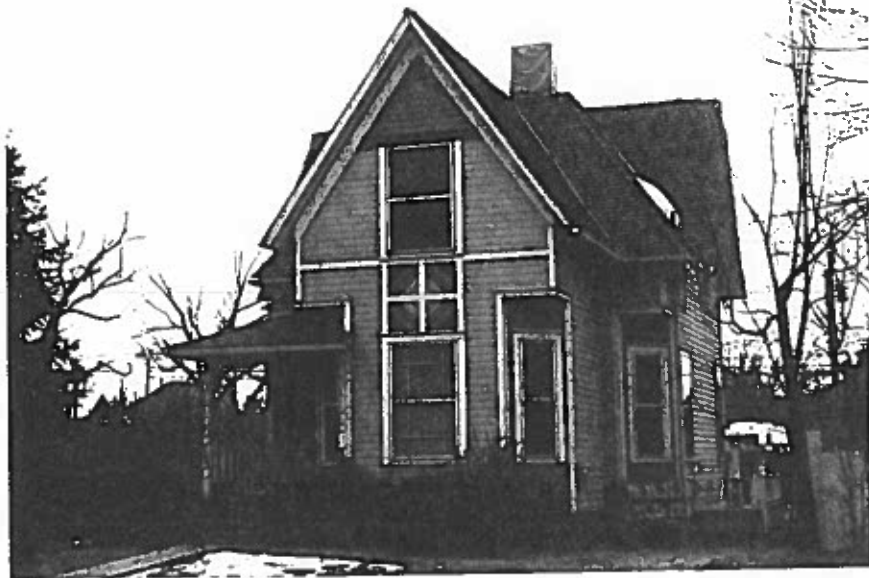
ARCHITECTURAL DESCRIPTION: Two story, hip roof with deck, and cross gables. Full basement has an apartment. Wood steps lead to open porch with hip roof on east side of facade. Three full height turned posts are on corners. A balustrade with turned spindles on east elevation of the porch. Paneled Eastlake door has a large light. A stairway to the basement apartment is on the west elevation. Windows are double hung, wood sash, one-over-one. Cutaway corners on the first floor of the front wing, and on front corner of the east and west elevations. Cutaways have a window on the face. On the first floor facade is a fixed sash window with a large center light. Muntins set off narrow lights around the four sides of the center light. White metal frame storm windows. Across the center third of the rear is a shed roof addition with full height single light windows. Cantaloupe, simple drop wood siding. Window and door surrounds, door, posts and balustrade, corner boards, string courses, frieze and cornices are cream. Cutaway faces and gable face shingles are brown. The water table and string courses in the gables are russet. On facade is a panel of siding laid on the diagonal, painted with the four colors. Wood shingle roof. Boxed eaves have cornices. Facade gable and east and west cross gables are steeply pitched, with notched wood shingles on the gable faces.
