HISTORIC BUILDING INVENTORY RECORD

project name: Grand Junction Downtown Survey  
county: Mesa city: Grand Junction  
state ID no. SME 7177 temporary no.  
current building name: Hardy Rooms  
address: 628 Colorado, Grand Junction, CO 81501  
owner: Grand Junction Downtown Development Authority  
115 N. 5th Street, Grand Junction 81501-2667  
township: 1S range: 1W section: 14, SE 1/4 SW 1/4  
historic name: Hardy Rooms  
USGS quad name: Grand Junction, CO N3900-W10830 1962 X 7.5'  
15'  
district name:  
block: 116 lot(s) 25, 26 addition: City  
yr. of addition  
film roll by: Marty Alexandroff no.  
negative nos. 6941-29, 6835-17  
location of negatives: City of Grand Junction  
date of construction: \_\_\_\_\_ estimate 1900 actual  
source: 1981 Historic Survey of City  
use: boarding house present boarding house historic  
condition: \_\_\_\_\_ excellent \_\_\_\_\_ good \_\_\_\_\_ fair  
X deteriorating  
extent of alterations: X minor \_\_\_\_\_ moderate \_\_\_\_\_ major

ARCHITECTURAL/HISTORICAL COMPONENT FORM

1) Resource No. \_\_\_\_\_ 2) Temp No. \_\_\_\_\_ 3) Name Hardy Rooms

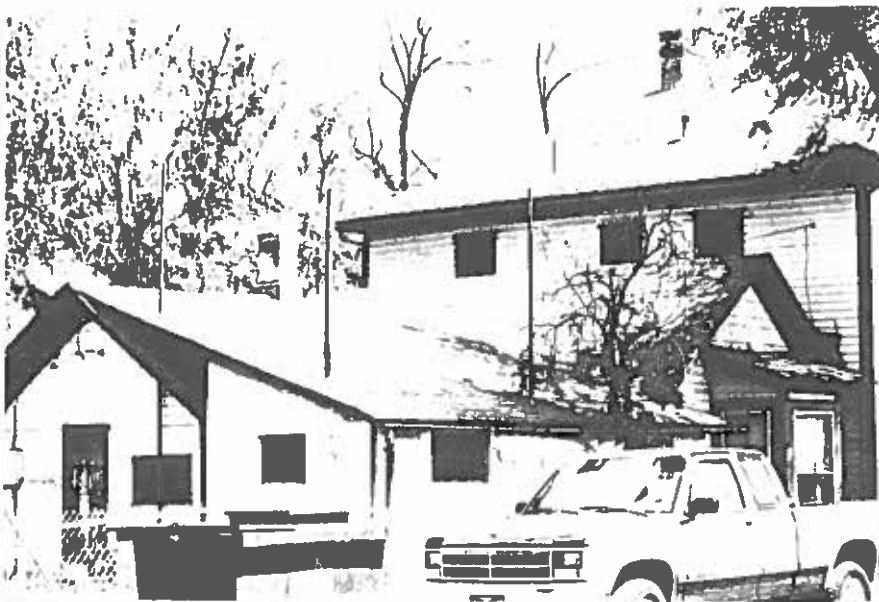
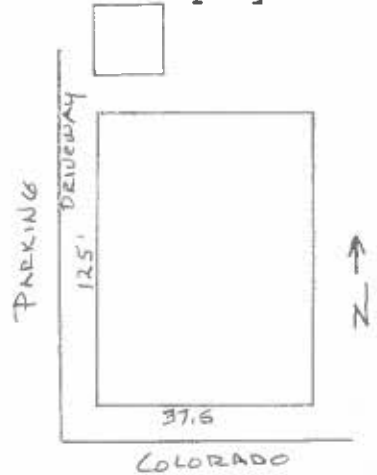
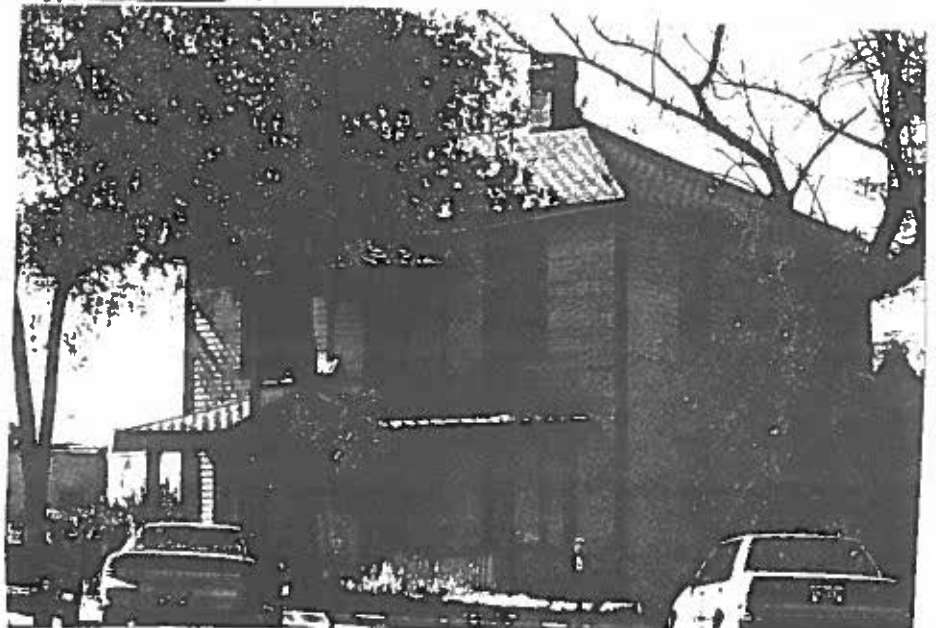
describe: Additions to rear  
style: Venacular Wood Frame Residence  
stories: 2

architectural description: Two-story, Venacular wood frame house with asphalt shingled hip roof and brick chimney on roof ridge. One-over-one double hung, wood sashed windows are on upper level. Second level has centered porch with gable roof and balustrade. Porch on first level has hip roof of asphalt shingles and balustrade and railings. Additions in rear are wood frame with intersecting gable roof and chimney on roof ridge. Large trees and some shrubbery are on the property.

construction history: (description, names, dates, etc. relating to major additions or alterations to original structure)  
Additions to rear--dates unknown

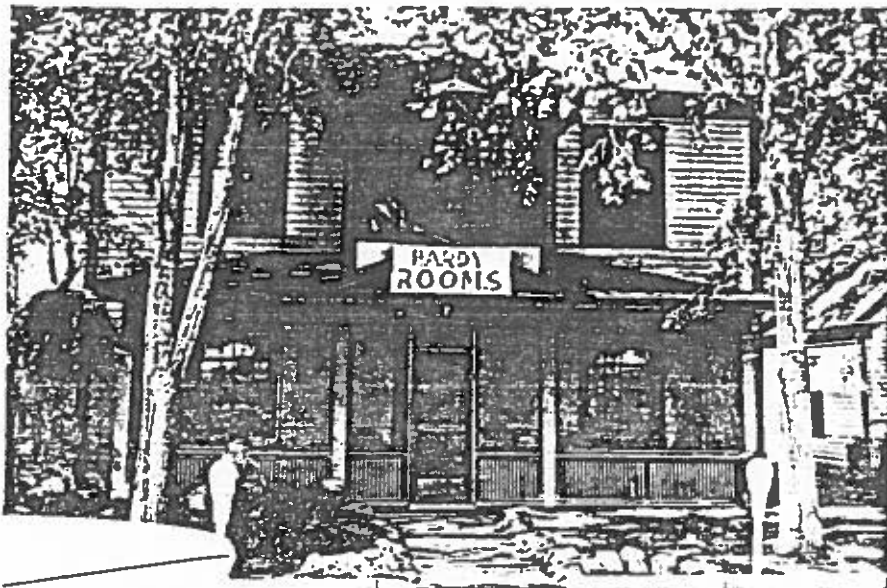
Frame Number 3,4  
Roll Number 17  
Facade Orientation N

10) Unaltered \_\_\_\_\_ Altered x Explain: Porch Screened, Accessory Bldg in alley

*large 2 story frame sided w/HL  
hip? roof 1/2 wood (rustic) windows  
on upper level  
door toward center and back  
to porch wood w/peas posts  
gable roof  
shed roof porch one lower  
front wood posts  
wood railing across front  
& side door*
