## COLORADO CULTURAL RESOURCE SURVEY

## INVENTORY RECORD

3)Resource Name4)Project NameHSI: Gnd. Jct. Vicinity
5)Category: Arch. Site, Hist./Archit. Structure X, Hist./Archit. District
6)(For Arch. site)In a District:yes_no <sup>X</sup> ;Name;
II. LOCATION: 7) Township IN ; Range IW. ; 4 of 12 of NE 2 of 2 of 2 of
Section 32; P.M. UTE PM . 8)County Mesa

14)Address 773 24 Rd. Lot Block Addition
III. MANAGEMENT DATA: 15)Field Assessment: EligibleNot EligibleNeed Data
16)Owner/Address Sharon D. Tuchscher 245-1503

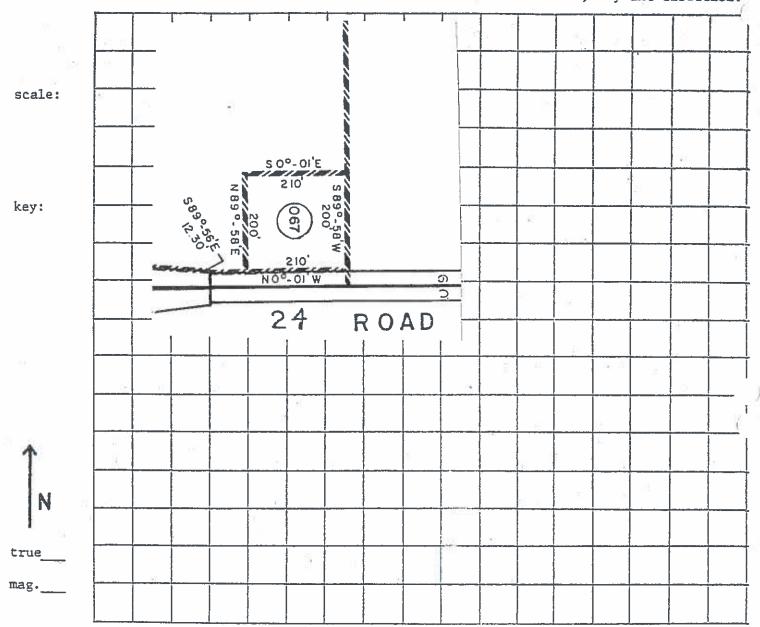
V. SKETCH MAF: Map all features and show the boundaries of the resources. Show all major topographic features, permanent modern features, and vegetation zones as appropriate Give names of features, streets and addresses if known. Provide scale, key and direction.

as shown on assessor map.

ownership.

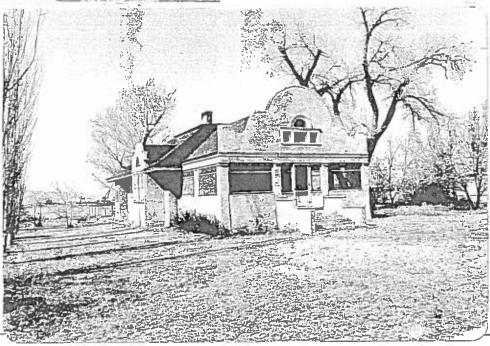
Frame Number35Roll NumberA6Facade OrientationE

-	
Altered <u>x</u> Explain:	porch screened in: minor	change	
			5
Date 1913	13) Architect/Builder		
Style(s) Mission sty	/le		
res/Surroundings:leaded	glass windows		
, 동작 전 생기 등기		die se	5
	21 - Carl 40 - Carl		<u> </u>
and off of the second	: 'NY 2017 - 2017 - 2017		
1 Peterstin I. Vec No.	Tinknown Fynlains		
ai rotentiai; ies no			5.5 * *
CTTVITIES. Ver the recour	ce type (ie: house harm s	bed school chur	ch.etc)
to the cultura	1 activity theme and sub-th	eme category asso	ciated
with it,

The house was built by Archie and Ema Thrailkill, in 1913. The Thrailkills traveled to California every winter due to the poor health of their son. Mrs. Thrailkill was impressed by the California Spanish farmhouses and she patterned her new house after these. The house is constructed with a lathe base and a stucco finish.

This mission style farm house possesses a high degree of integrity and is a style very rare in Mesa County.
