COLORADO HISTORICAL SOCIETY Office of Archaeology and Historic Preservation 1300 Broadway Denver, CO 80203		SITE NO.: 5ME7886 Eligible for National Registeryesno dateinitiats CriteriaABCD Contributes to a potential National Register district
HISTORIC BUILDING INVENTORY		vesno district name: Eligible for State Registervesno
COUNTY: Mesa	CITY: Grand Junction	Criteria
HISTORIC BUILDING NAME: Carson, John W., House		Period of significance Needs data date initials
CURRENT BUILDING NAME: ADDRESS: 801 Chipeta Ave., Grand Junction, CO 81501-3347		LOCAL LANDMARK DESIGNATION: [] yes [X] no Date of designation: N/A Designating authority: N/A
		P.M.: UTE township: 1S range:1W NW ¼ of SE ¼ of SW% of NE¼ of section 14
OWNER NAME & ADDRESS: Donald E. Carpenter, 628 29 1/2 Rd., Grand Junction, CO 81501-5279		UTM REFERENCE-12 Easting: 711210 Northing: 4327440
		USGS QUAD NAME: Grand Junction Year: 1962; photorevised 1973 [X] 7.5' [] 15'

Resources Survey, Phase 2

801 Chipeta Ave., Grand Junction, Mesa Co, CO

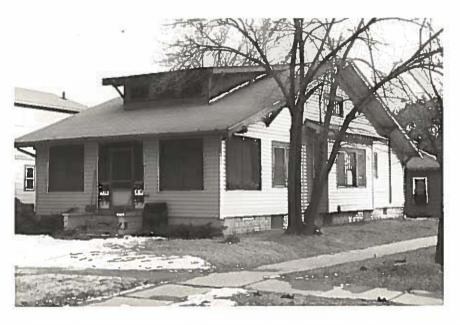
Roll
 20
 Frame
 16
 View
 N
 Dir SW

ARCHITECTURAL DESCRIPTION: One story with side gable. Concrete block foundation. Concrete steps, with concrete block piers, lead up to full width screened porch under principal roof. Siding on porch half-wall and on four wide columns. Batten front door with four large beveled lights. Windows are double hung wood sash, six, nine, and twelve over one. Wide projecting bay on west elevation has shed roof, and a ribbon of three windows. Gray metal lapped siding. White corner boards. Blue-gray door and window surrounds, knee braces and bargeboards. Gray composition shingle roof with wide eaves, knee braces, and bargeboards. Roof of bay and dormer have exposed rafter ends. Shed roof dormer on north slope has three windows, with 10 lights each and brown wood shingle soling. Brick chimney on south slope.
