COLORADO HISTORICAL SOCIETY Office of Archaeology and Historic Preservation 1300 Broadway Denver, CO 80203		SITE NO.: 5ME7887
		Eligible for National Registeryesno date initials CriteriaABCD
HISTORIC BUILDING INVENTORY		Contributes to a potential National Register district
COUNTY: Mesa	Спу: Grand Junction	Eligible for State Registeryesno date initials Criteriaabcde Areas of significance:
HISTORIC BUILDING NAME: Theos, Angelo, House		Period of significance  Needs data date initials
CURRENT BUILDING NAME: Bilbao Residence		LOCAL LANDMARK DESIGNATION: [ ] yes [X] no  Date of designation: N/A  Designating authority: N/A
ADDRESS: 625 N. 11th St., Grand Junction, CO 81501-3341		
		P.M.: UTE township: 1S range:1W SW ¼ of NE ¼ of SE¼ of NE% of section 14
OWNER NAME & ADDRESS: Macia K. Bilbao, 625 N. 11th St., Grand Junction, CO 81501-3341		UTM REFERENCE-12 Easting: 711590 Northing: 4327560
		USGS QUAD NAME: Grand Junction

INVENTORY COMPLETED BY: Museum Group Staff DATE: 3/29/96 AFFILIATION: Museum of Western Colorado PHONE: (970) 241-9117 ADDRESS: PO Box 20000-5020, Grand Junction, Colorado 81502-5020 PROJECT NAME: Grand Junction Historic Resources Survey, Phase 2

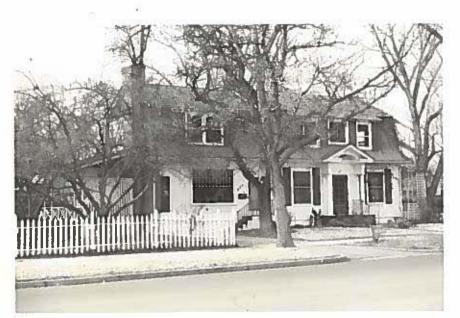
625 N. 11th St., Grand Junction, Mesa Co, CO 2945-141-29-007 1/29/1996 Roll 20 Frame 09 View E Dir NW 5ME7887

ARCHITECTURAL DESCRIPTION: Two story with gambrel roof. Painted concrete foundation. Red painted concrete steps and stoop with brick pavers on treads of steps, and floor of stoop. Wrought iron railings. Gabled portico over stoop. A Roman, fluted Doric column with cushioned base and capital at both front corners of the portico. A squared respond on both rear corners of the portico. Portico has raking cornices, return cornices, and curved ceiling. Storm door over French front door. Wing on south facade also has entry of concrete steps, wrought iron railing, and flush door with small light. Windows are double hung wood sash, one-over-one. First floor facade windows are twelve over one. Large wing on the south facade has an 8' wide fixed sash window, with twenty-four lights over one. Most windows have gray louvered shutters. White lapped siding. Red shingles and shakes on gambrel roof with flared eaves. Wide dormers and gables have red cedar shingle siding. Brick chimney on west slope. Full height brick fireplace chimney on south gable wall.
