Re: Proposal for Investigation of the Lamplite Park Subdivision

Report to the City of
Grand Junction on the
Lamplite Landslide

April 6, 2012

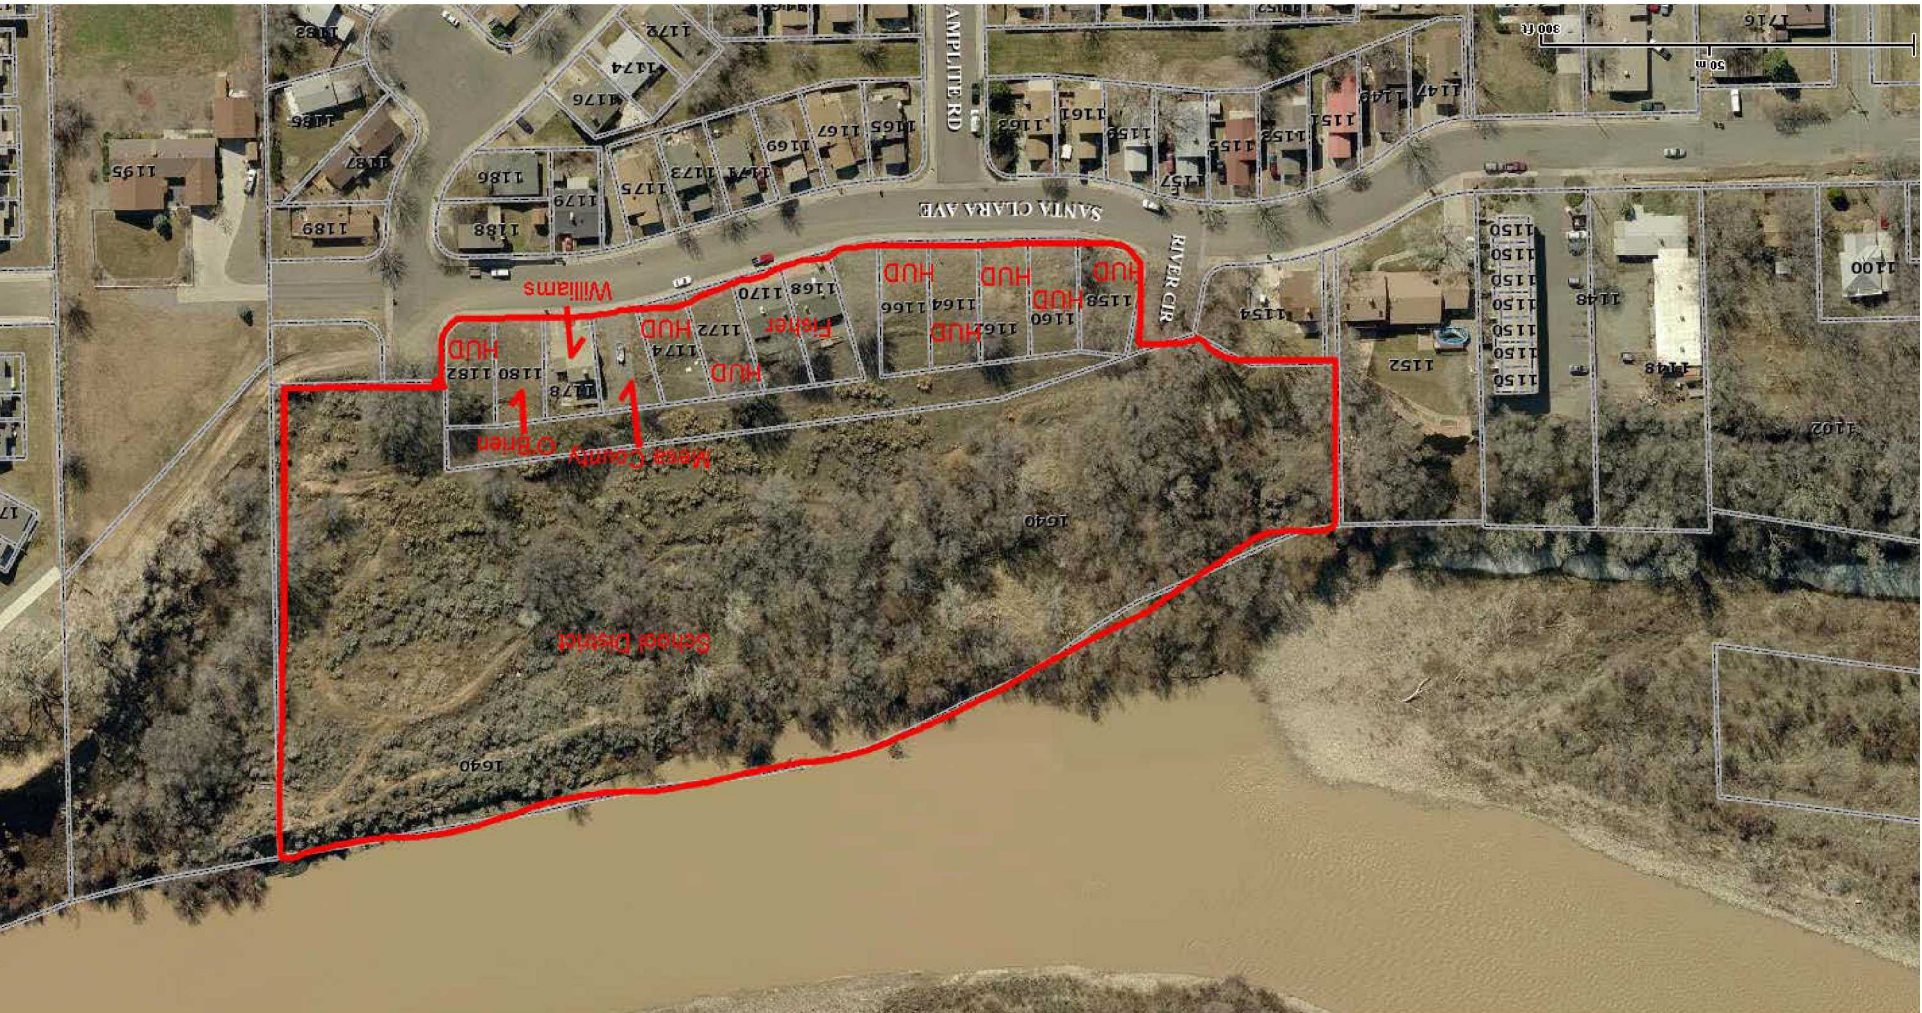
AMPLITUDE RD

SANTA CLARA AVE

CGS geologists visited the Lamplite Landslide on March 6, 2012 to remap the location of the headscarp and any new features within the landslide mass. They also attempted to find the borings from the 1985 study and the Lincoln-DeVore holes from 1977 with little success. Several locked piezometer casings were observed at the locations of the homes that were removed in 1986. The map comparison of landslide scarps and tension cracks from the original 1985 work and the new 2012 work are shown in figure 2.

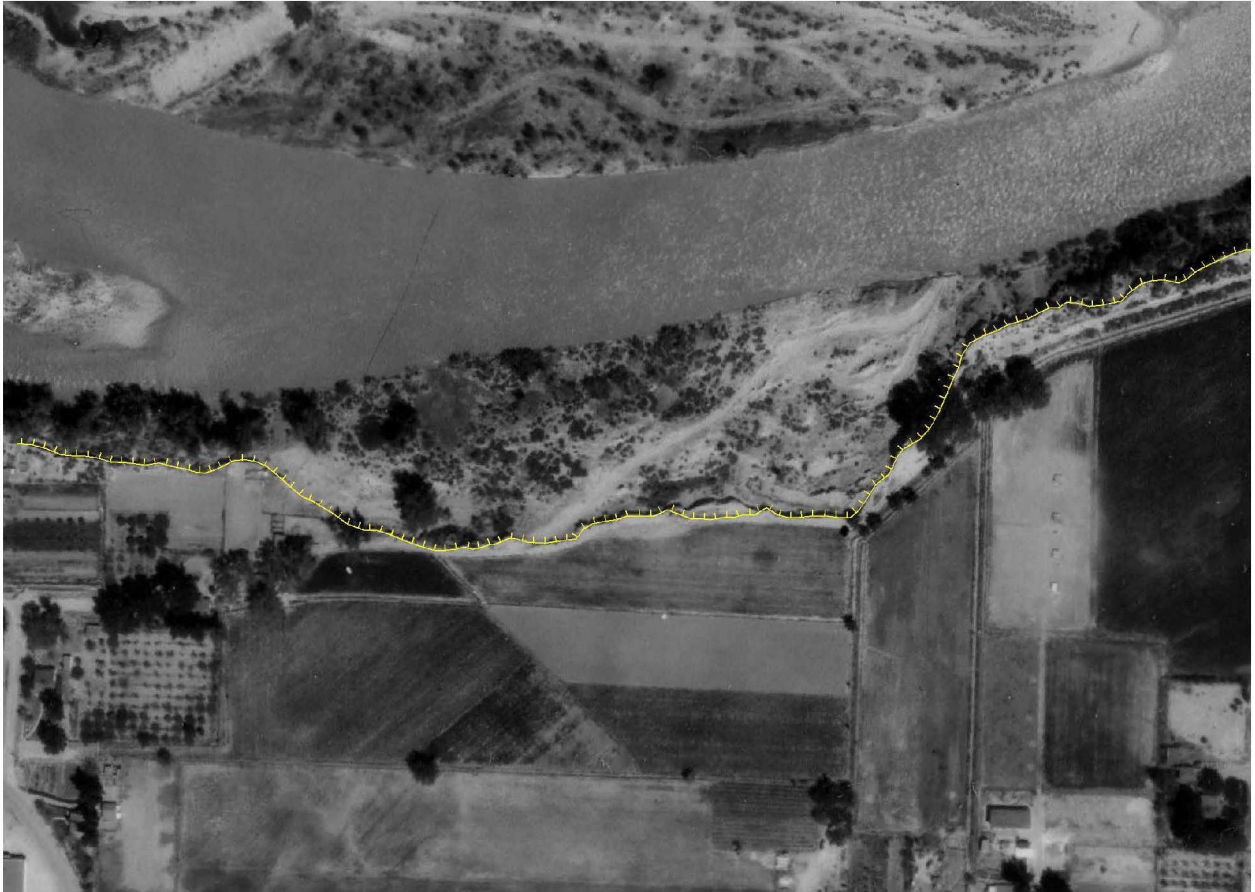
The CGS was able to obtain 1:20,000-scale black and white stereo aerial photography of the Lamplite Landslide that were taken in 1950 when the Orchard Mesa was still predominantly used for agriculture (**Figure 1**). It is clear the landslide existed at that time. The photos were scanned, georeferenced, and imported into a GIS project where the 1950 headscarp or top visible tension crack was digitized for later comparison to current images. Landslide features from the 1985 report map by the CGS were also scanned, digitized, and imported for comparison.

Figure 1. Landslide and headscarp (yellow) in 1950 prior to development.

In summary, the 2012 investigation by the CGS found direct evidence of more recent landslide movement and distress to the rear of the William's residence. The 1950 photo shows the landslide was pre-existing and the movement is not restricted to the original fill placement, but showing retrogressive failures into native materials beyond the original 1950 scarp (Figure 1). The failure is occurring by

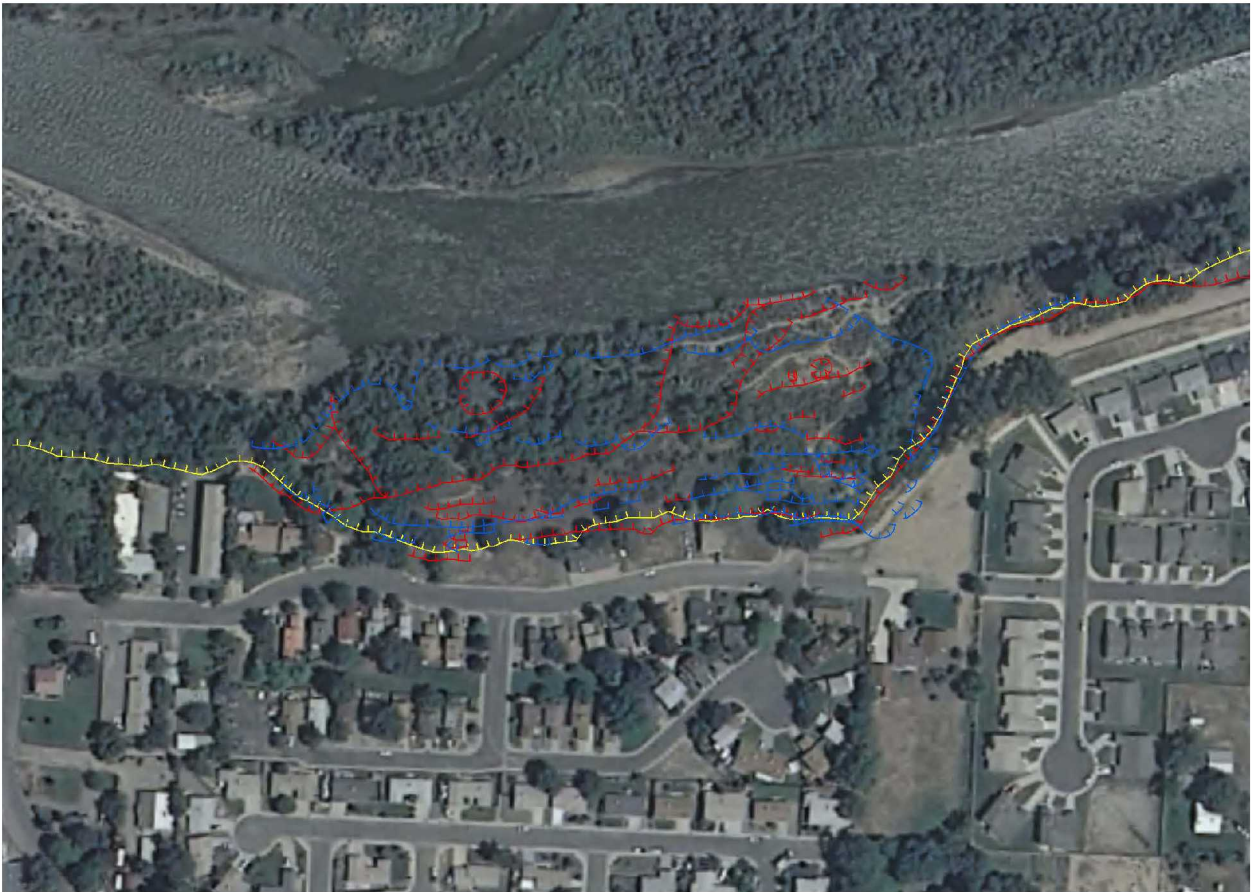
Figure 2. The Lamplite Landslide and surrounding neighborhood in a 2009 NAIP image. The yellow hachured line is the location of the 1950 headscarp and blue hachured lines are from the 1985 CGS study. The red hachured lines are scarps, pressure ridges, slumps, and depressions mapped in March of 2012.

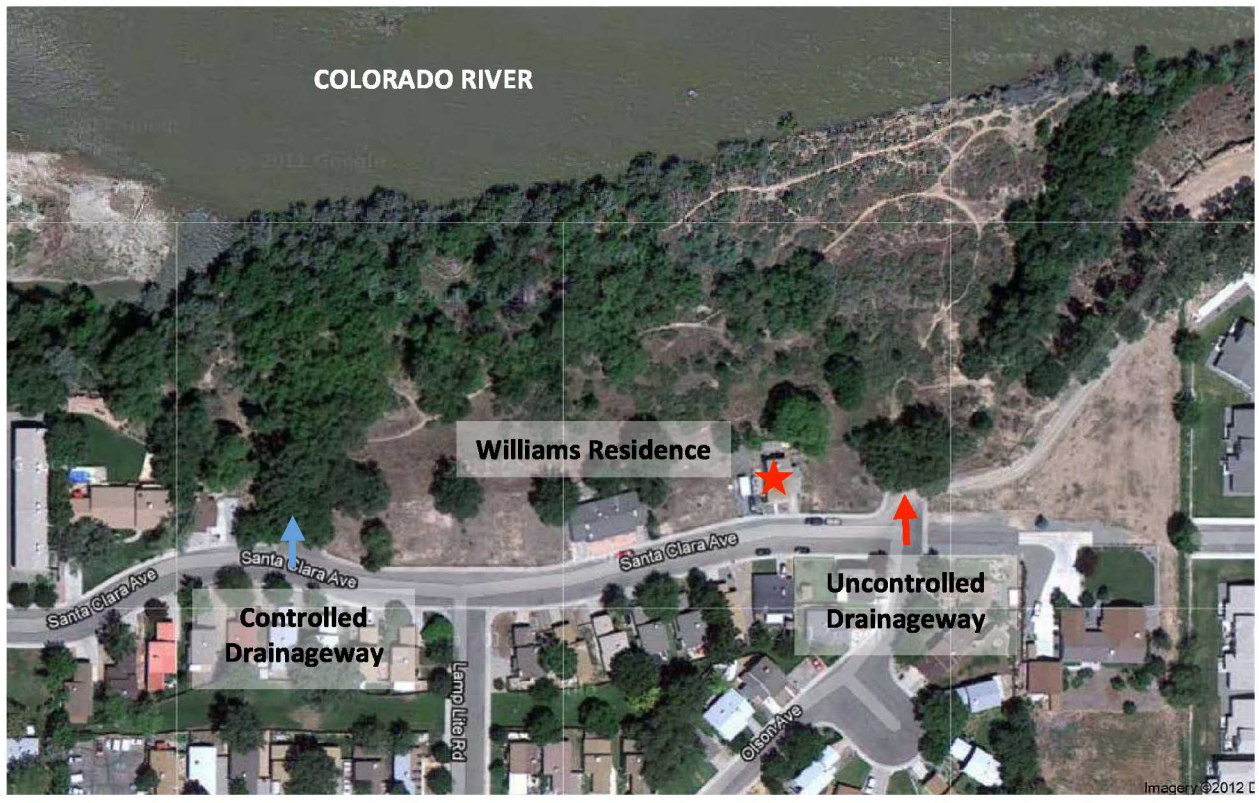
From a small parking area at the intersection of Santa Clara Avenue and Olsen Avenue, an uncontrolled drainageway empties over the main headscarp (**Figure 3**) into the landslide mass below. A fire hydrant is located nearby. Adjacent to this uncontrolled drainageway, were fresh exposures of Mancos Shale bedrock and overlying Colorado River alluvial gravels, as well as an embankment for a more recent dirt road to the east. Conversely, near the western edge of the landslide there is another curbside drainageway that is controlled by an inlet grate, cement channel, and culvert.

Figure 3. Aerial photograph of the Lamplite Landslide with locations described in this text.

- Construct culvert and storm drain improvements on the east side so storms flows don't flow onto the landslide mass in an uncontrolled manner.
- The 6x6-inch timbers currently used for fence posts on the eastern part of the landslide could be used as survey monuments by attaching reflectors to them.
