HISTORIC BUILDING INVENTORY

SITE NO.: 5ME7929

HISTORIC BUILDING NAME: Stiles, Dr. Frank, House

PROJECT NAME: Grand Junction Historic Resources Survey, Phase 2

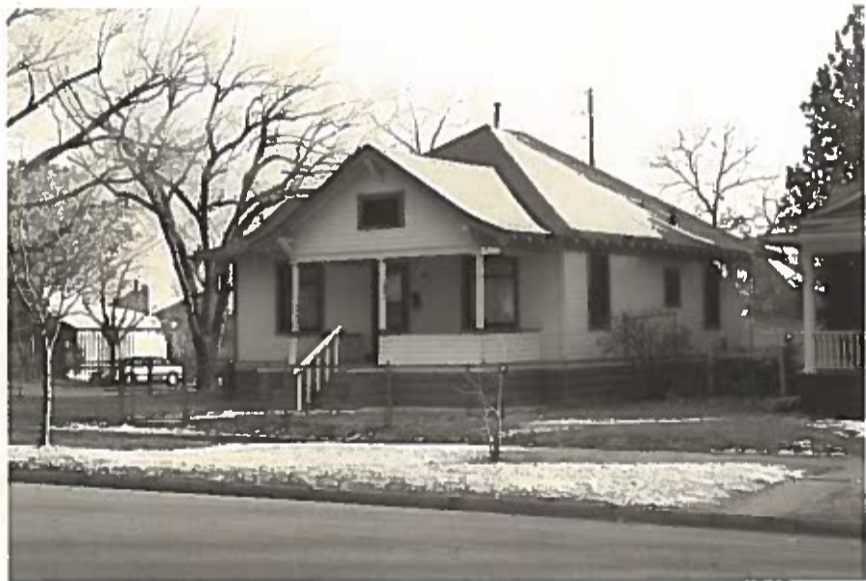
961 Chipeta Ave. , Grand Junction, Mesa Co, CO
2945-141-33-008 1/29/1996
Roll 21 Frame 04 View N Dir S/SW
5ME7929

ARCHITECTURAL DESCRIPTION: One story with hip roof. Concrete block foundation. A gabled porch on both north (front) and east elevations. Both porches have concrete steps with concrete block piers with coping. North steps have wood railing. Both porches have shingled half-walls and both have three Tuscan half columns across the porch with cushioned bases and capitals. East porch is screened and has a screen door. The front (north) door is paneled with a very large light. Storm door. Windows are double hung wood sash, one-over-one. On north and south facades, they are transom over one, with lozenge pattern leaded glass. Buff false bevel siding. Window and door surrounds, foundation and bargeboards are russet. Brown composition shingle roof with flared eaves. Exposed rafter ends and bargeboards are shaped. Knee braces under eaves have ornamental sawing. Gable faces have buff wood shingles and a window with eight lights. Brick chimney on the south slope.
