HISTORIC BUILDING INVENTORY

SITE NO.: 5ME8377

HISTORIC BUILDING NAME: Hands, Dr. Wilbur, House

PROJECT NAME: Grand Junction Historic Resources Survey, Phase 2

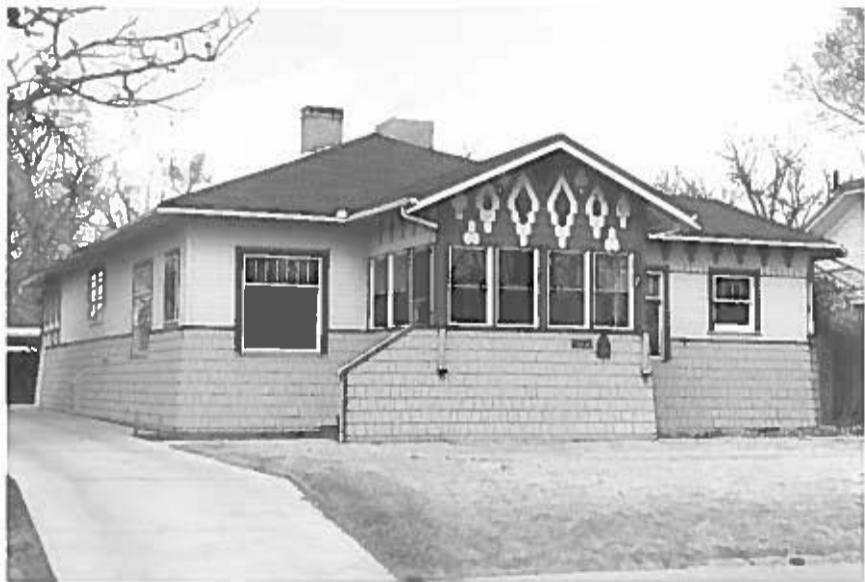
Roll 33 Frame 12 View S Dir N/NE

ARCHITECTURAL DESCRIPTION: One story, hip roof with front gable. Battered foundation. Carpeted wood steps, has half wall pier, with a downward sloping coping. The steps approach the gabled sunporch/entry from the west side. Ribbons of double hung metal sash, one-over-one windows on three sides of porch. Shingled battered half-wall. Across the facade are three 4x4 half posts. The storm door is metal framed. The front door is paneled with four vertical lights. Windows around the house are double hung wood sash, four vertical lights over one. On the facade flanking the porch, and on the west elevation, are large windows with seven light transoms. A short wing on the east elevation has a cutaway bay with a pentagonal roof. Light gray, narrow lapped, wood siding. The battered foundation on house and porch tapers inward to a six foot height on the walls and is sided with gray wood shingles. Door and window surrounds, and porch posts are gray. Dark gray composition shingle roof. On the porch gable face, under the eaves, under the eave of the east facade and its wing, are multi-color fishscale shingles in geometric patterns. They are shades of gray and russet. A brick chimney is on the west slope.

Lawn has sloping embankment near the sidewalk. A large elm is on parking area. Annual bed across the facade
 Two car garage at rear with a hip on gable and gray false bevel siding. Adjoining is a storage shed with gray vertical siding and a fiberglass roof carport.

1022 Gunnison Ave., Grand Junction, Mesa Co, CO
