File           CUP-1995-137

Project Name: Retail Center

Accompanying is a modification to the existing Conditional Use permit issued by the City some months ago for the Rimrock Marketplace shopping facility. The site is located south of Highway 50 and west of 25 1/2 Road.

<b>SITE PHOTOLOG</b>	<b>StatesWest</b>	<b>Phase I ESA</b>
Site:Hwy. 6 & 50, Grand Junction, Colorado	Environmental Corporation	12/30/94

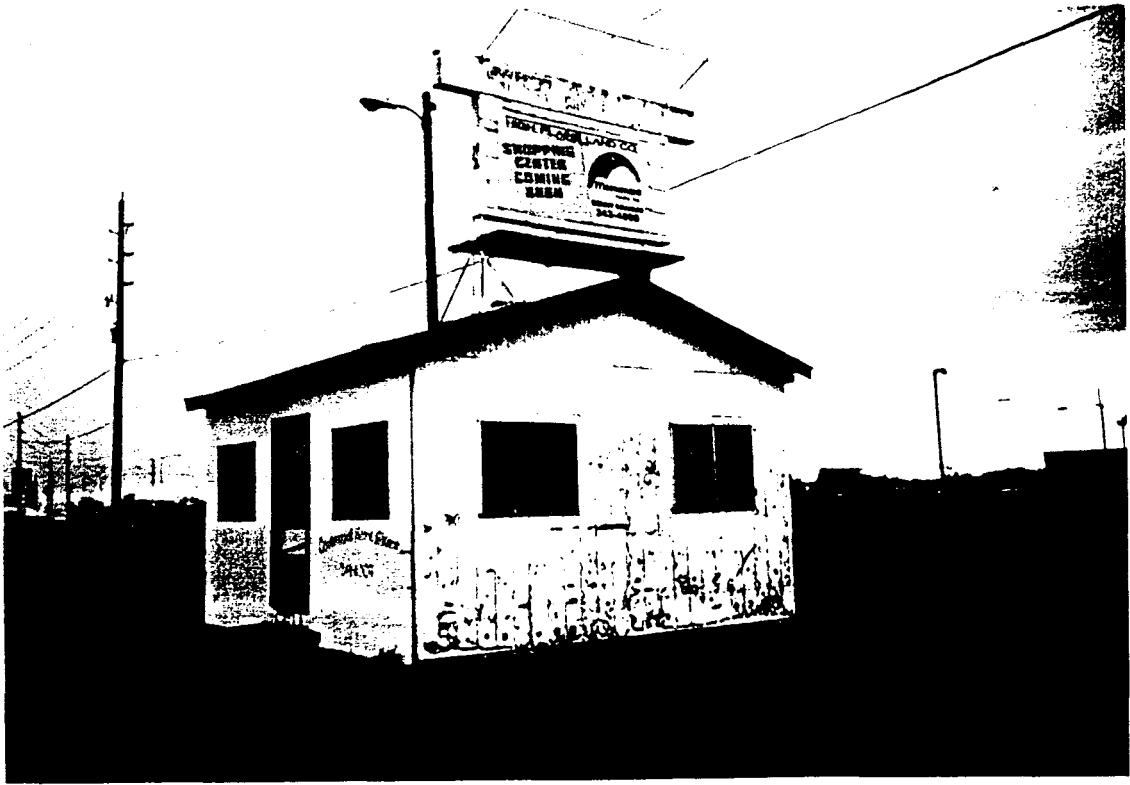
PHOTO NO: 10

10.	Central location of lubricants and gear grease. Note staining of concrete floor.
11.	Building located on northeastern portion of Ligrani property previously used for mobile home sales. Note vent pipe to UST to the right of the structure.
