TANK BOTTOM INSPECTION REPORT

**City of Grand Junction
South 4.0 MG Water Storage Tank
170' Diameter**

**Water Treatment Plant
Grand Junction, Colorado**

Inspection Completion Date: November 20, 2025

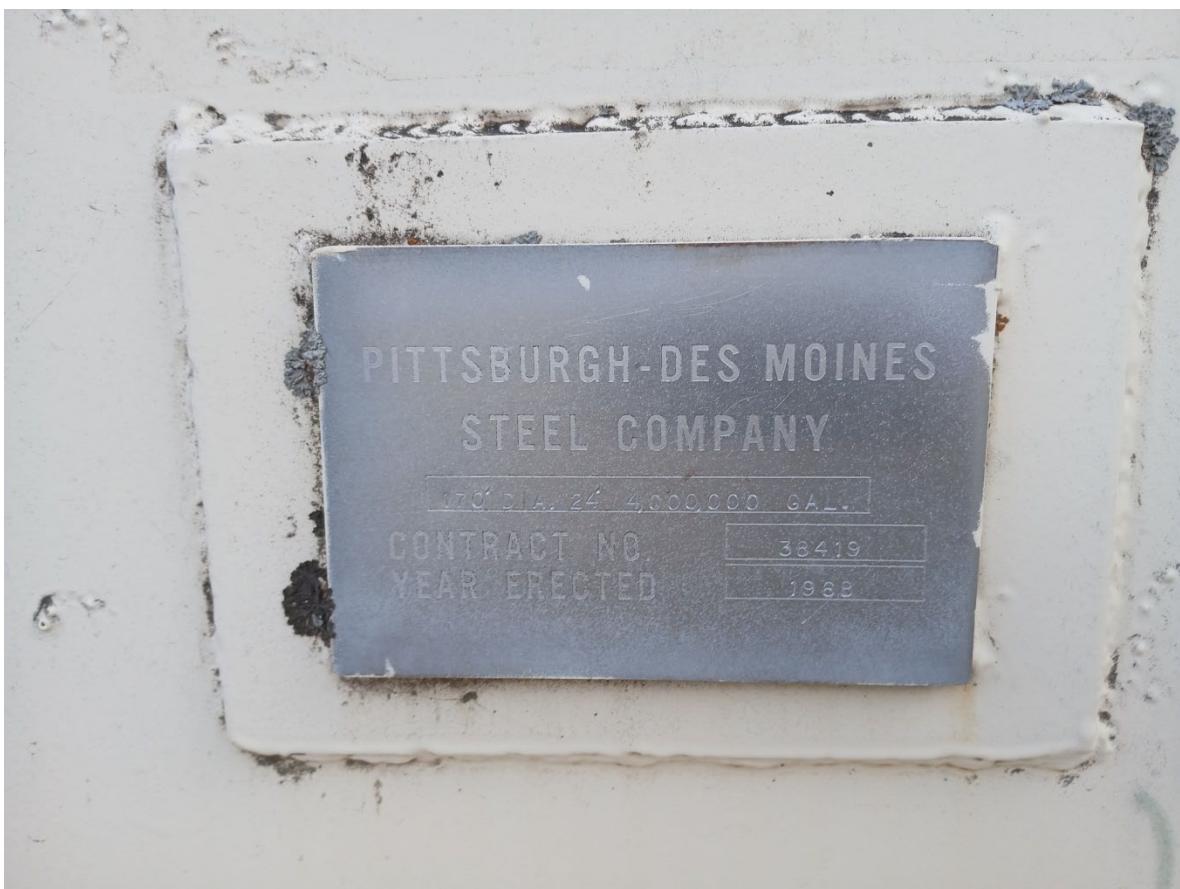
The tank was constructed in 1968 per a manufacturer nameplate above the manway on the North side of the tank. See photos 01 and 02. A few drawings related to the tank were provided and reviewed. These drawings are included with this report.

Photo 02. Tank construction nameplate

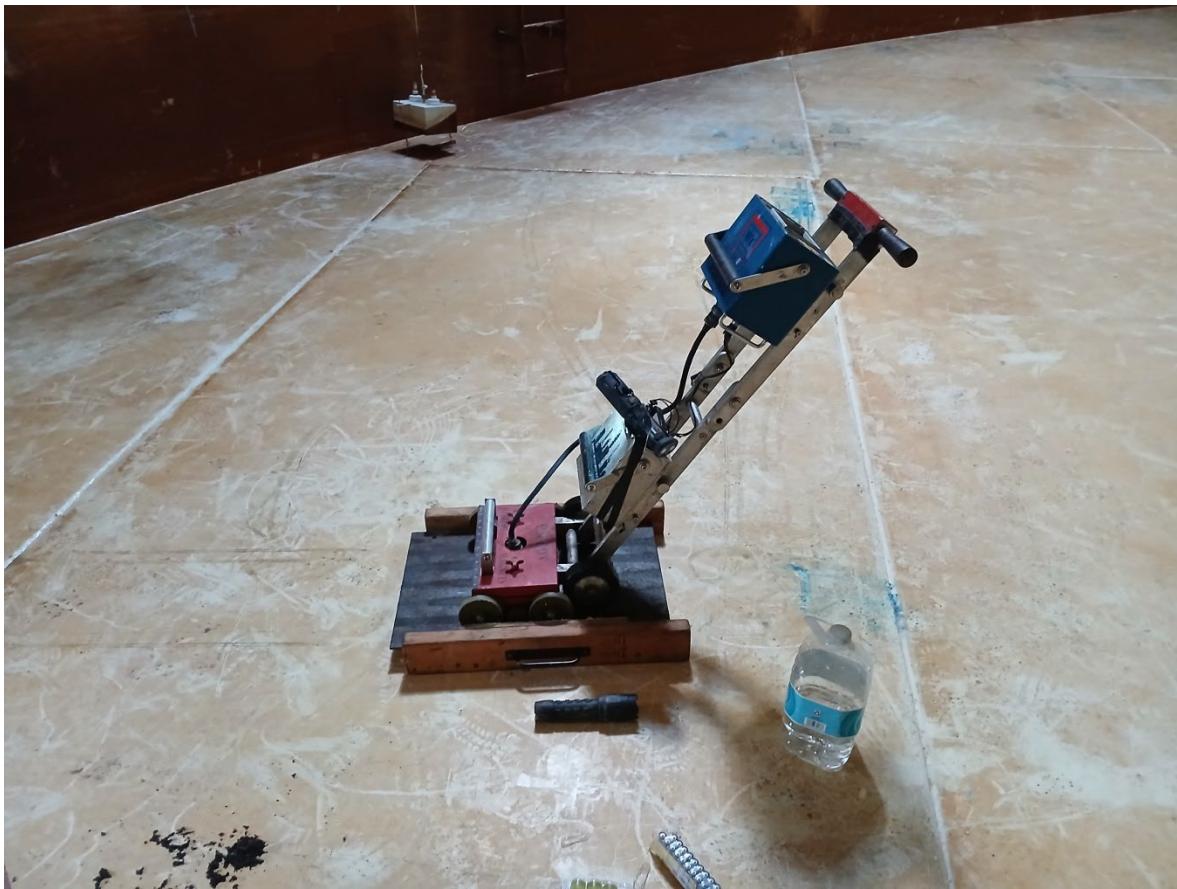
A MFE Enterprises 2412 Mark II scanner was setup for a 0.250" nominal bottom thickness with a thin film coating. The "green" wheels were utilized with the scanner setup and verified with the manufacturer provided 1/4" steel function plate. See photos 03 and 04. Guidance from the attached Premier NDT MFL procedure along with the scanner manufacturer manual was followed. The scan was completed to determine if corrosion / pitting was present from the soil side of the bottom. In addition, product side pits with detectable volume loss could be identified with the scan. The following issues were identified with the MFL scan:

Photo 03. MFL scanner on function test plate

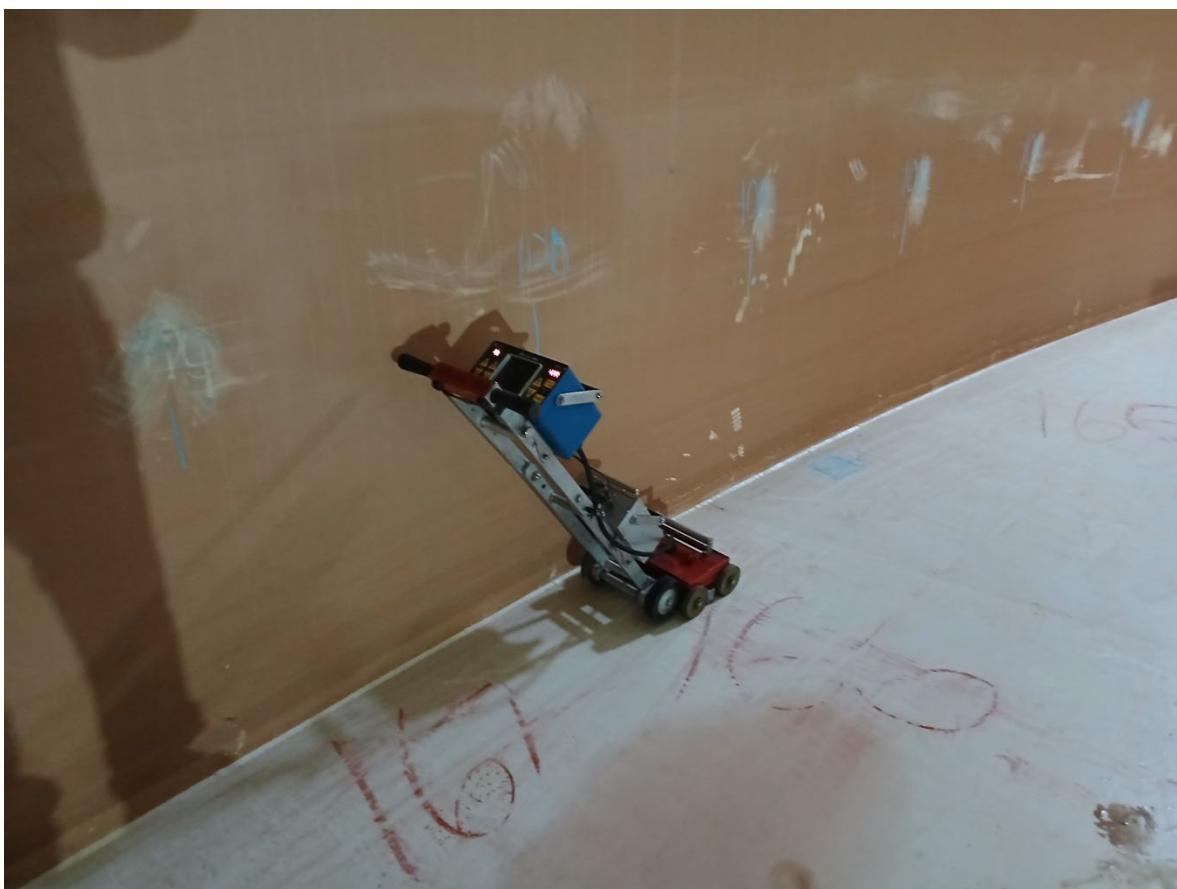
Photo 04. MFE Enterprises, Mark II 2412 floor scanner

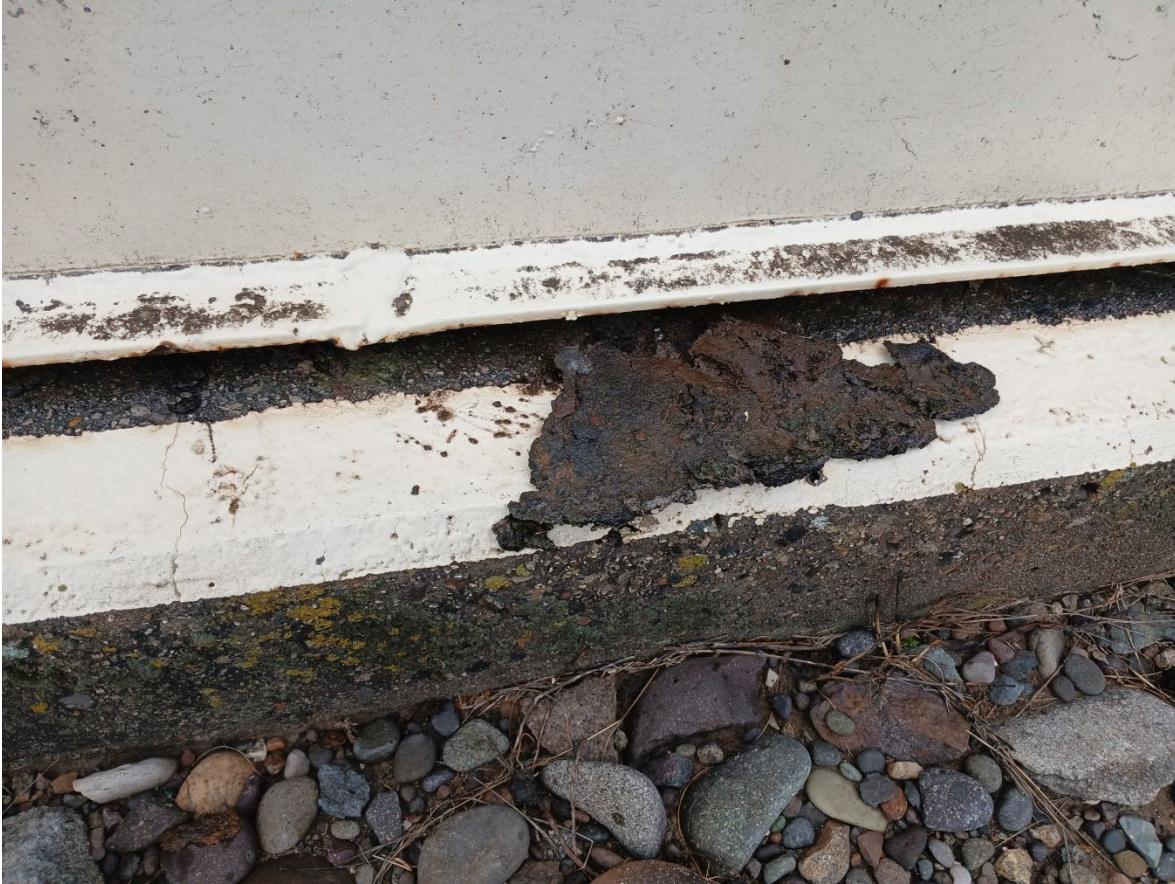
- On the external side of the tank, the bottom plate projection was visually inspected. There are significant gaps between the concrete ring wall and the bottom plate projection. The most significant gaps are on the West side of the tank where mud jacking was completed around the sump. The air gap is up to 1 $\frac{1}{4}$ ". The current condition allows water to migrate under the bottom. There are widely scattered areas of hairline cracks in the concrete ring wall. The surrounding grade is higher than the concrete ring wall at a few locations. See photos 07 through 17.

Photo 15. Remnant of asphalt impregnated fiberboard between concrete ring wall and bottom

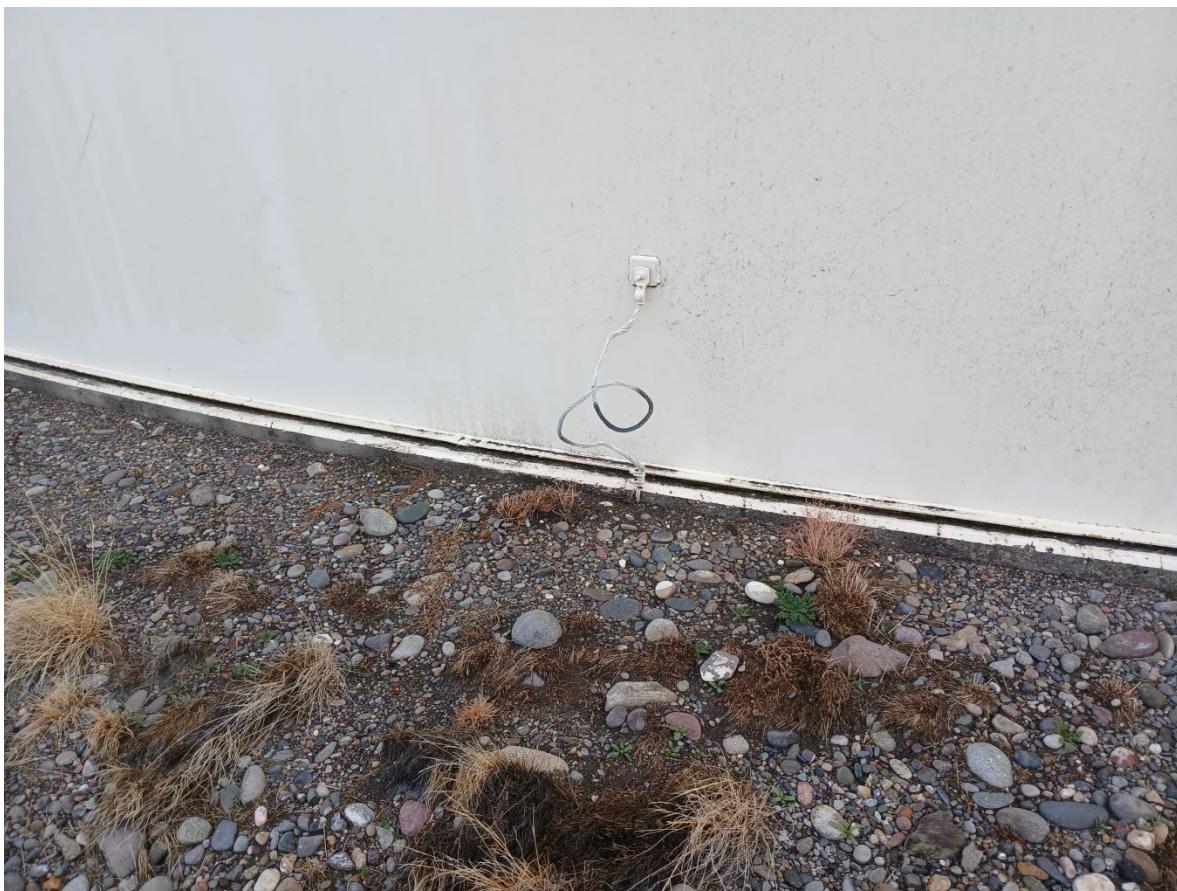
- There is a cathodic protection rectifiers mounted to the shell at the North side of the tank that is an impressed current system for the interior of the tank at three (3) anodes suspended above the bottom. See photos 21 and 22. A CP system for the soil side of the tank bottom was recently installed. See photo 20. Two (2) grounding wires were identified for the tank. See photos 18 and 19.

Photo 18. One (1) of two (2) grounding wires at bottom of tank

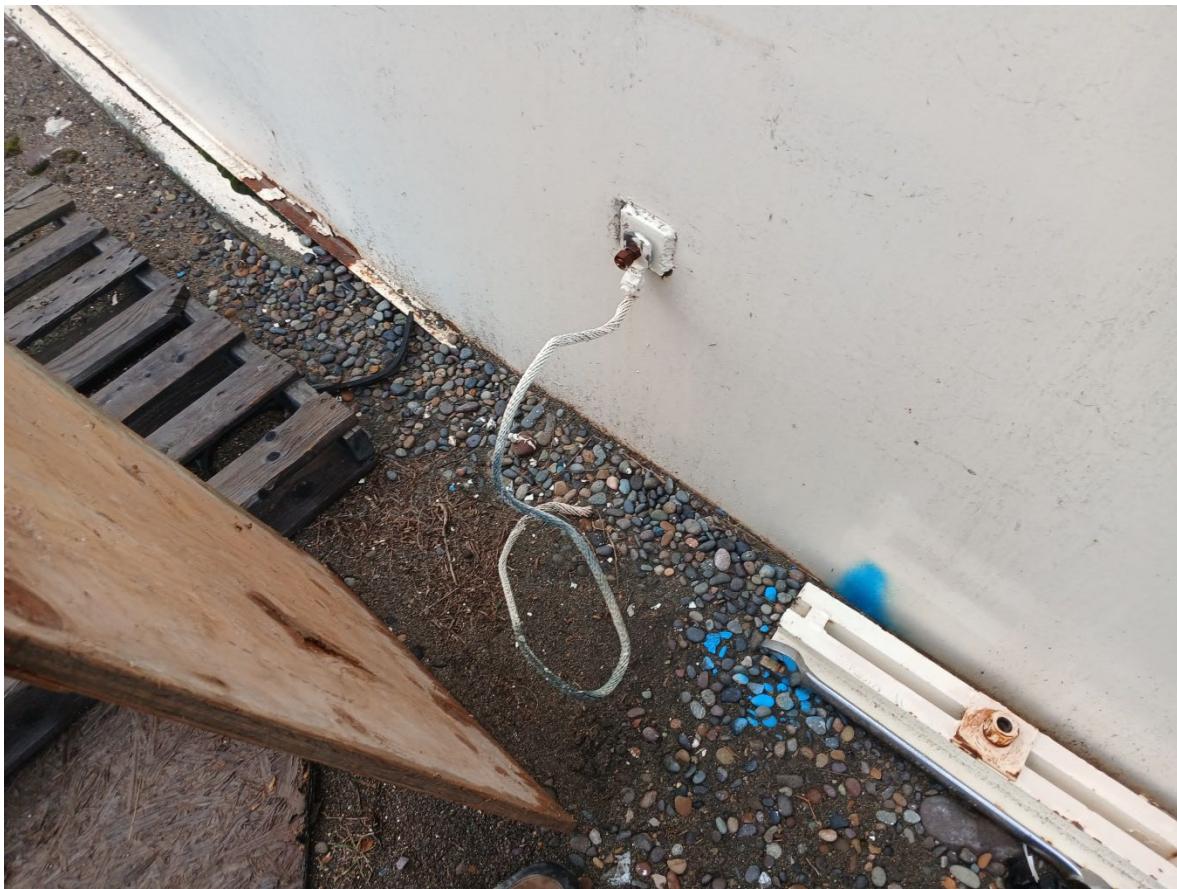
Photo 19. Two (2) of two (2) grounding wires at bottom of tank

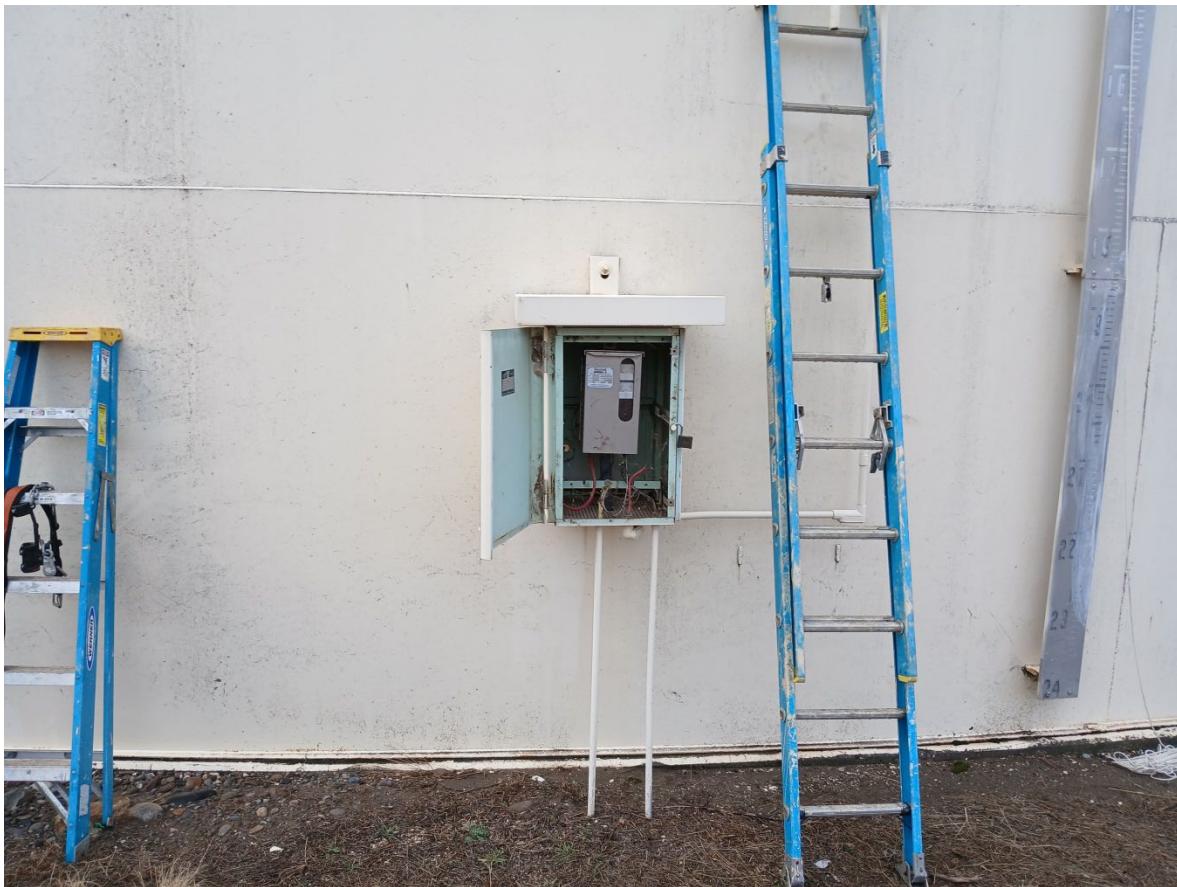
Photo 20. Cathodic protection rectifier for soil side of tank bottom

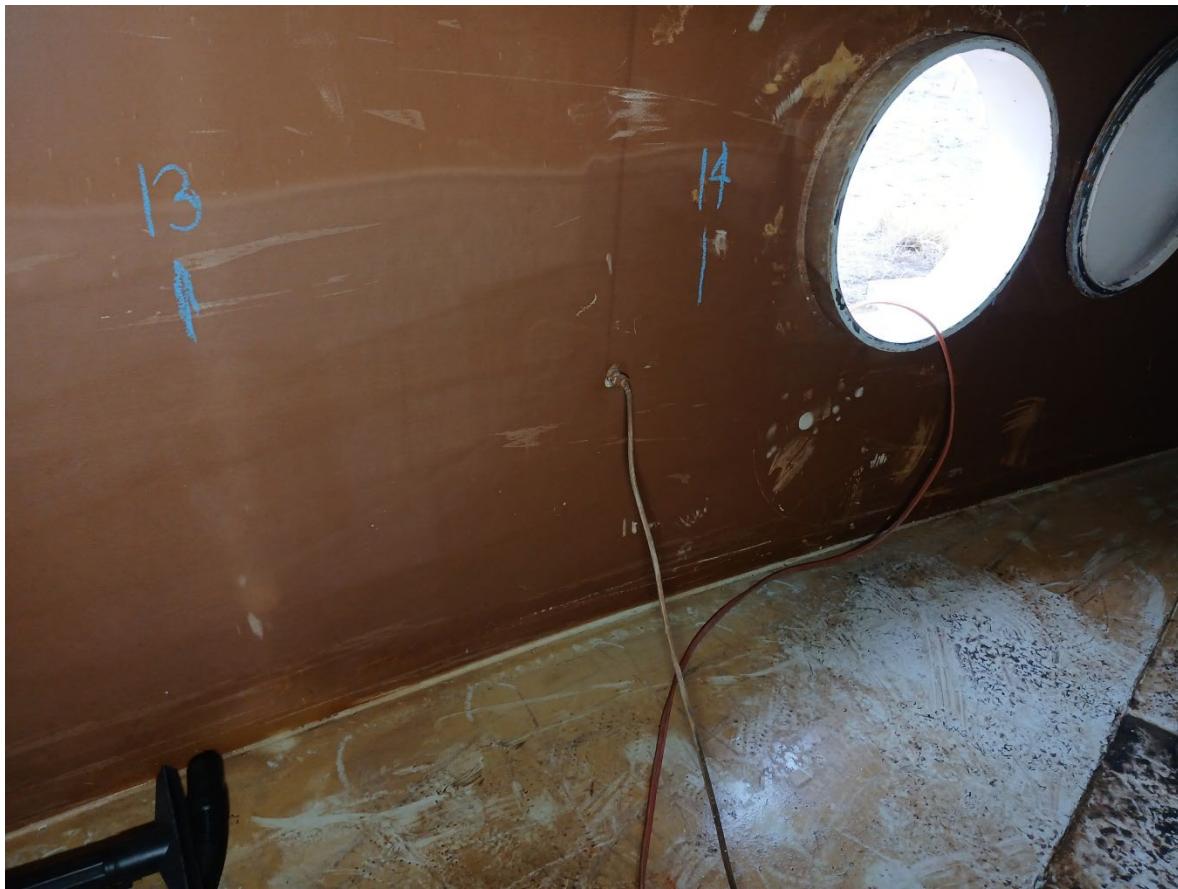
Photo 21. Shell connection for internal impressed current CP system

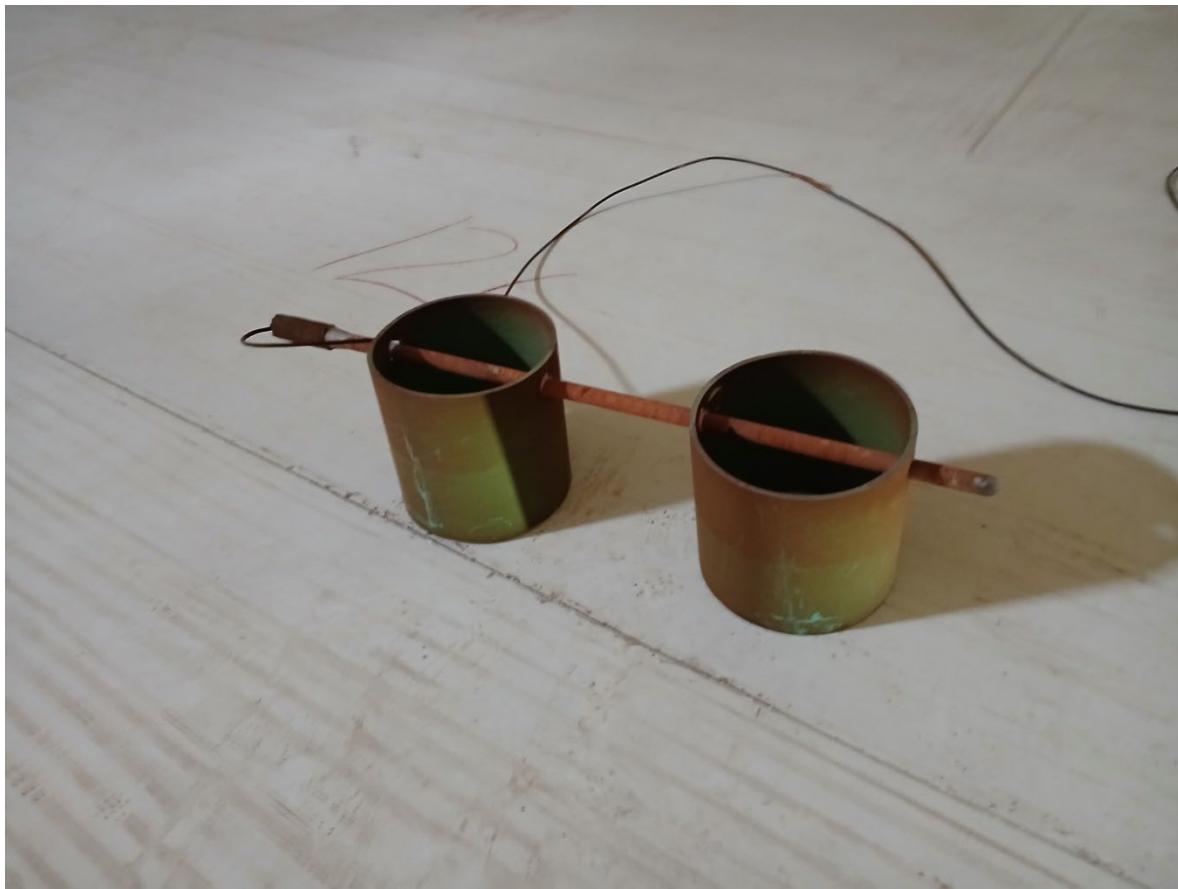
Photo 22. One (1) of three (3) anodes associated with internal impressed current CP system

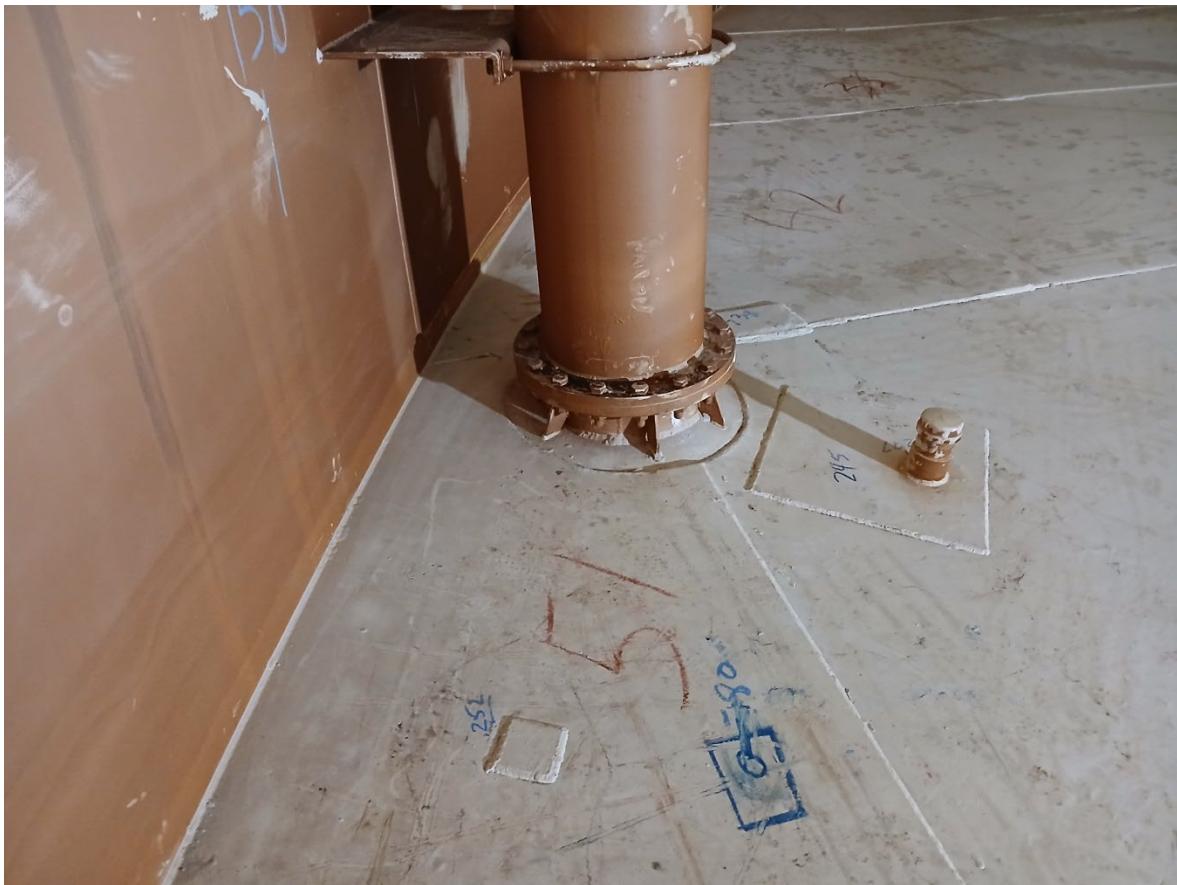
- There is a 16" flanged overflow pipe at bottom plate 51 with underside reinforcement. There are gussets at the flanged connection that may or may not be original to the tank construction. See photos 42 through 45. No obvious issue was observed with this overflow connection at this inspection.

Photo 44. 16" overflow pipe

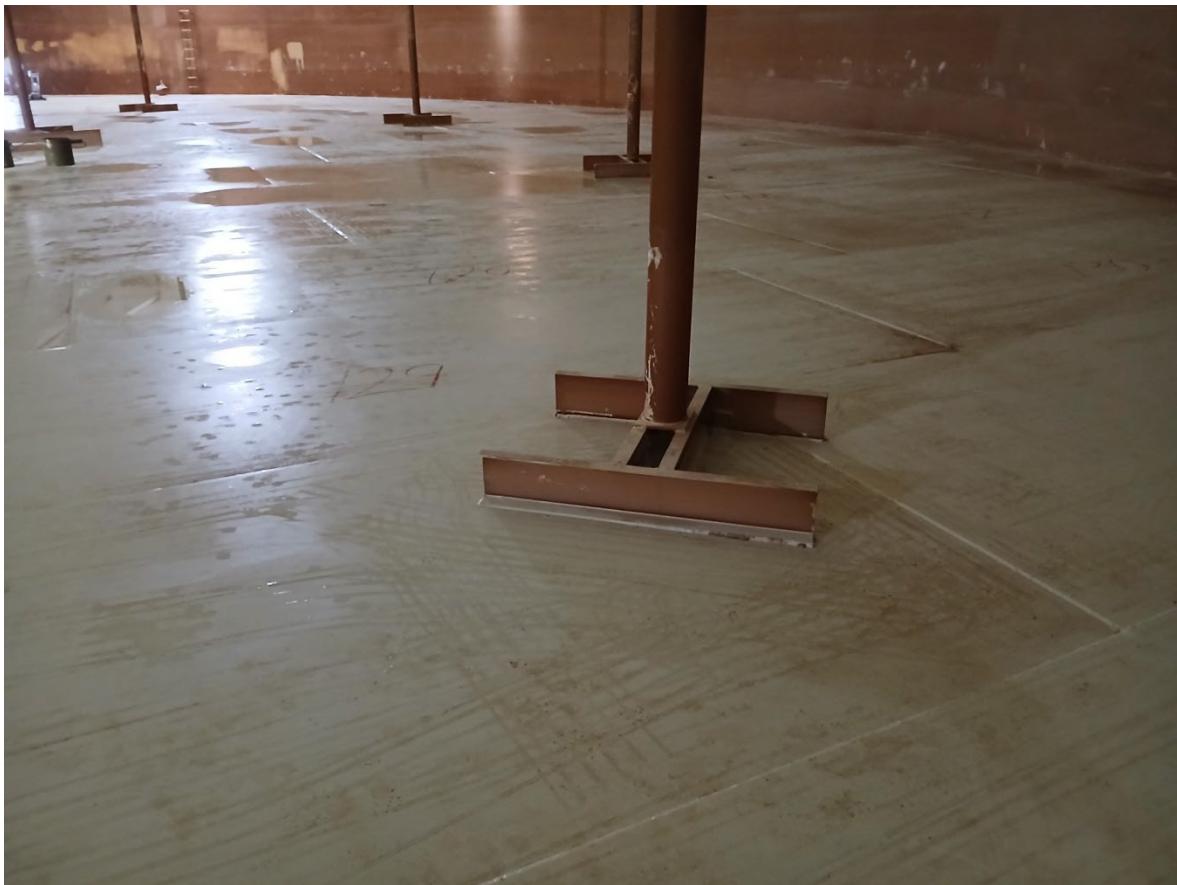
- There are twelve (12) outer roof support columns and six (6) associated with the inner ring. There is also a center column for a total of nineteen (19) roof supports. Spot ultrasonic thickness testing did not identify significant internal corrosion / pitting on the pipe columns. The support bases associated with all of the columns are channel iron(s) in direct contact with the bottom plates. There are restraining clips to limit lateral movement. There is caulking at these interfaces between the channel iron(s) with the bottom to prevent crevice corrosion, as coating the bottom plate under the support base is not possible. The concern is that crevice corrosion could be taking place. See photos 46 through 50.

Photo 46. Roof support column and base configuration

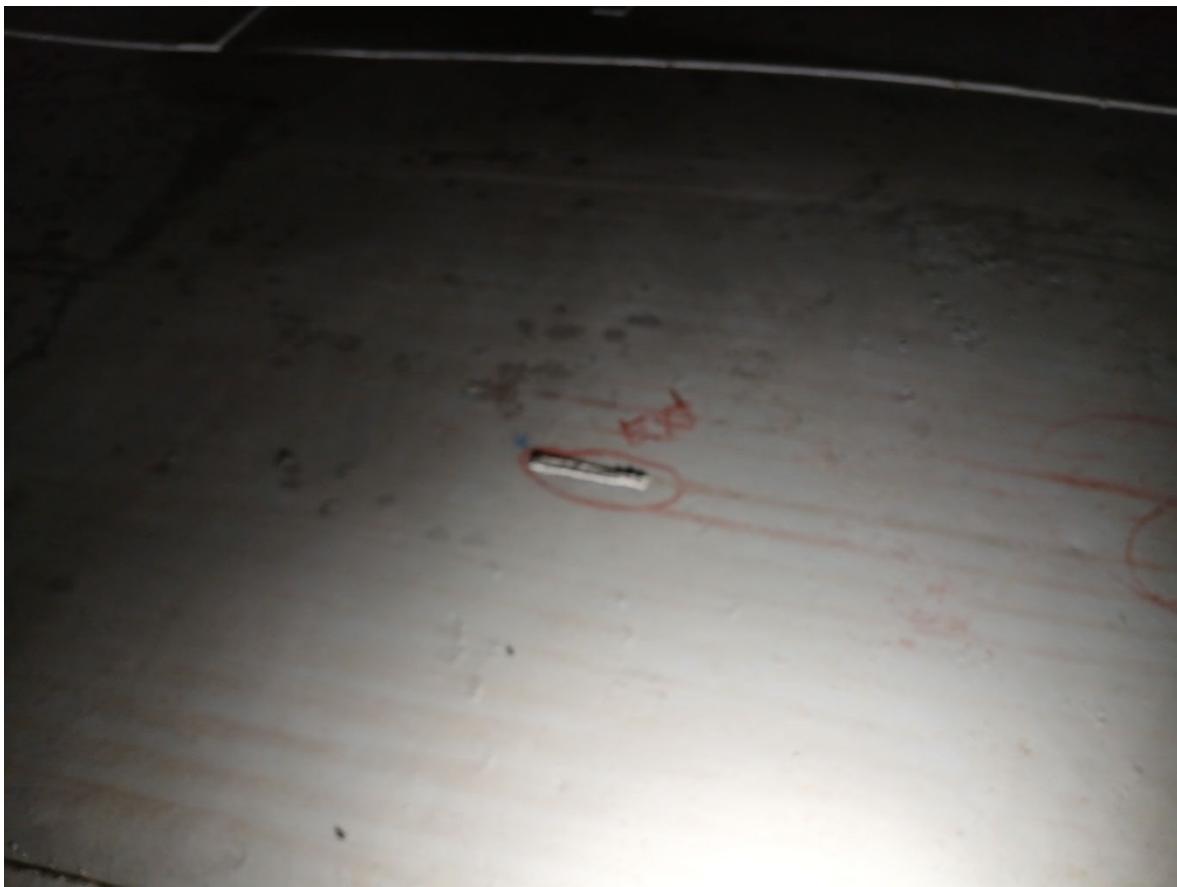
- There are several extraneous welds across the bottom. There are a few gouges and dents across the bottom. The locations are noted on drawings and a spreadsheet included with this report. See photos 58, 59 and 60.

Photo 60. Example of extraneous weld on tank bottom plate

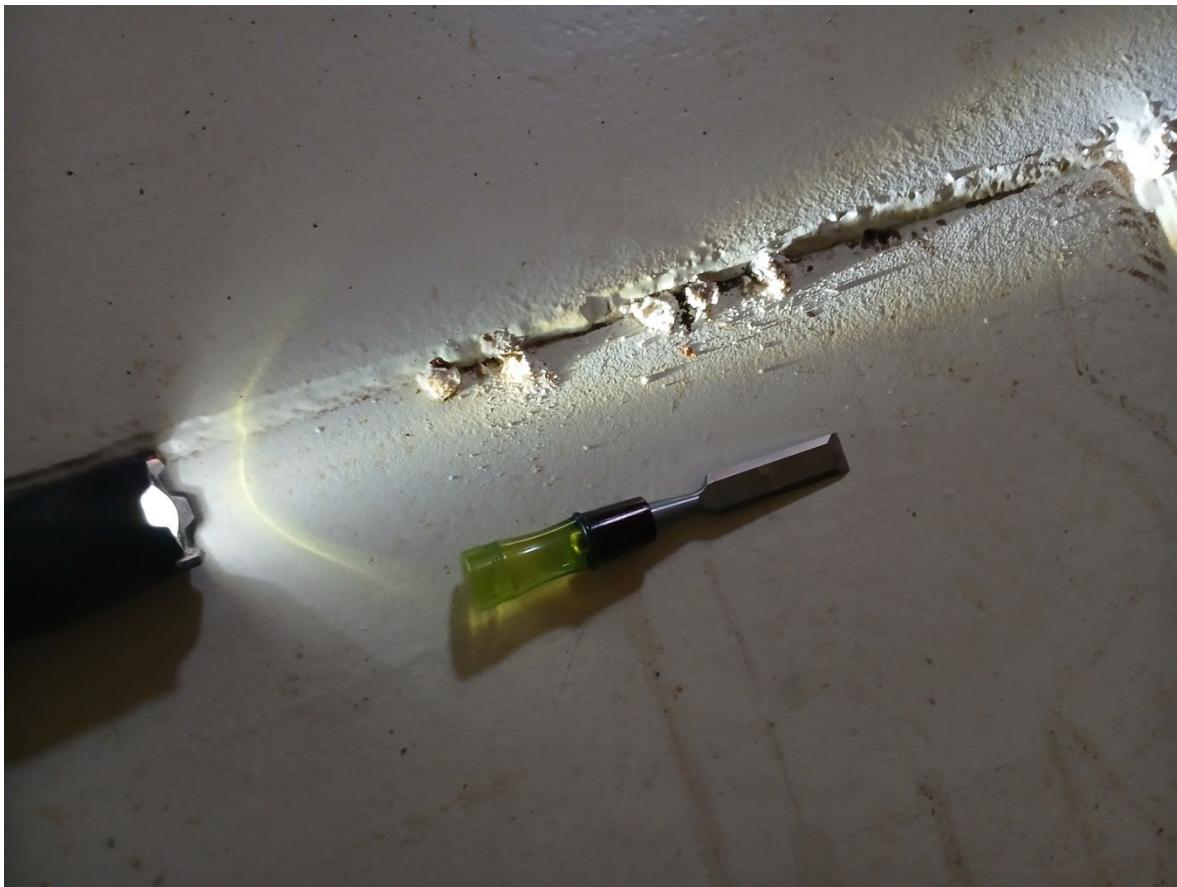
- The internal coating is not original to the tank construction. There appears to be a couple of layers with slightly different colors. There are calcium / mineral deposits at several of the lap welds with breaks in the coating visible when deposits are removed. See photos 61 and 62.

Photo 61. Example of calcium / mineral deposits at bottom lap welds
