**RESIDENTIAL SOILS INVESTIGATION  
2287 Vista Rio Court  
Lot 16, Vista del Rio Subdivision  
Grand Junction, Colorado**

**Job No. 1,160**

**Geotechnical, Environmental and Materials Testing Consultants**

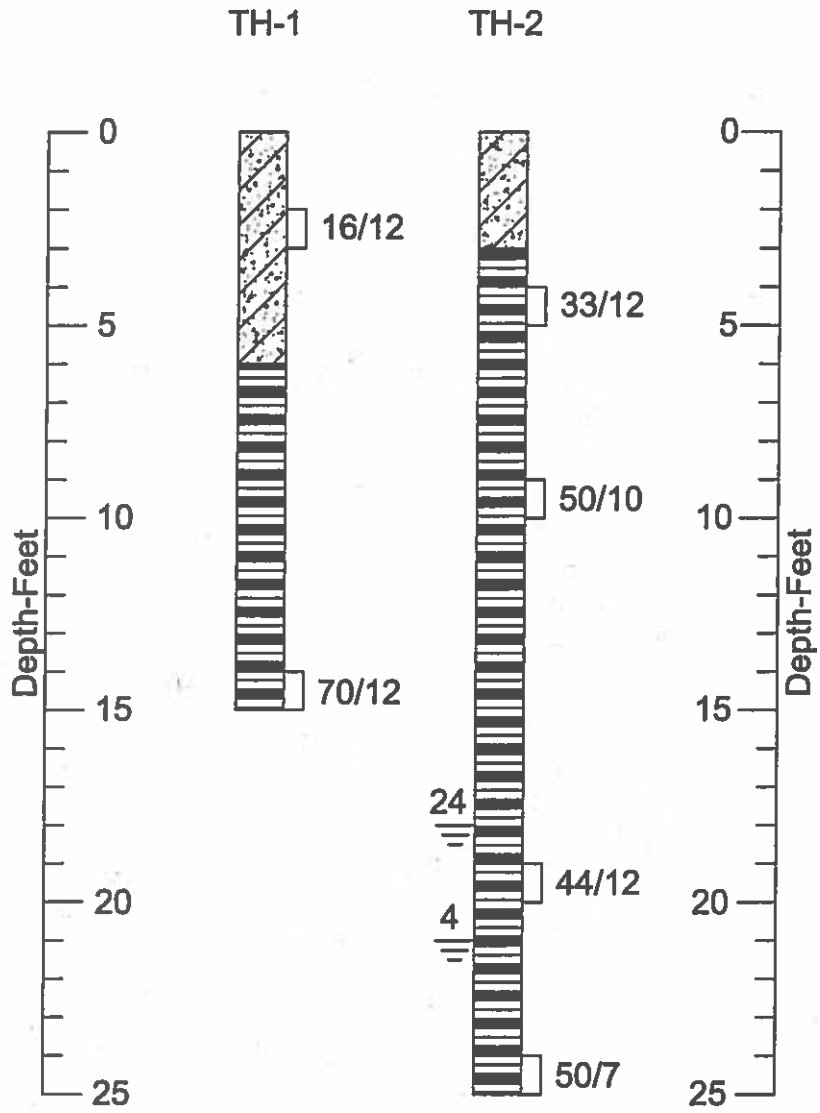
## Legend of Logs of Exploratory Borings

Sand, clayey, gravelly, cobbles noted, medium dense, dry, tan red (SC)

Shale, clayey, medium hard to very hard, dry to moist, dark green, dark brown, sulfates noted

1. Exploratory borings were drilled and sampled on August 16, 2002 using a 6- inch diameter solid stem, continuous flight auger and a truck mounted rig.
2. These logs are subject to the explanations, limitations and conclusions as contained in this report.

FIG. 3 - LOGS OF EXPLORATORY BORINGS

Subsurface conditions at the site were investigated by drilling and sampling two exploratory borings. Locations of exploratory borings are shown on Fig. 2. Graphic logs of the soils found in the exploratory borings and field penetration resistance tests are presented on Figs. 3 and 4. Subsurface conditions

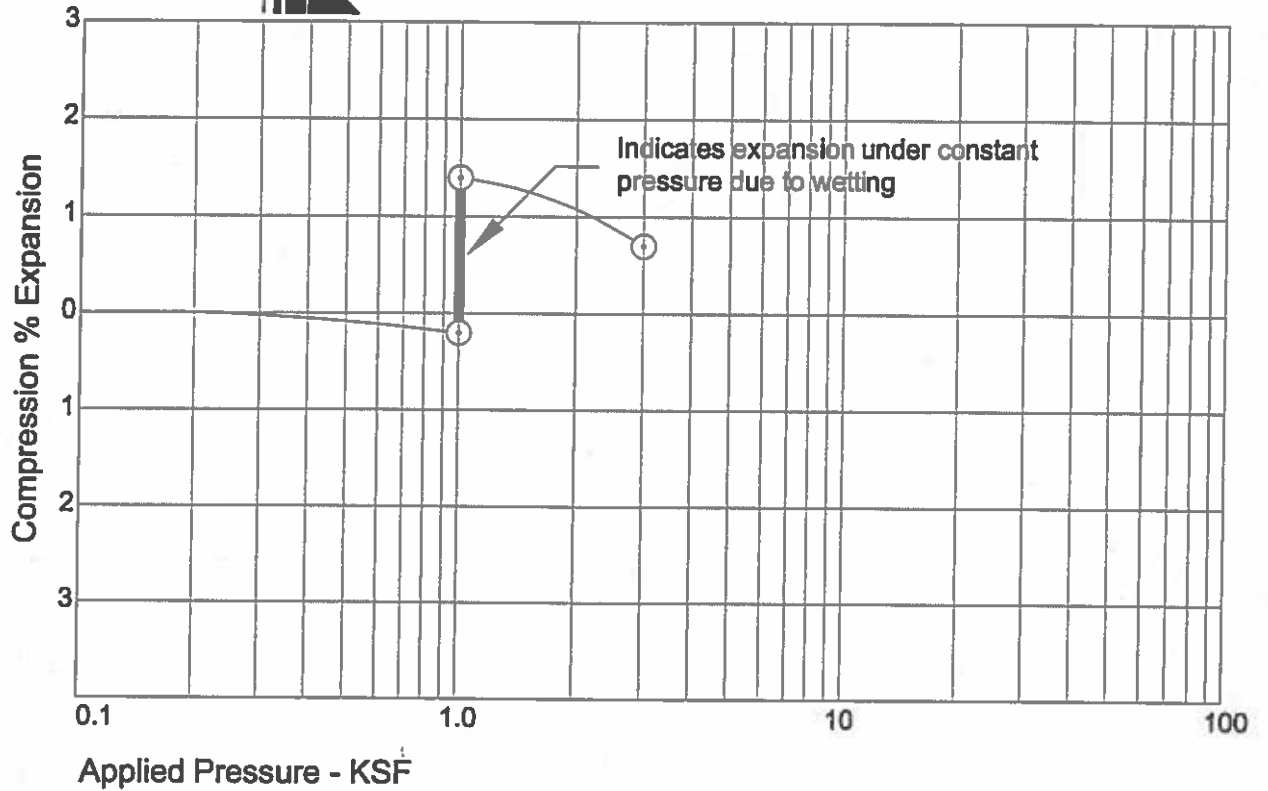
Sample of: Shale, clayey  
From: TH-1 @ 14 feet

Dry Unit Weight= 110 PCF  
Moisture Content= 16.3 %

FIGS. 5 AND 6 - SWELL CONSOLIDATION TEST RESULTS

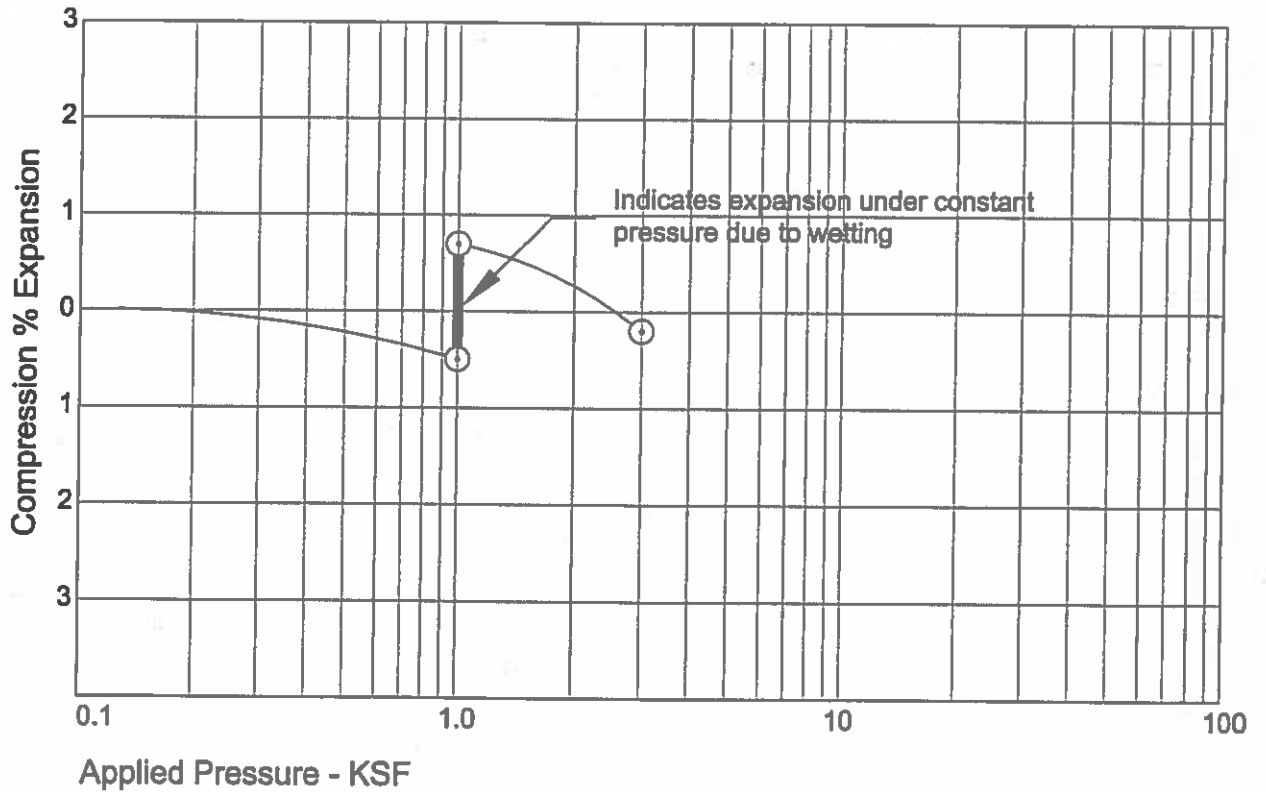
Sample of: Shale  
From: TH-2 @ 9 feet

Dry Unit Weight= 121 PCF  
Moisture Content= 12.7 %

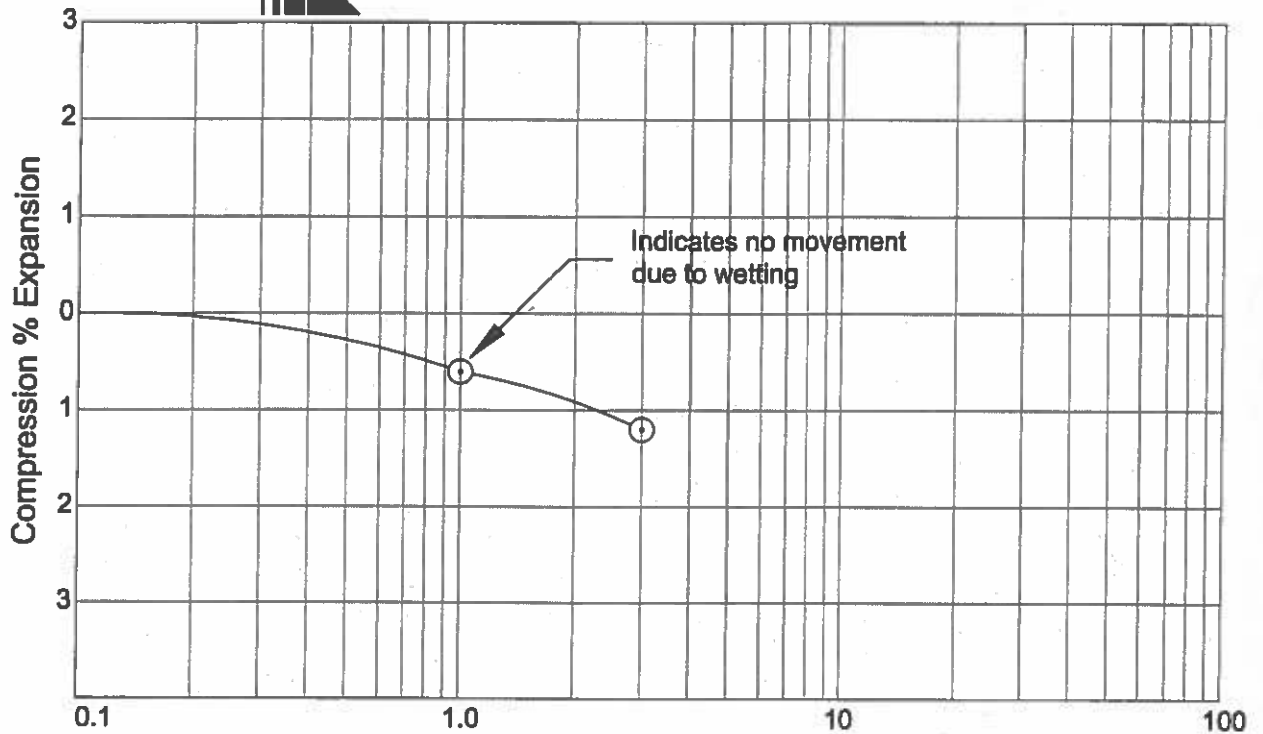
Applied Pressure - KSF

Sample of: Shale, clayey  
From: TH-2 @ 19 feet

Dry Unit Weight= 107 PCF  
Moisture Content= 17.6 %

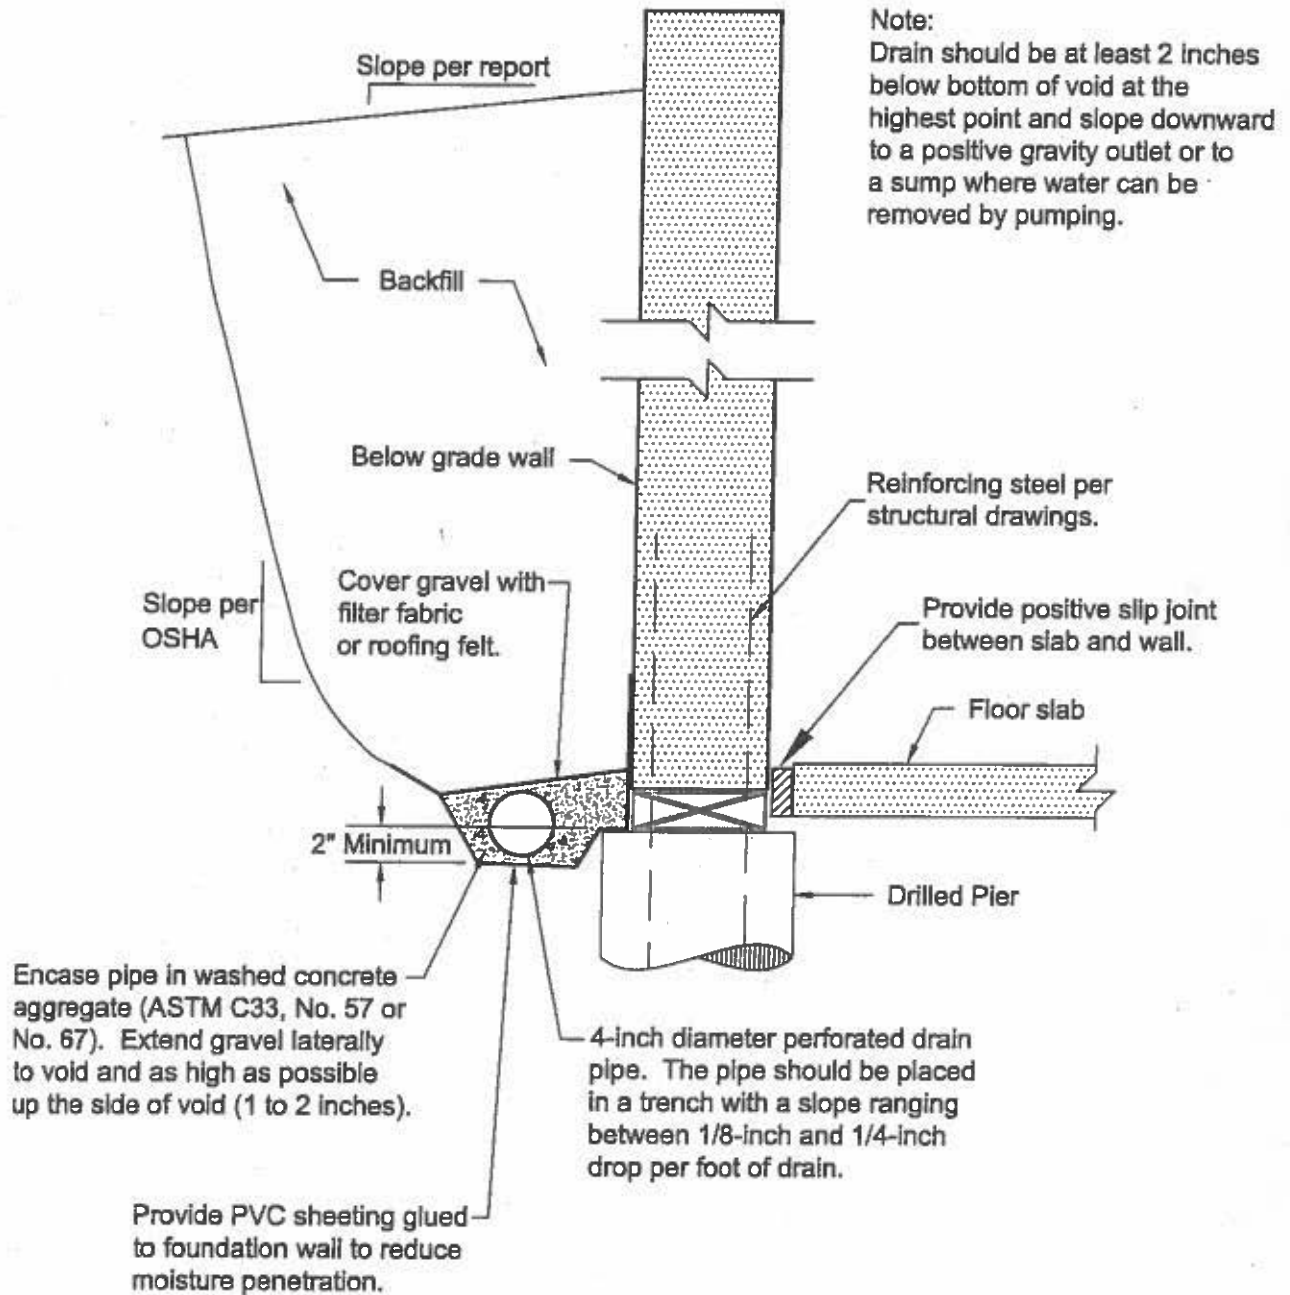
Fig. 7

Job No. 1,160 Exterior Foundation Wall Drain

pipe encased in free draining gravel. The drain should lead to a positive gravity outlet or to a sump where water can be removed by pumping. Typical foundation drain details are presented on Figs. 7 and 8.

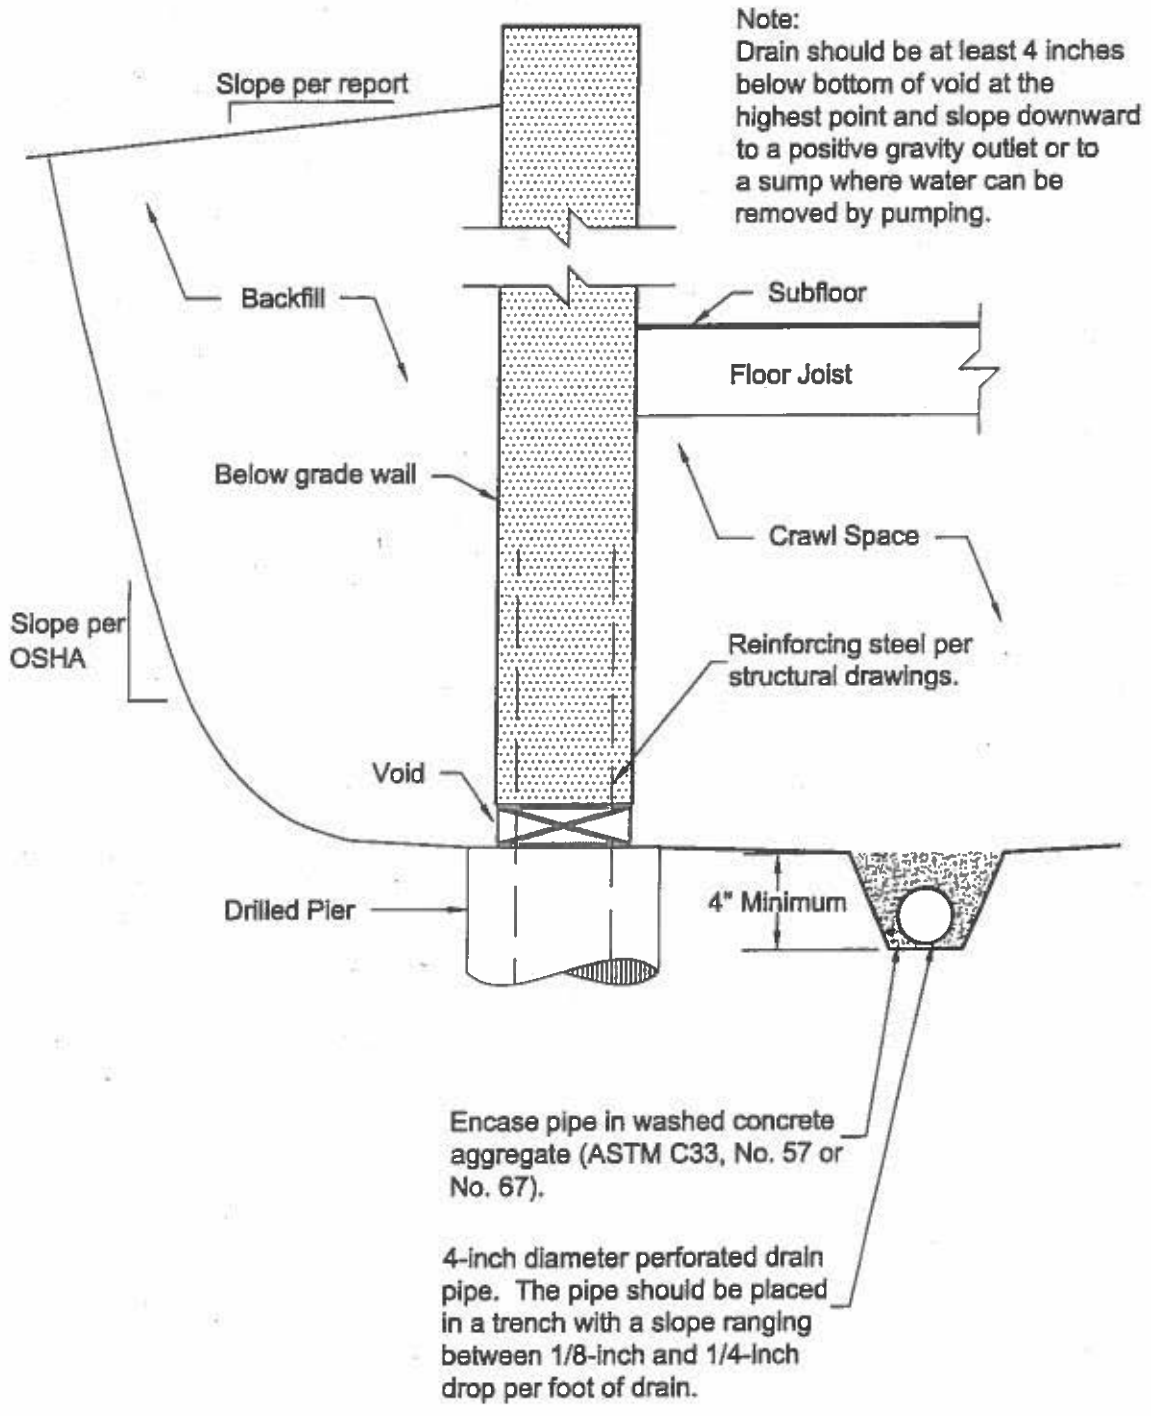
Job No. 1,160 Interior Foundation Wall Drain Fig. 8

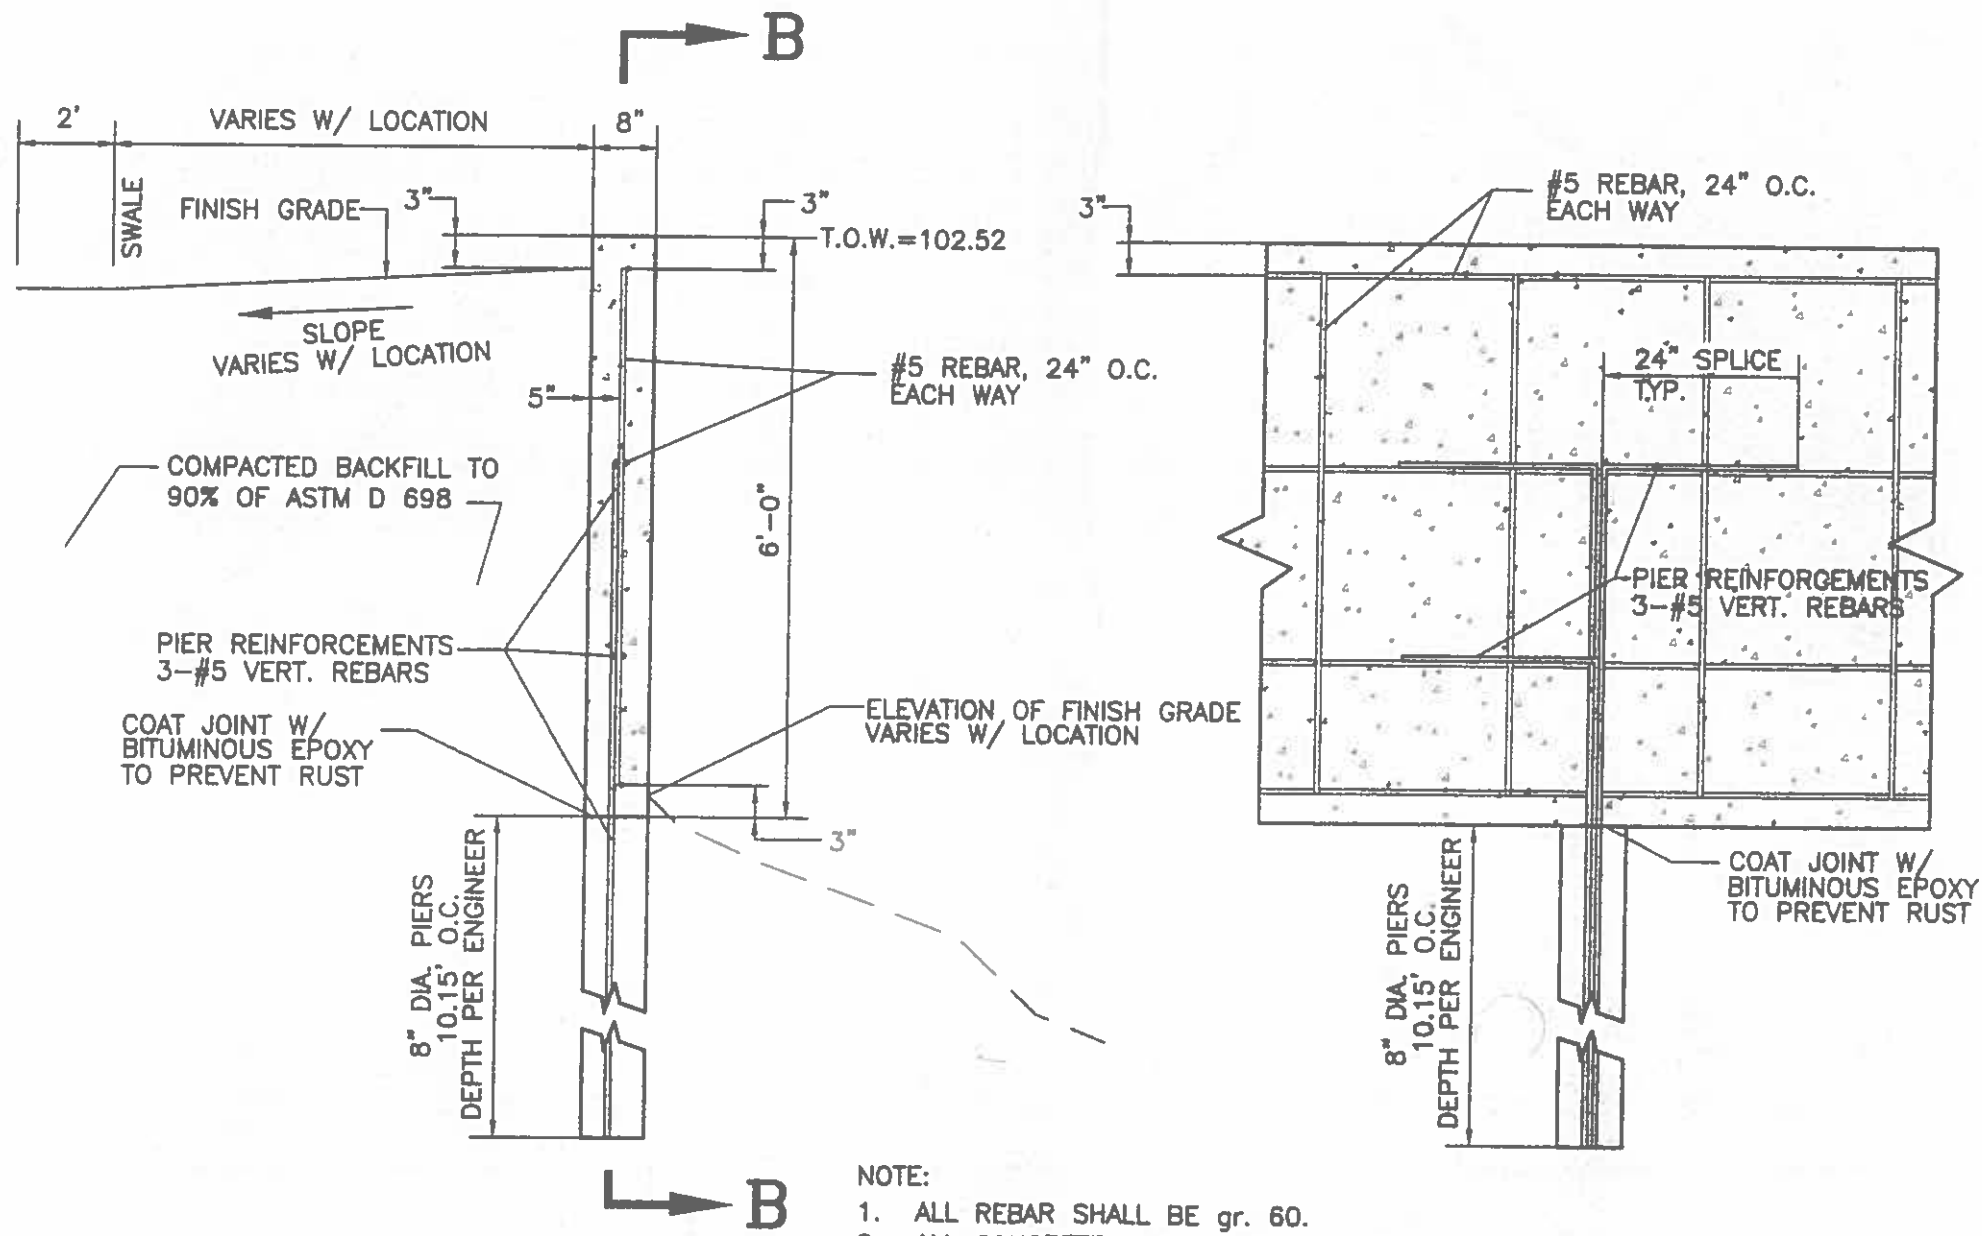
**RETAINING WALL DETAILS**

- NOTE:
1. ALL REBAR SHALL BE gr. 60.
  2. ALL CONCRETE IS 3,500 PSI - SULFATE RESISTANT

**SECTION A-A**  
N.T.S.

**SECTION B-B**  
N.T.S.

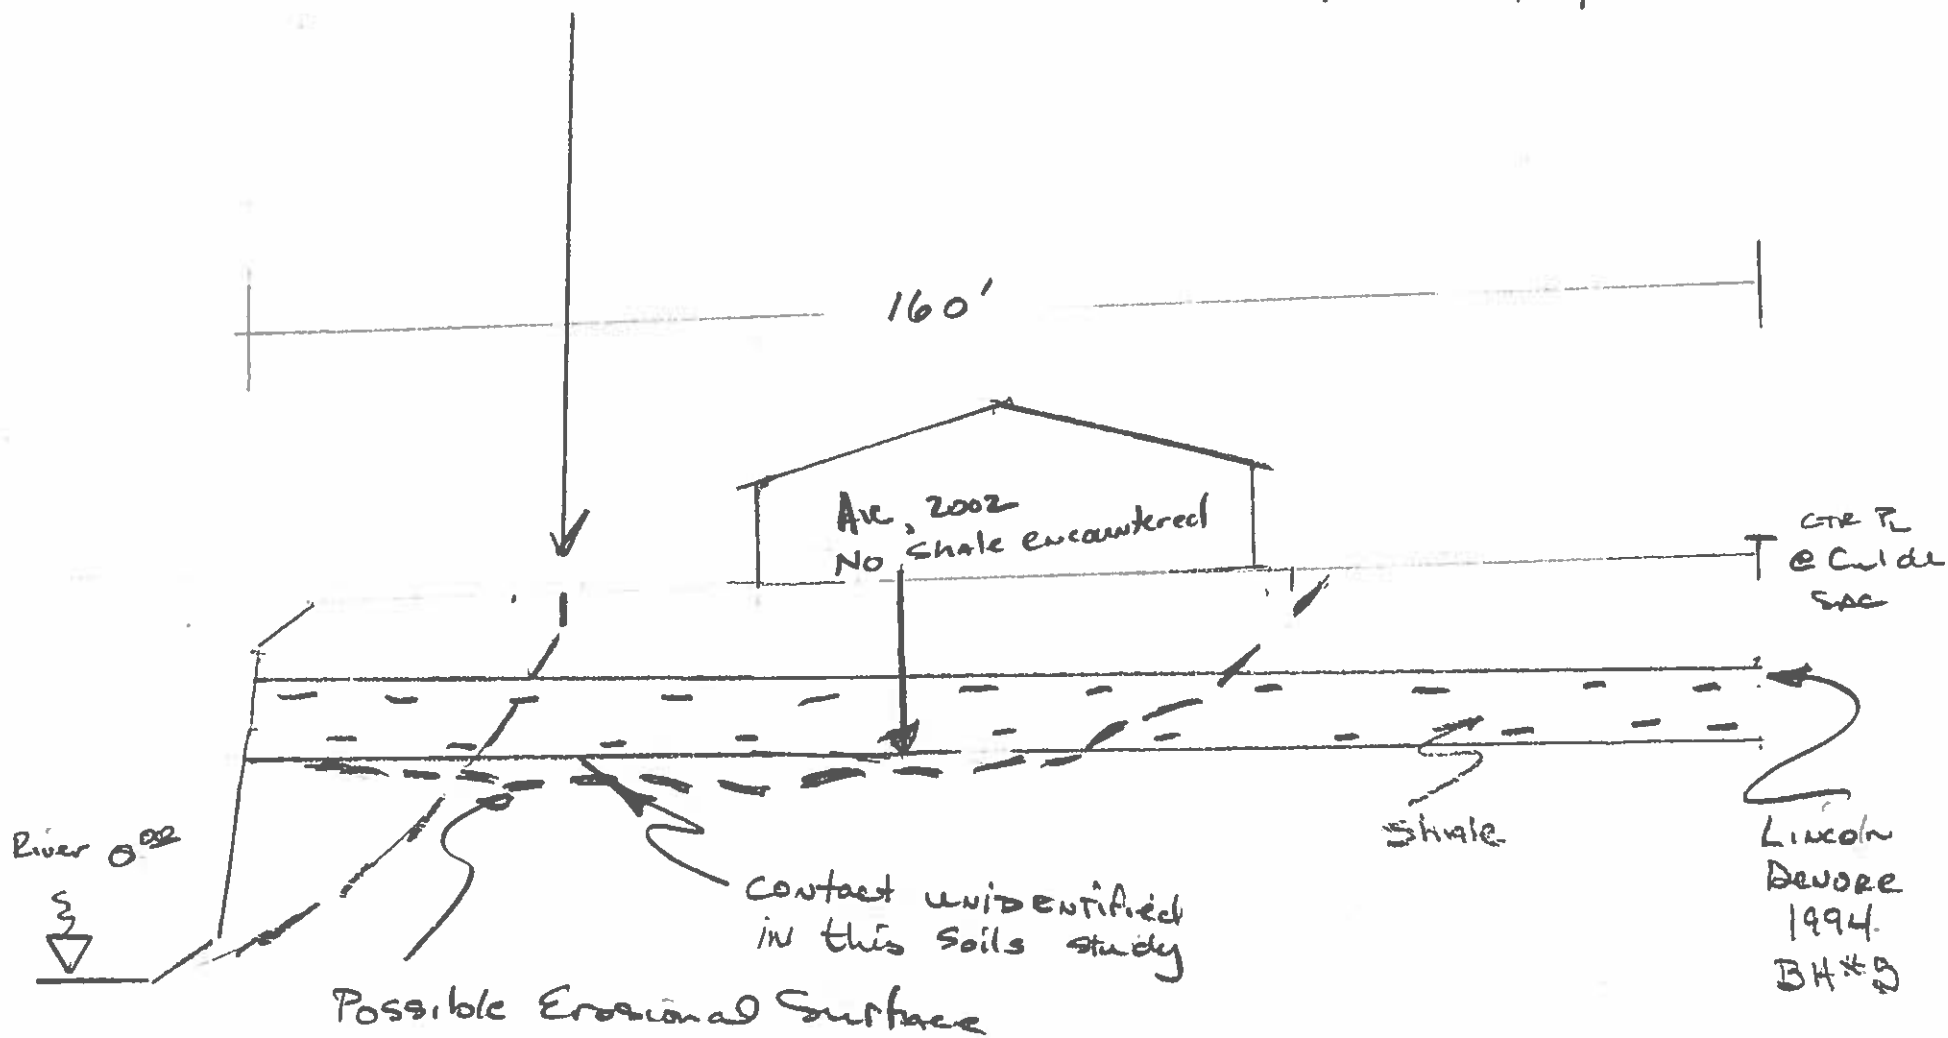
FIG S1

# X-SEC ANALYSIS

Possible movement @ 20' from edge of proposed home

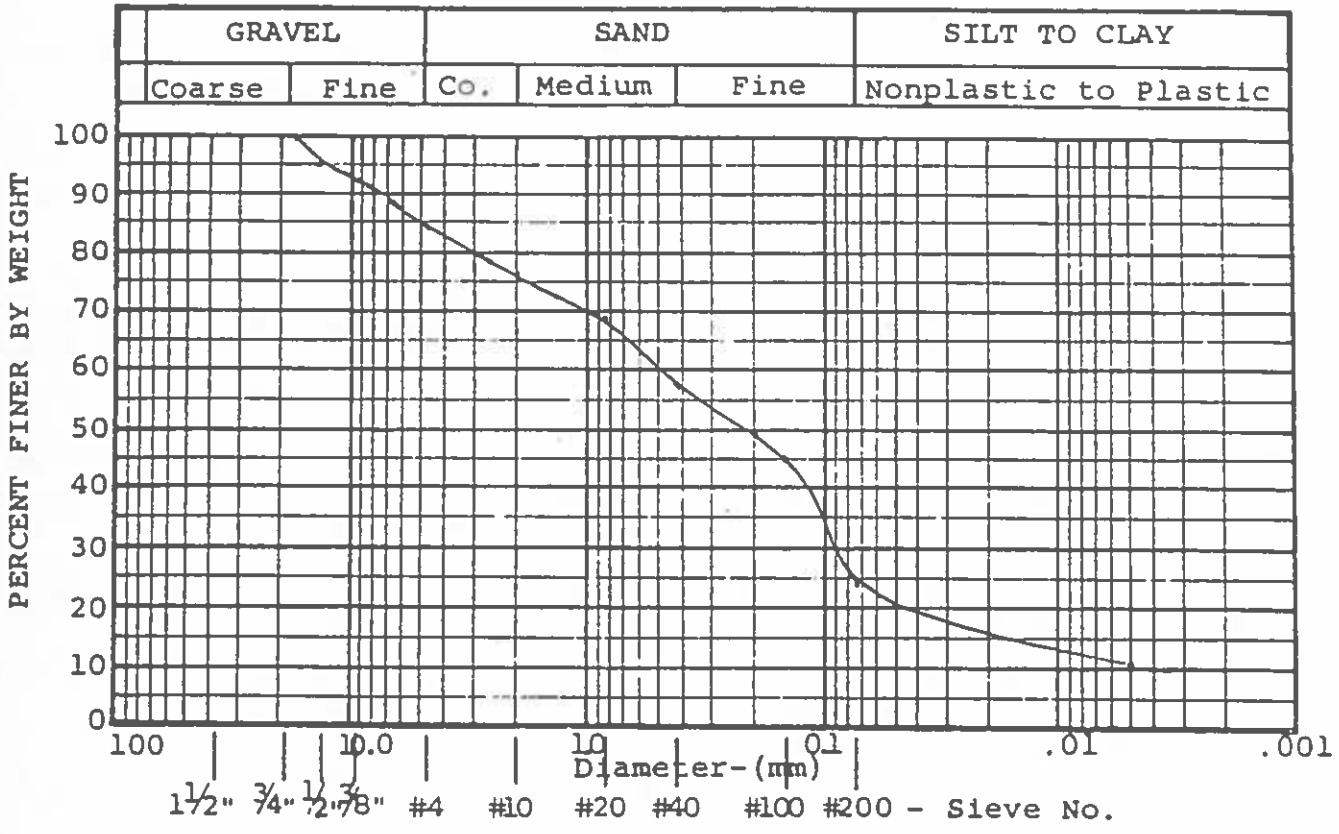
Soil Sample GRAVELLY SILTY SAND (SM)

Sample Location T.H. #7 @ 4'

Sulfates 250 ppm

Sieve Size	% Passing
1-1/2"	_____
1"	_____
3/4"	100
1/2"	95
3/8"	92
#4	84
#10	76
#20	69
#40	58
#100	45
#200	24
0.0200	16
0.0050	11

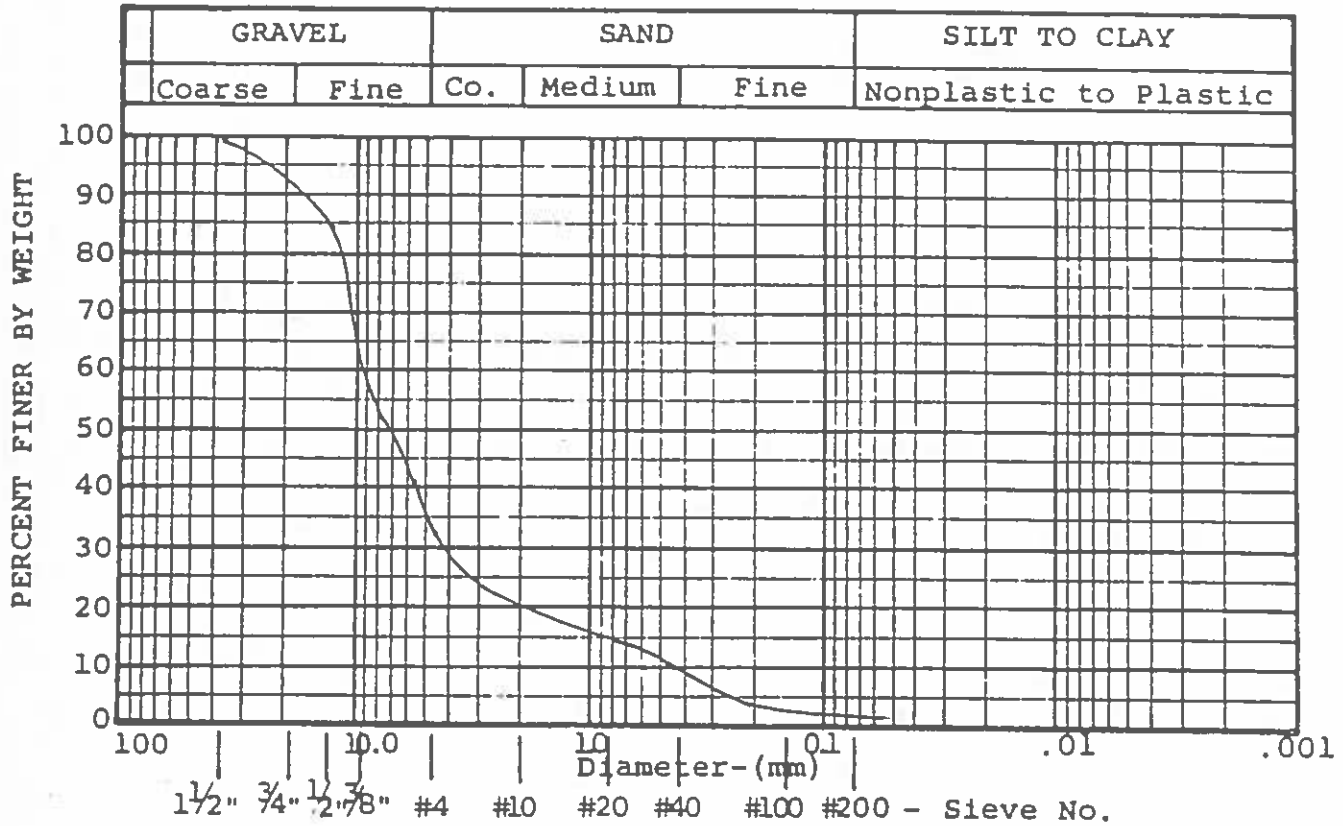
Soil Sample SILTY, SANDY GRAVEL (GM)

Sample Location TB<sup>#</sup>1 @ 4'
