**Request for Proposal
RFP-4519-18-DH**

**Professional Services for
Safety Evaluation of Hogchute Dam**

INSPECTION REPORT
Division 4 Dam Safety Engineer's Inspection Report
(October 27, 2017)

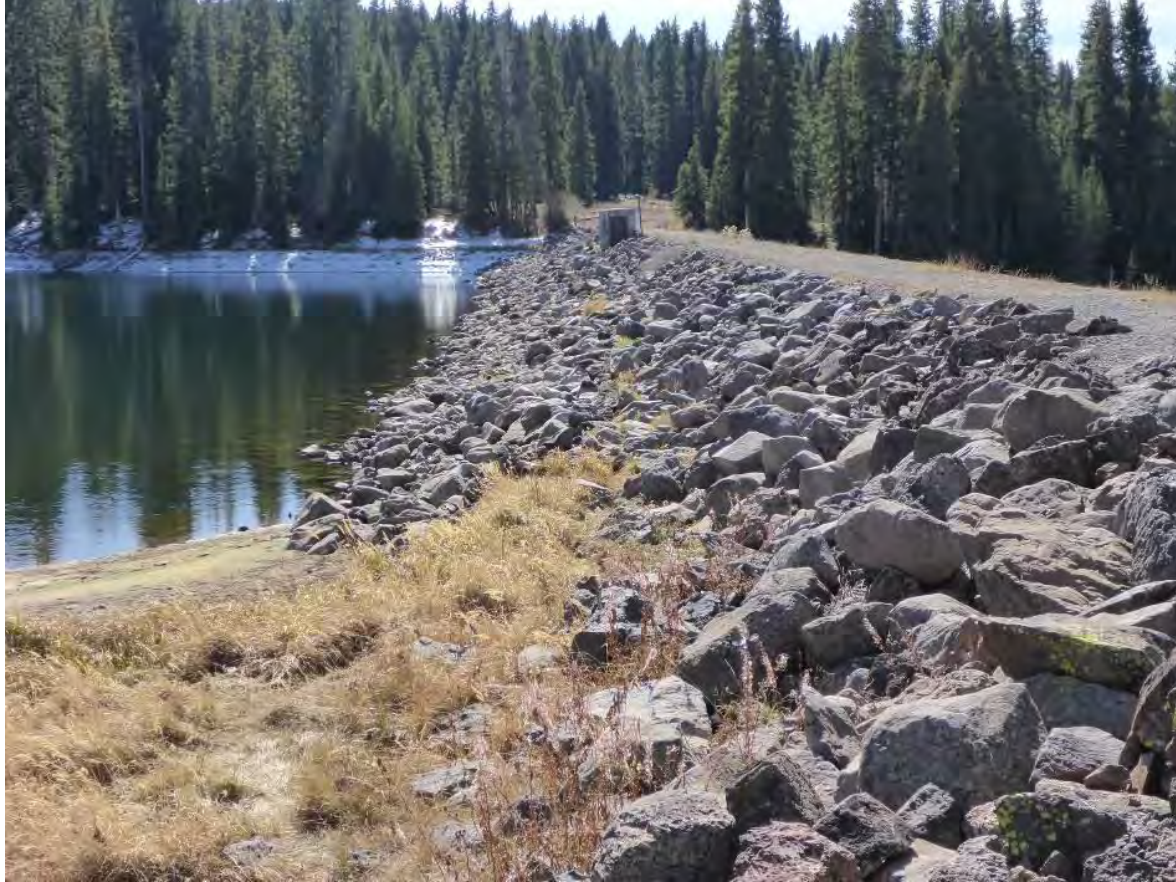
Upstream slope and crest viewed from spillway at right end of dam.

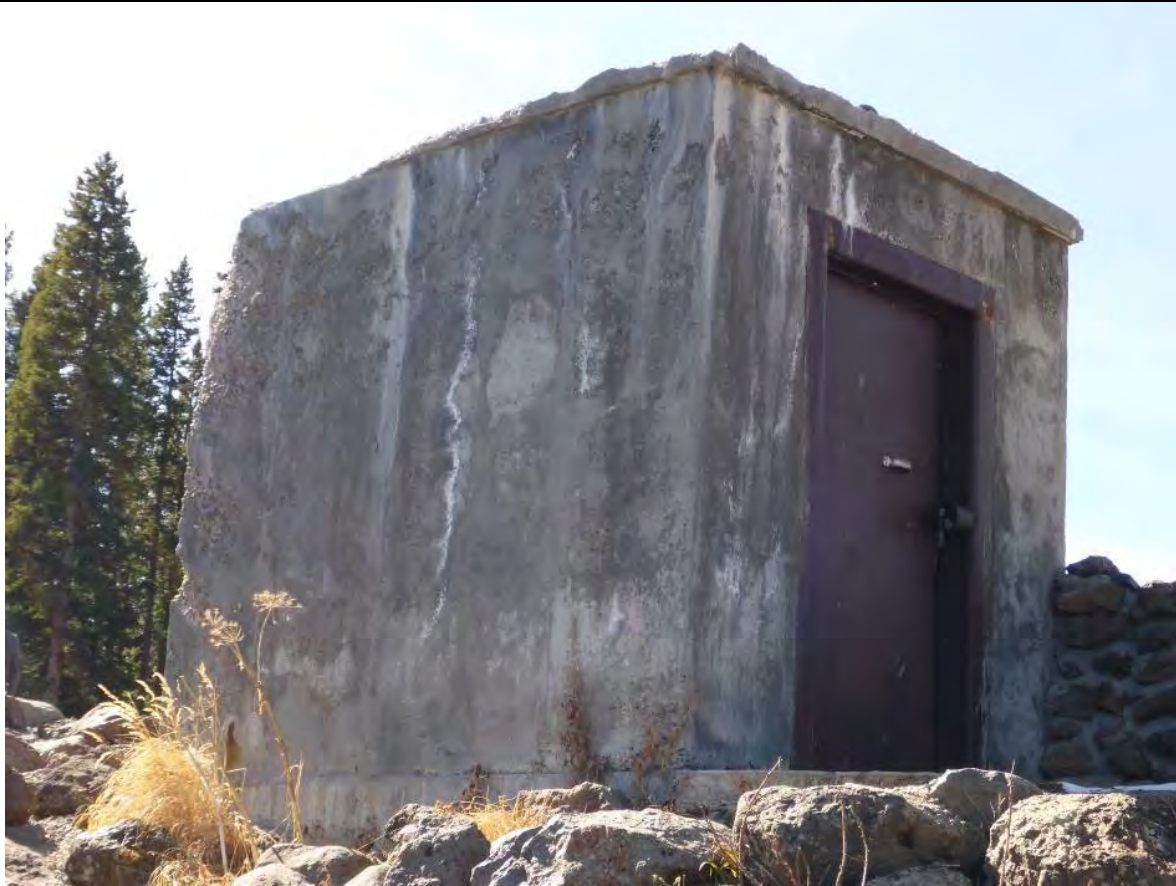
Roof and corners of outlet control structure are badly deteriorated, but building is intact and secure.

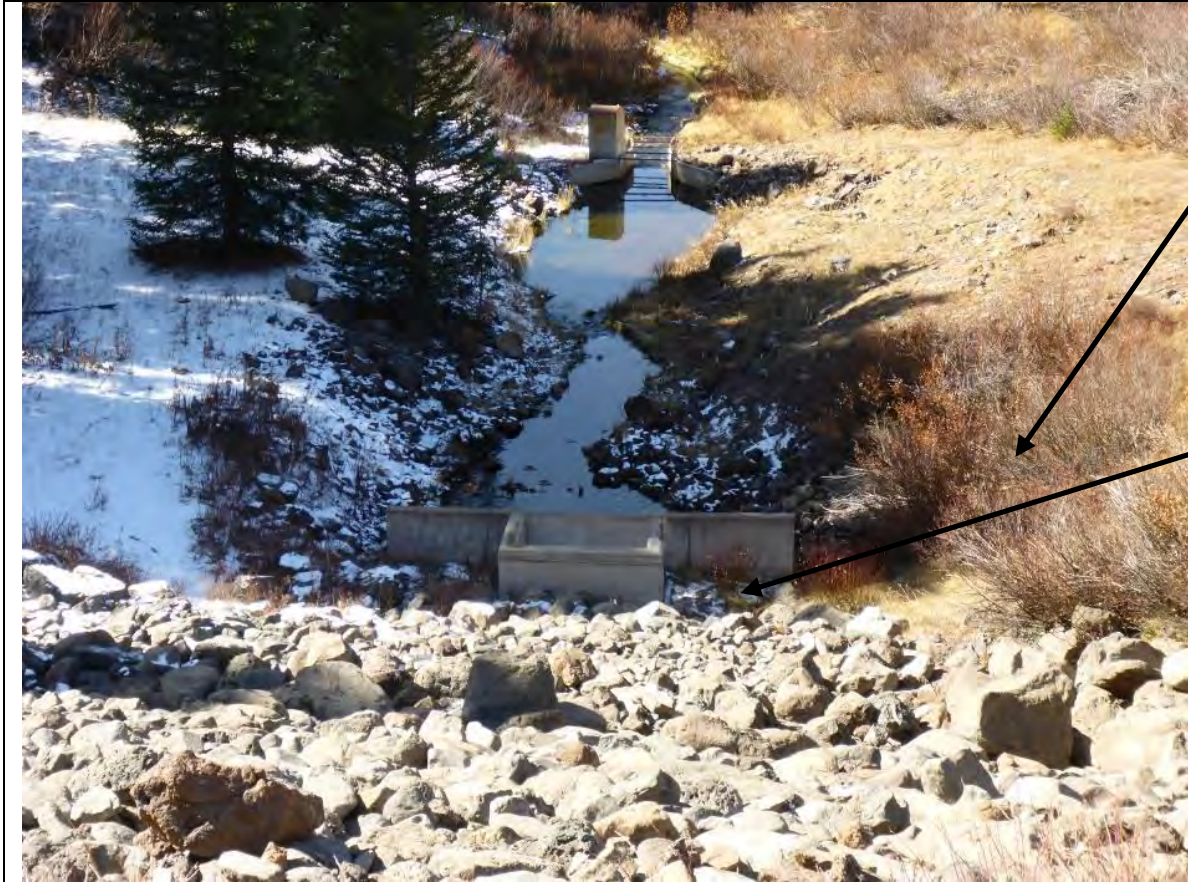
Outlet channel viewed from crest.

Two small but distinct seepage channels flow through the willows on the right and discharge into the outlet channel.

Seepage ponds behind the old retaining wall and drains around the right end.

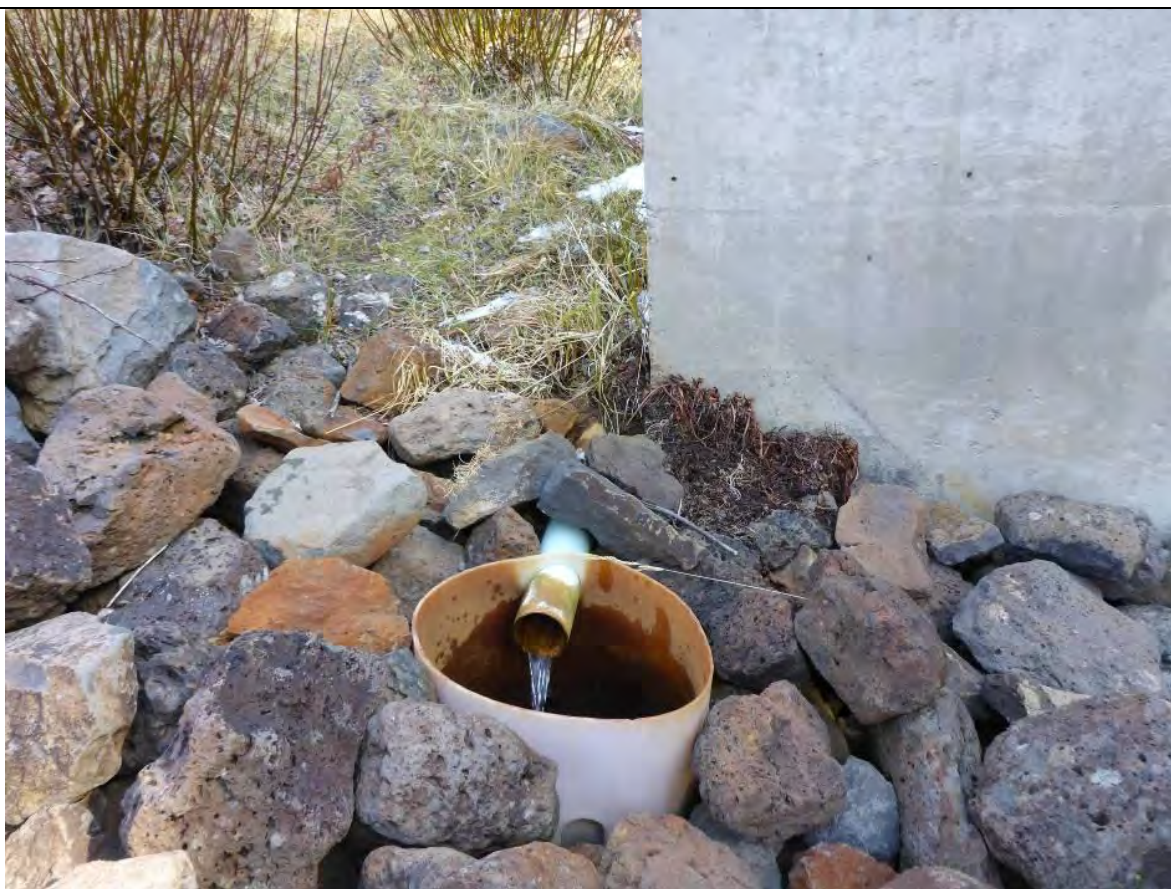
Seepage drain around the right end of the old retaining wall.

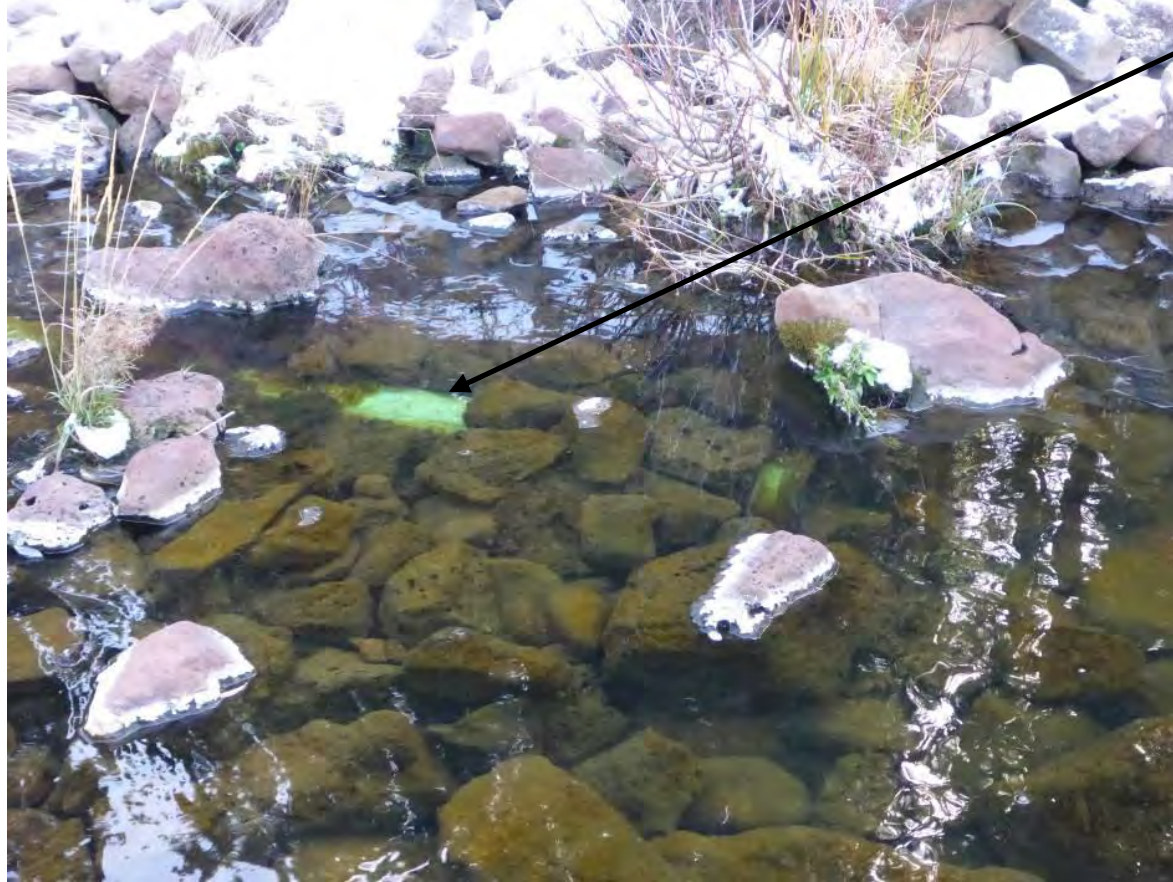
A PVC pipe, believed to be a toe drain discharge pipe, is submerged in the left side of the outlet basin.

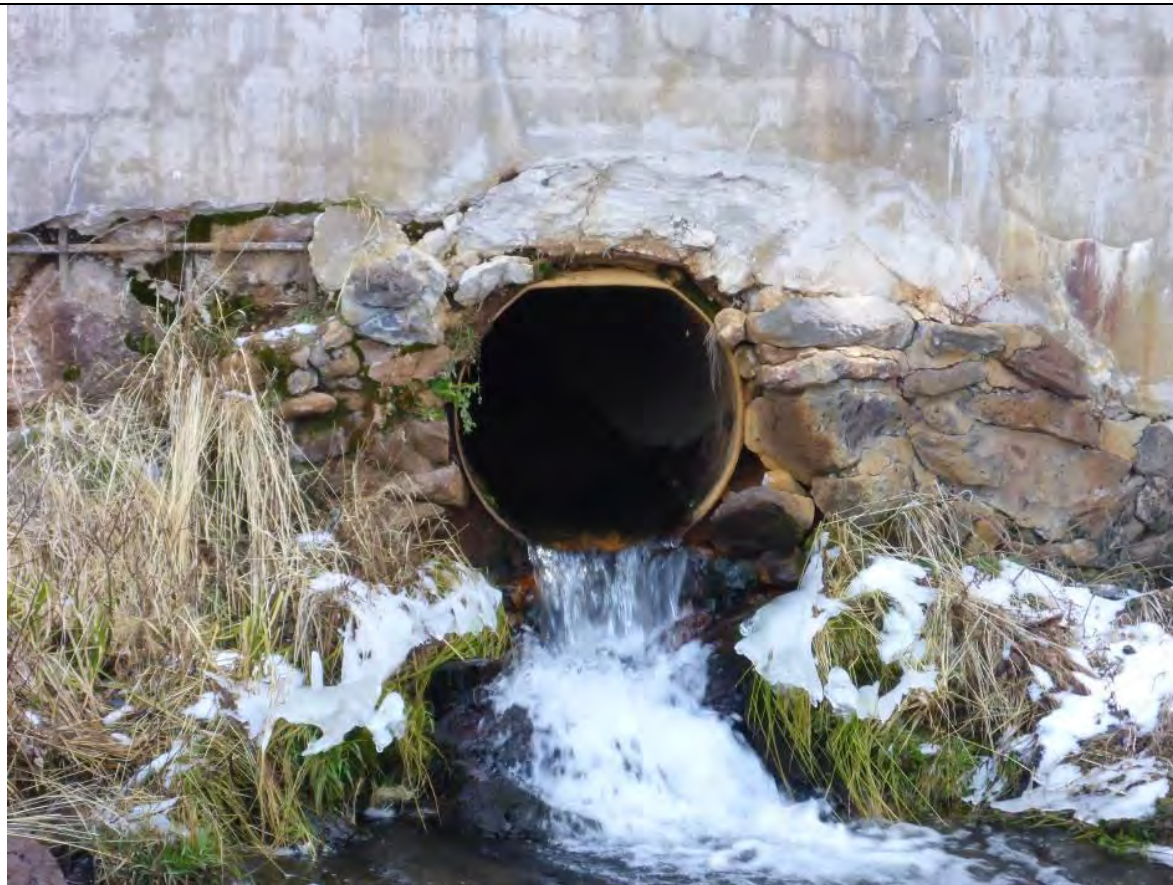
Deterioration of the concrete retaining wall at the outlet discharge.

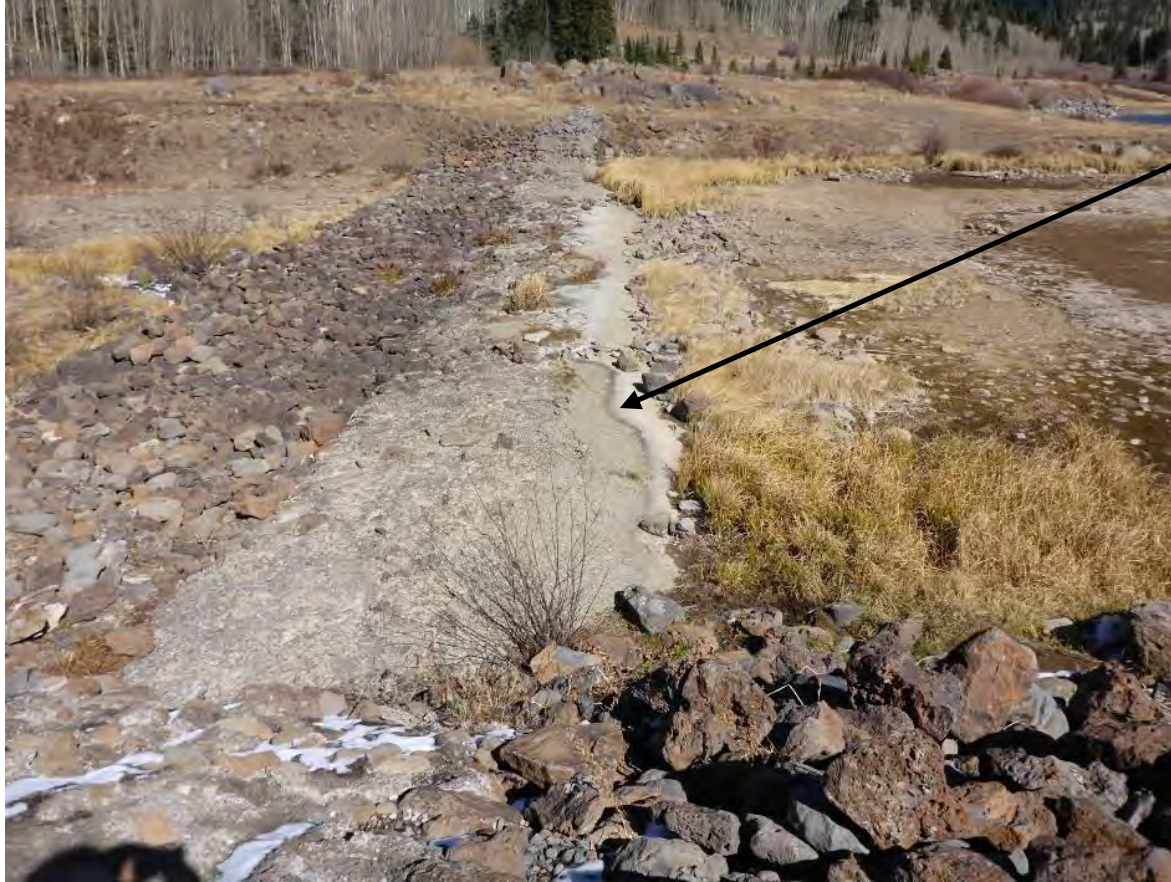
Spillway control structure is deteriorated and cracked through in several places. Note uneven waterline on the concrete.

(53, 58) Concrete crest structure is badly deteriorated and cracked through in several places, permitting water to flow under the crest. (59) 1947 construction plans show a 20'-wide (10' bottom width) trapezoidal low-flow channel through the center of the spillway. This channel does not exist now.

(66) Concrete spillway crest is badly deteriorated, not level.

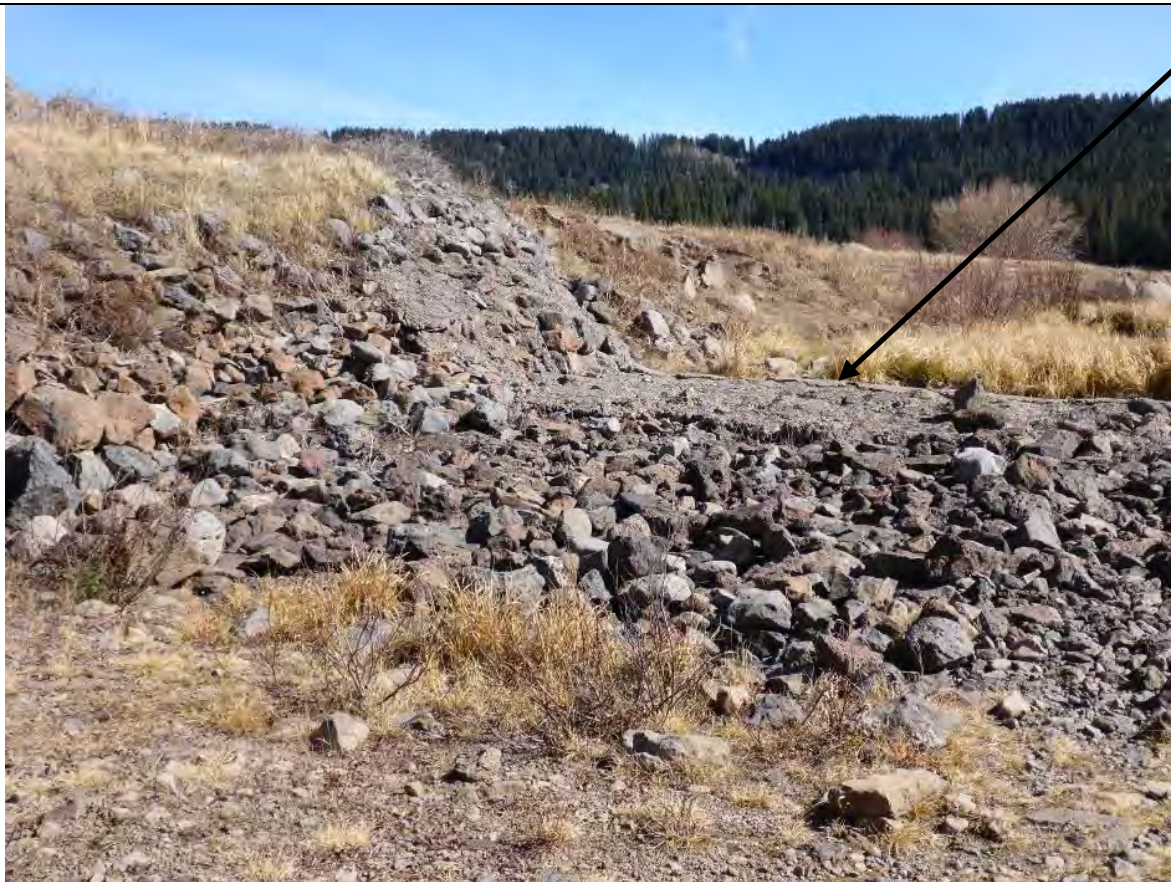
Apparent concrete overlay on old spillway crest.

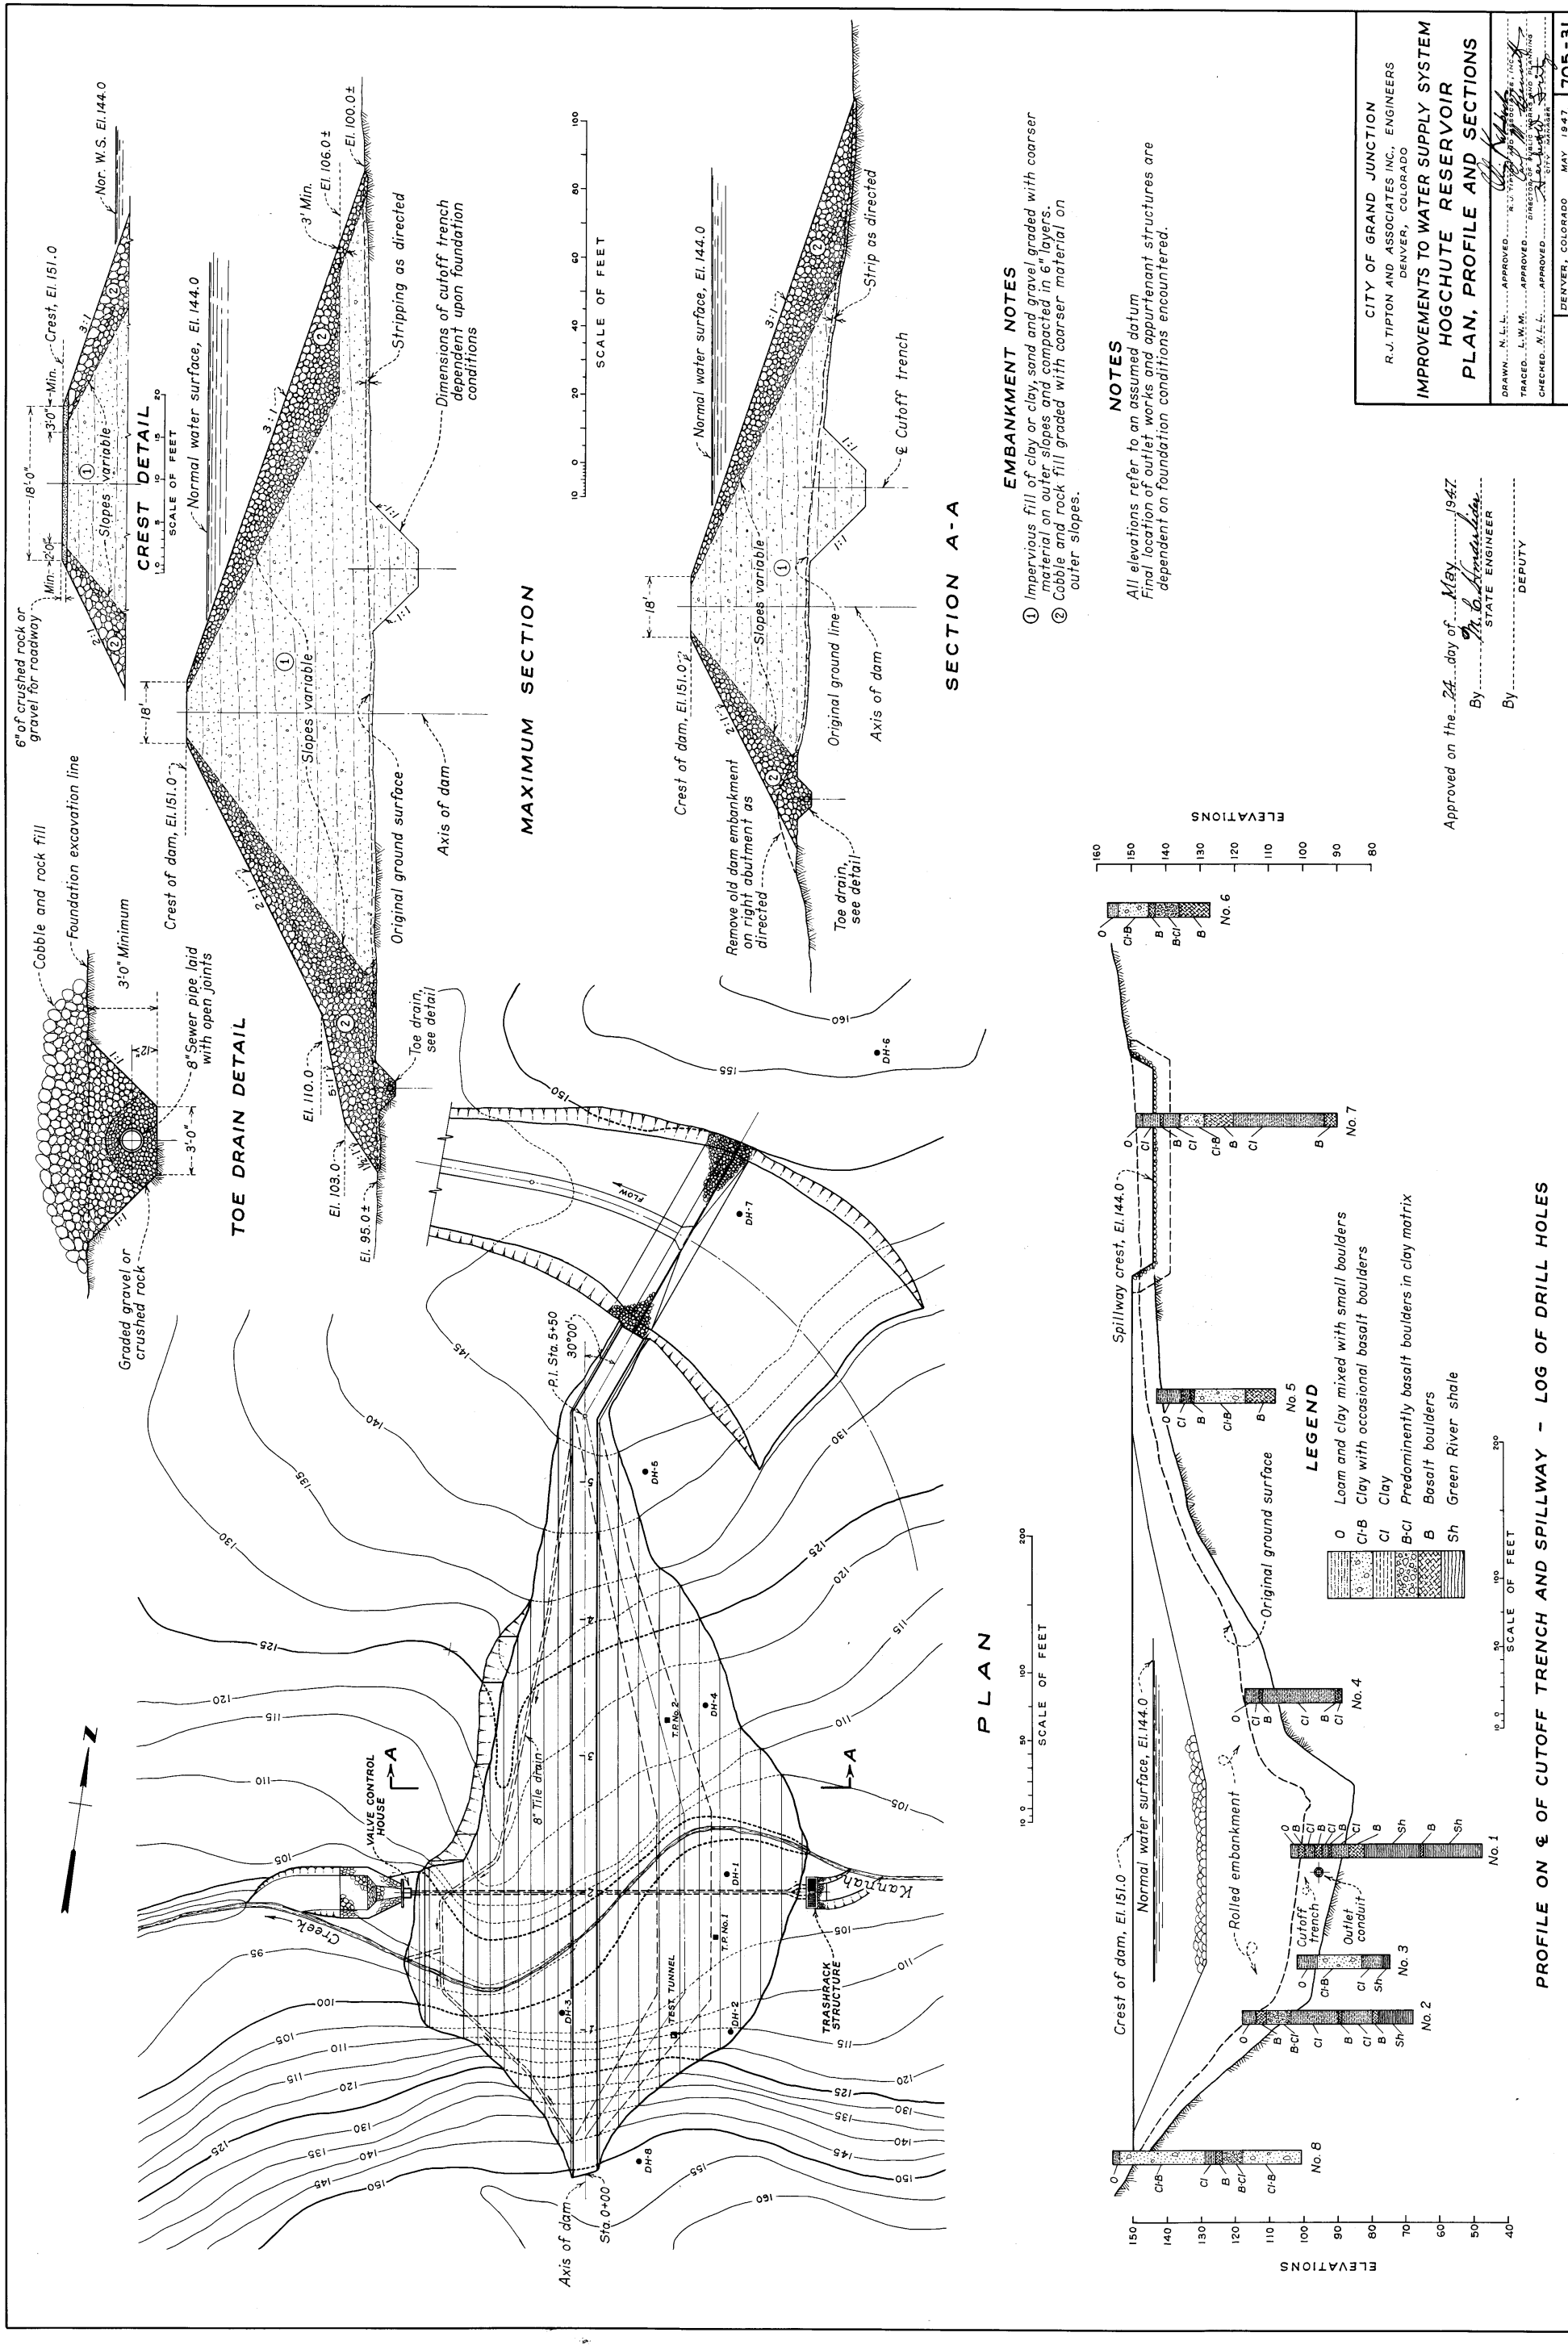
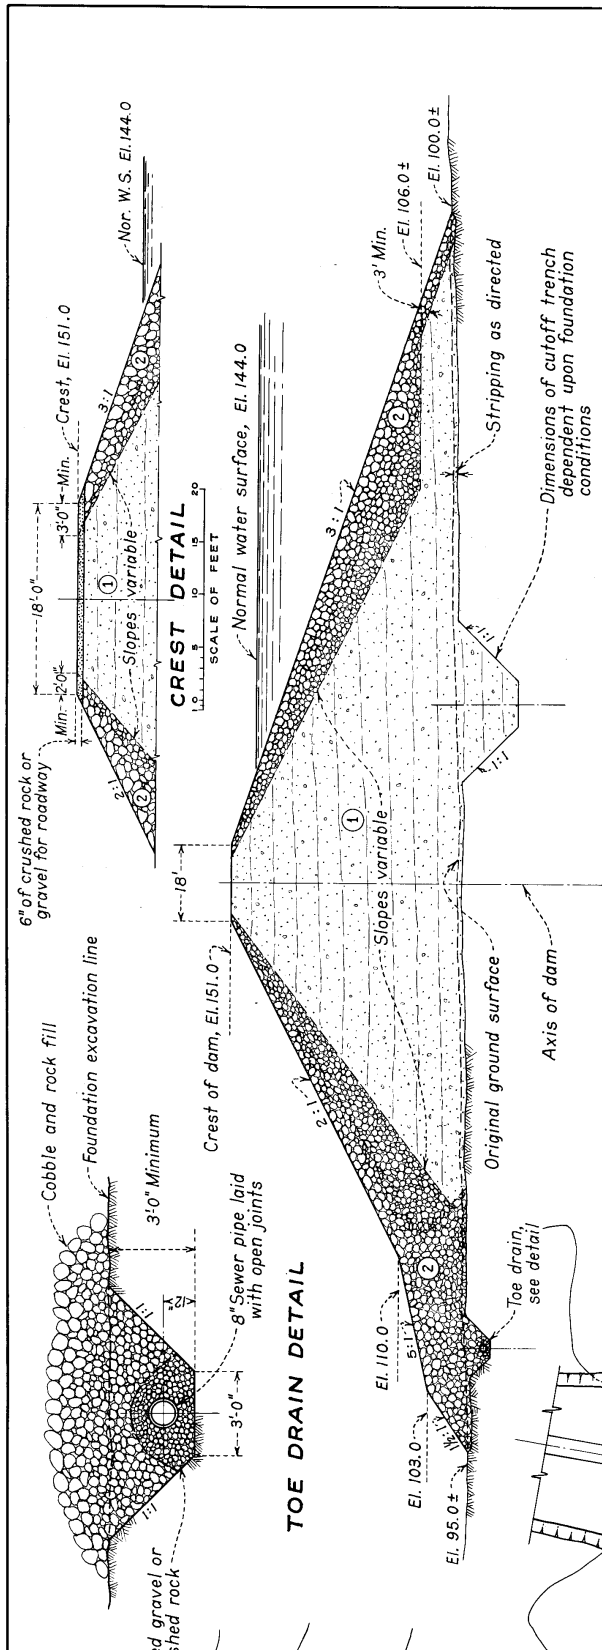
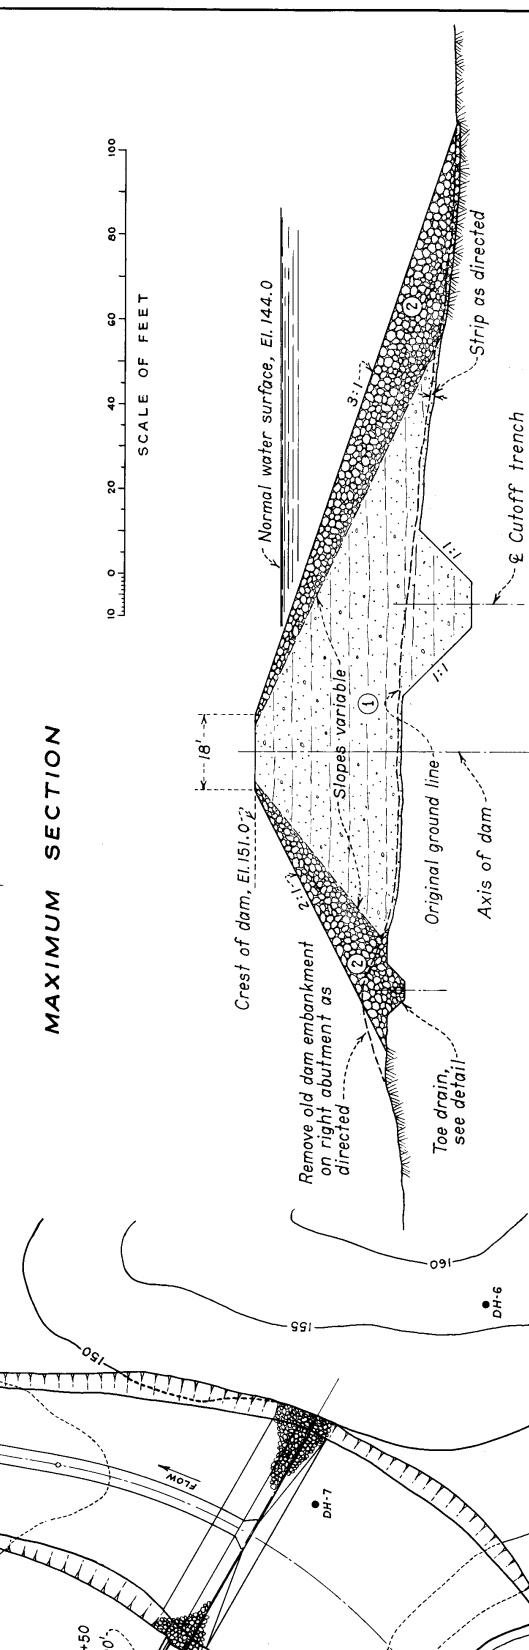
C-454

EMBANKMENT NOTES
 ① Impervious fill of clay or clay, sand and gravel graded with coarser material on outer slopes and compacted in 6" layers.
 ② Cobble and rock fill graded with coarser material on outer slopes.

NOTES
 All elevations refer to an assumed datum
 Final location of outlet works and appurtenant structures are dependent on foundation conditions encountered.

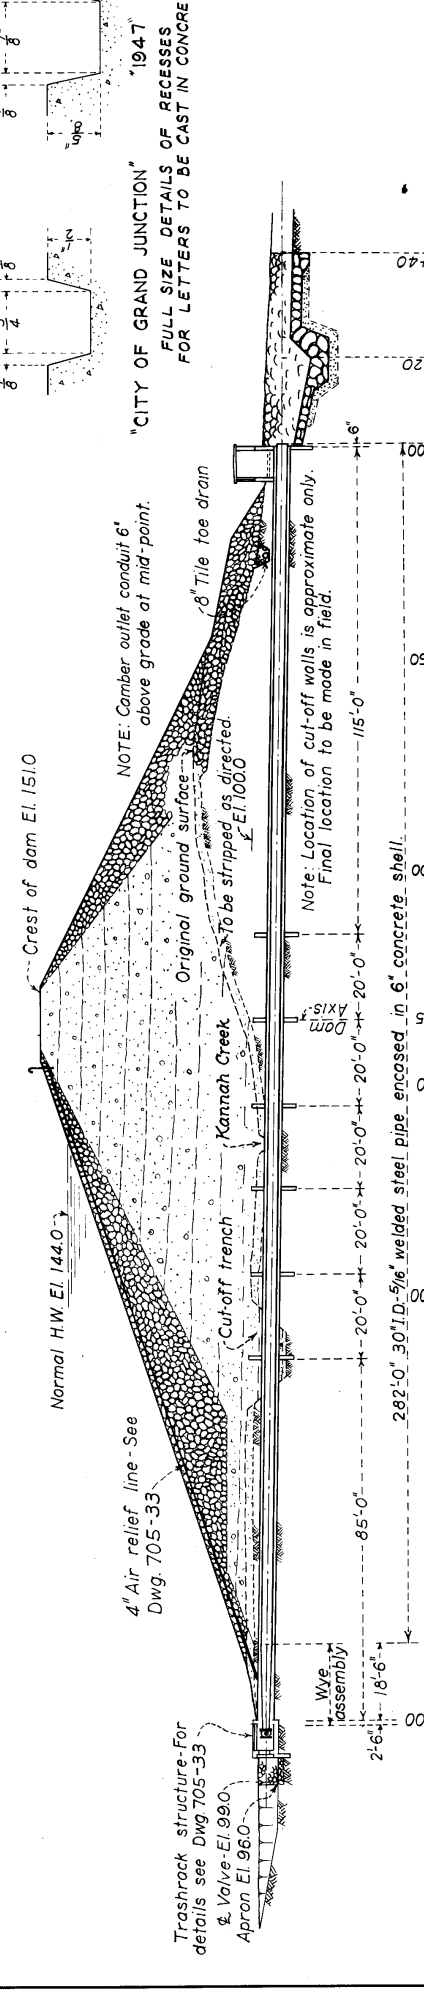
SECTION A-A OF OUTLET CONDUIT

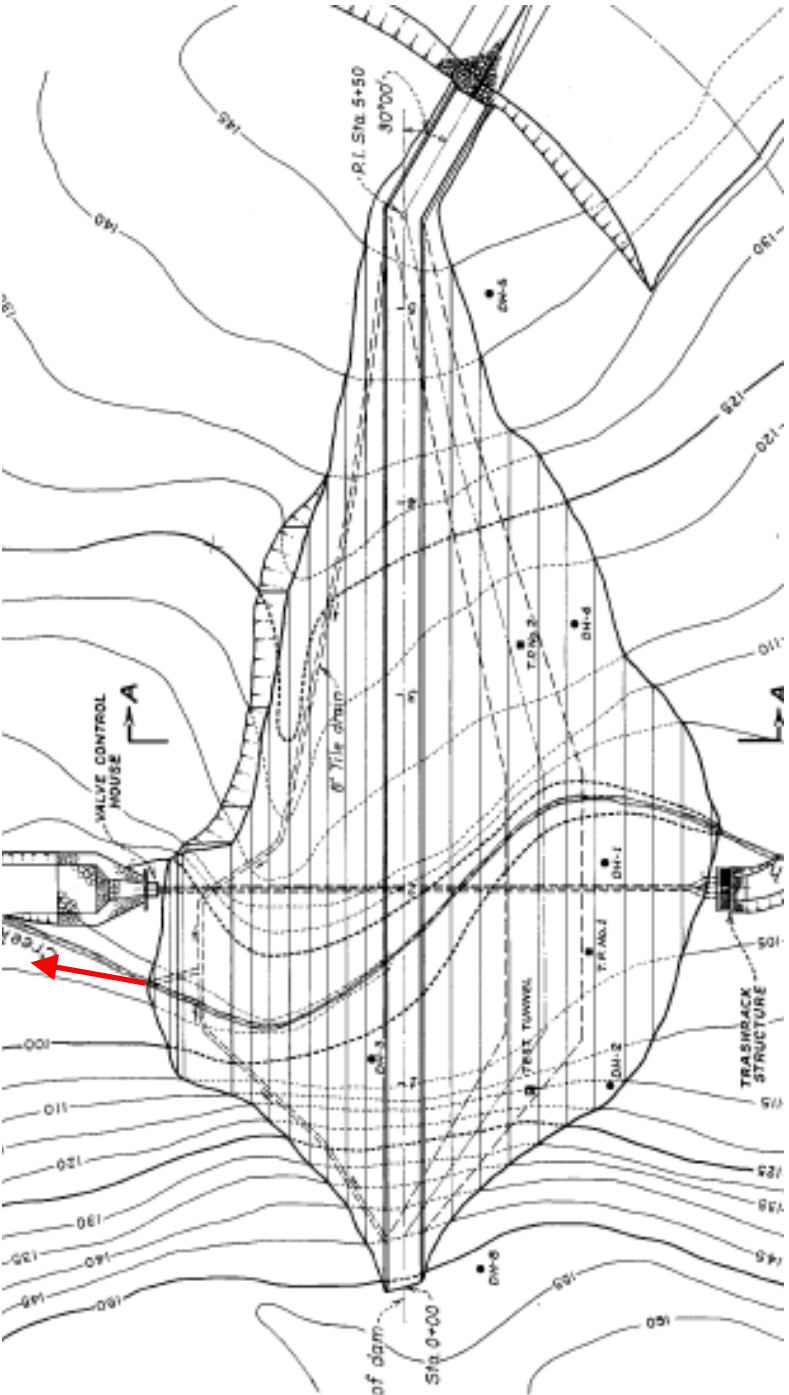
<div style="margin-left: 20px;"> <ul style="list-style-type: none"> • Toe drain discharge excavated and extended into 40-downstream along left side of discharge channel (red arrow above) • Seepage from right side behind headwall "traced to the tubes which were installed for reservoir level gauge in the old valve house" (letter from City of Grand Junction to Jim Norfleet, Nov 14, 1988). • Headwall repaired and tie-back cable installed. </div> </div>

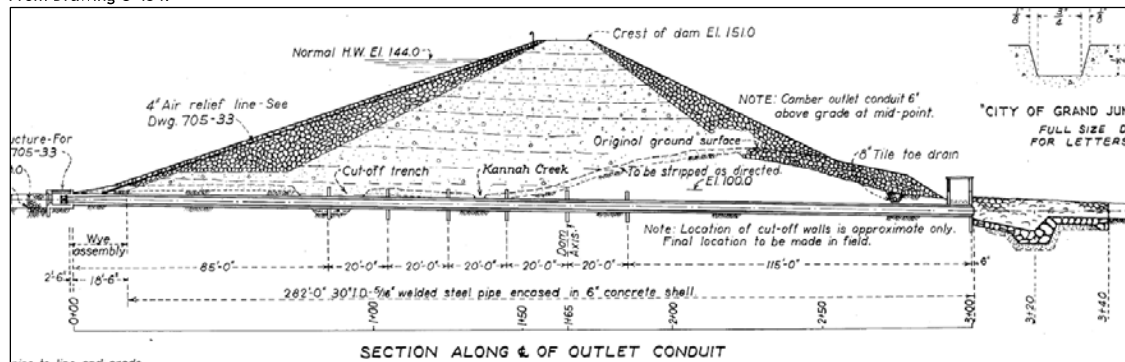
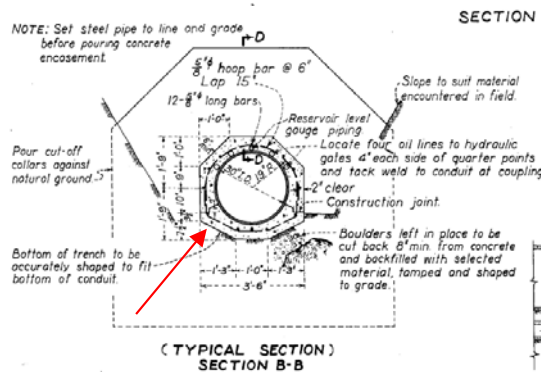
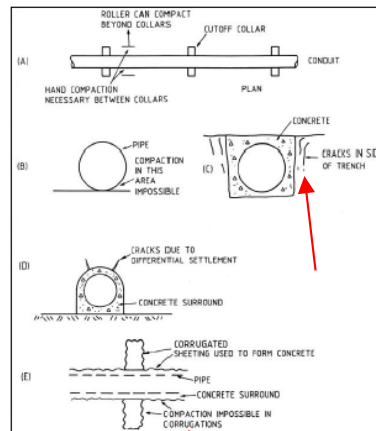
PFM Sketch

From Drawing C-454:

PFM Title: Internal Erosion Along the Conduit	
PFM #12	Concentrated Leak Erosion or Backward Erosion Piping Along Conduit
Initiation: (flaw exists/seepage velocity is high enough to erode material)	<ul style="list-style-type: none"> • Reservoir level rises Normal Storage level at Spillway Crest¹. • The initial construction of the dam resulted in a <i>defect</i>² in the backfill along the entire length (i.e., continuous) of the contact with the outlet conduit leading to <i>concentrated leak erosion</i>³ along the conduit. • Seepage gradient and resulting velocity of flow is sufficient to erode backfill material along the conduit.
Continuation: (unfiltered exit)	<ul style="list-style-type: none"> • No effective filter is present at the seepage exit to prevent removal of eroded material. • Eroded material exits at the downstream toe <i>behind the outlet headwall and from the right abutment</i>⁴.

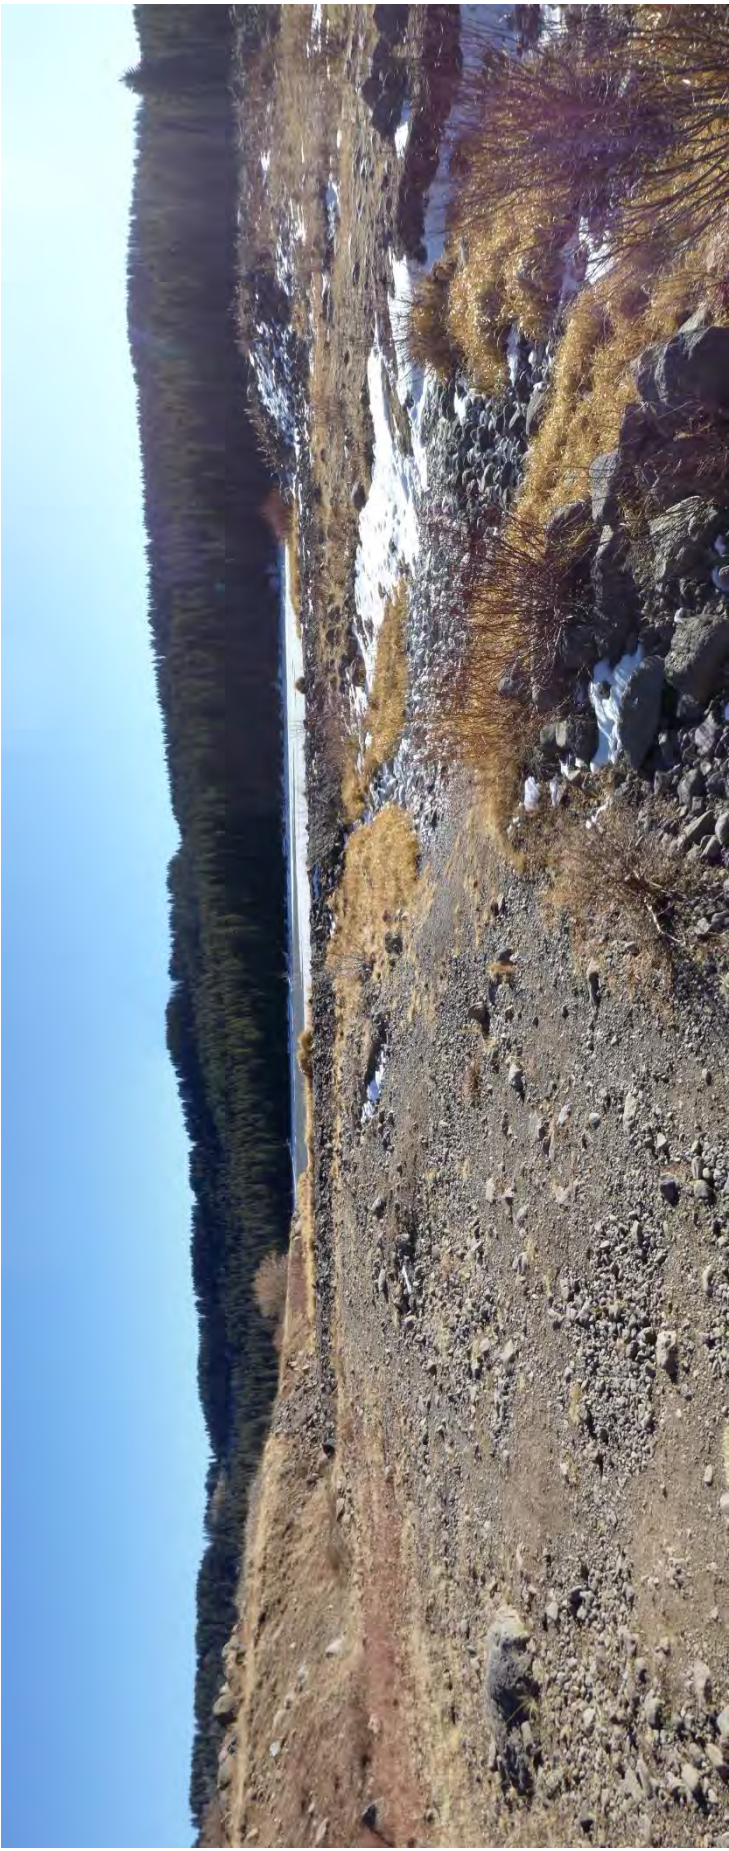
Photo 1: View looking upstream at spillway crest, 12/11/2017

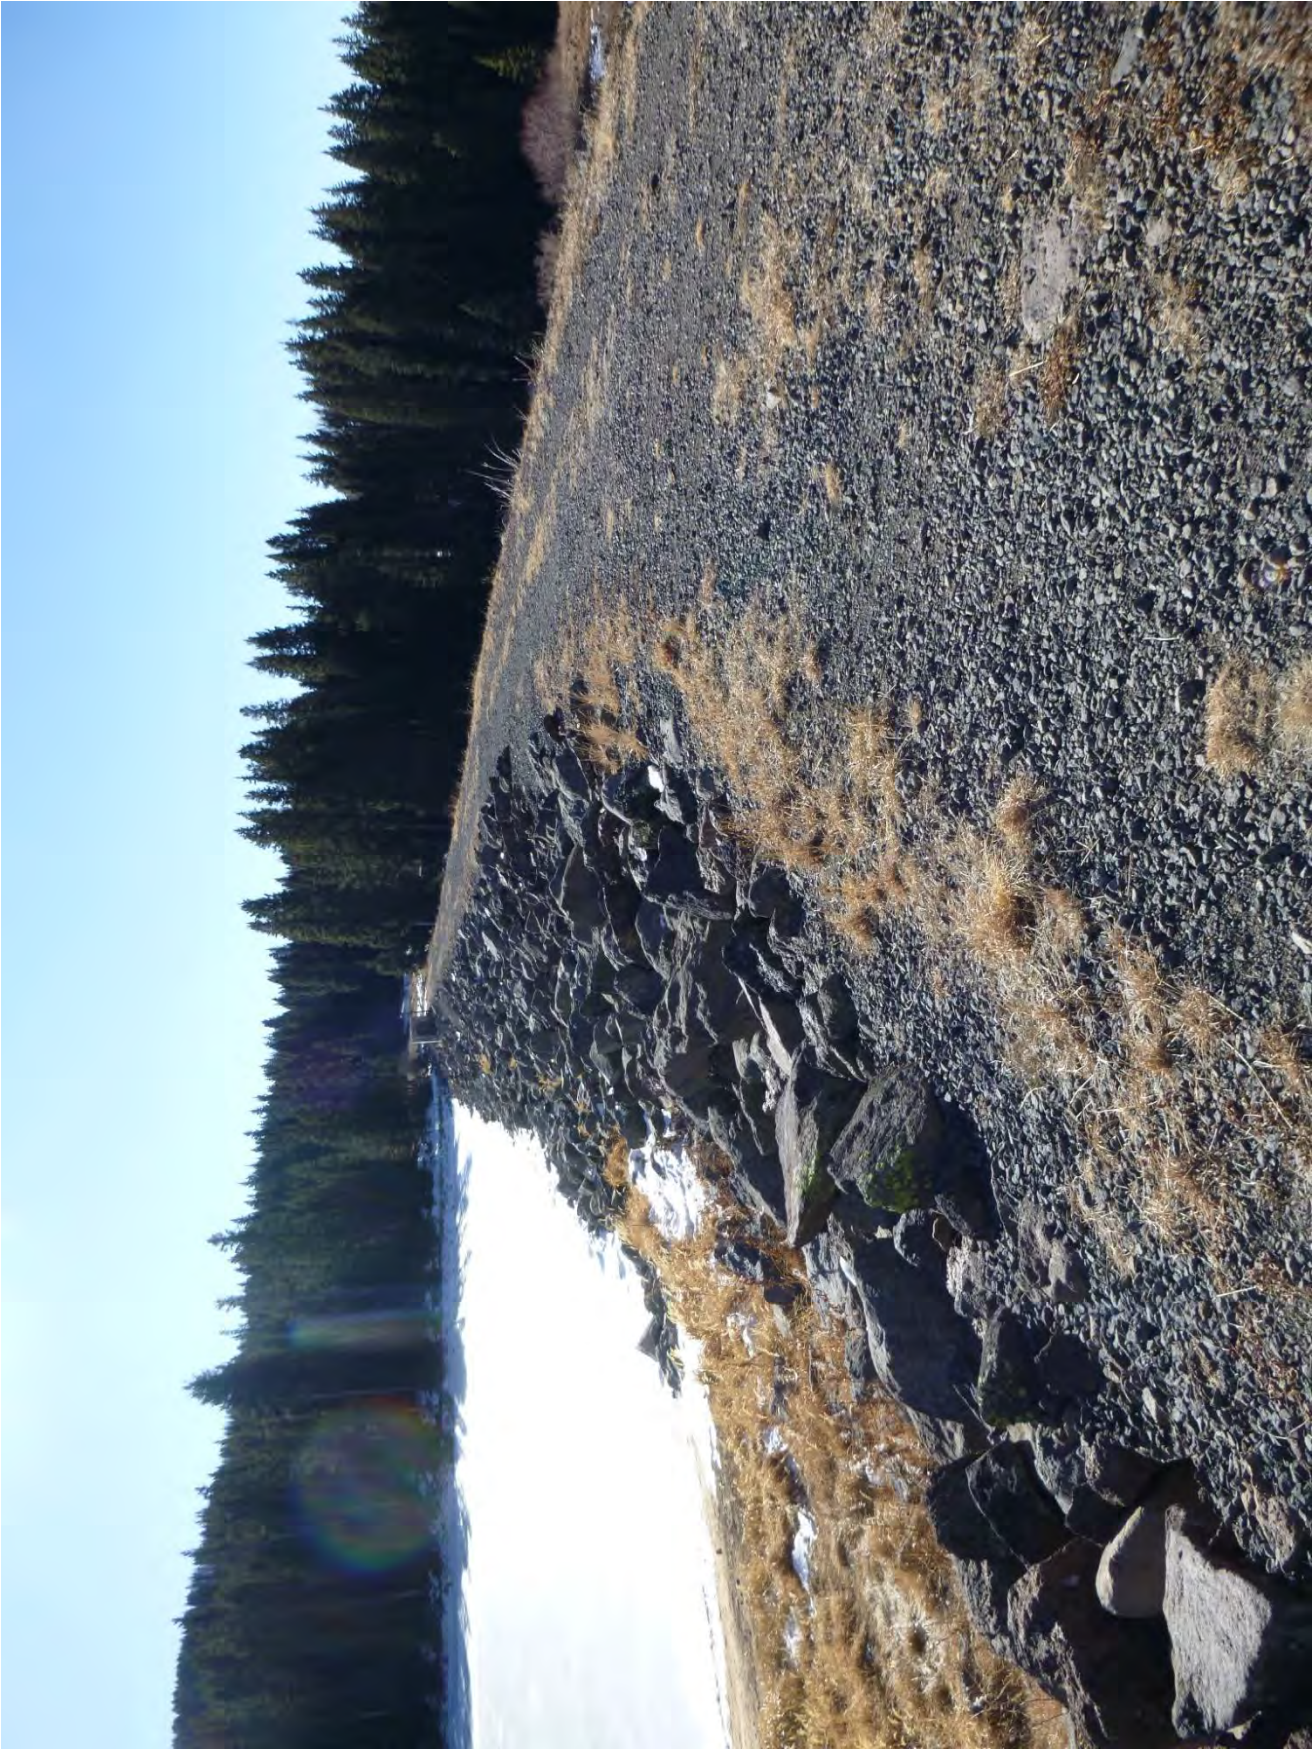
Photo 2: Upstream slope; Outlet hydraulics control building at center of dam on upstream edge of dam crest.
