**Request for Proposal
RFP-4519-18-DH**

**Professional Services for
Safety Evaluation of Hogchute Dam**

INSPECTION REPORT
Division 4 Dam Safety Engineer's Inspection Report
(October 27, 2017)

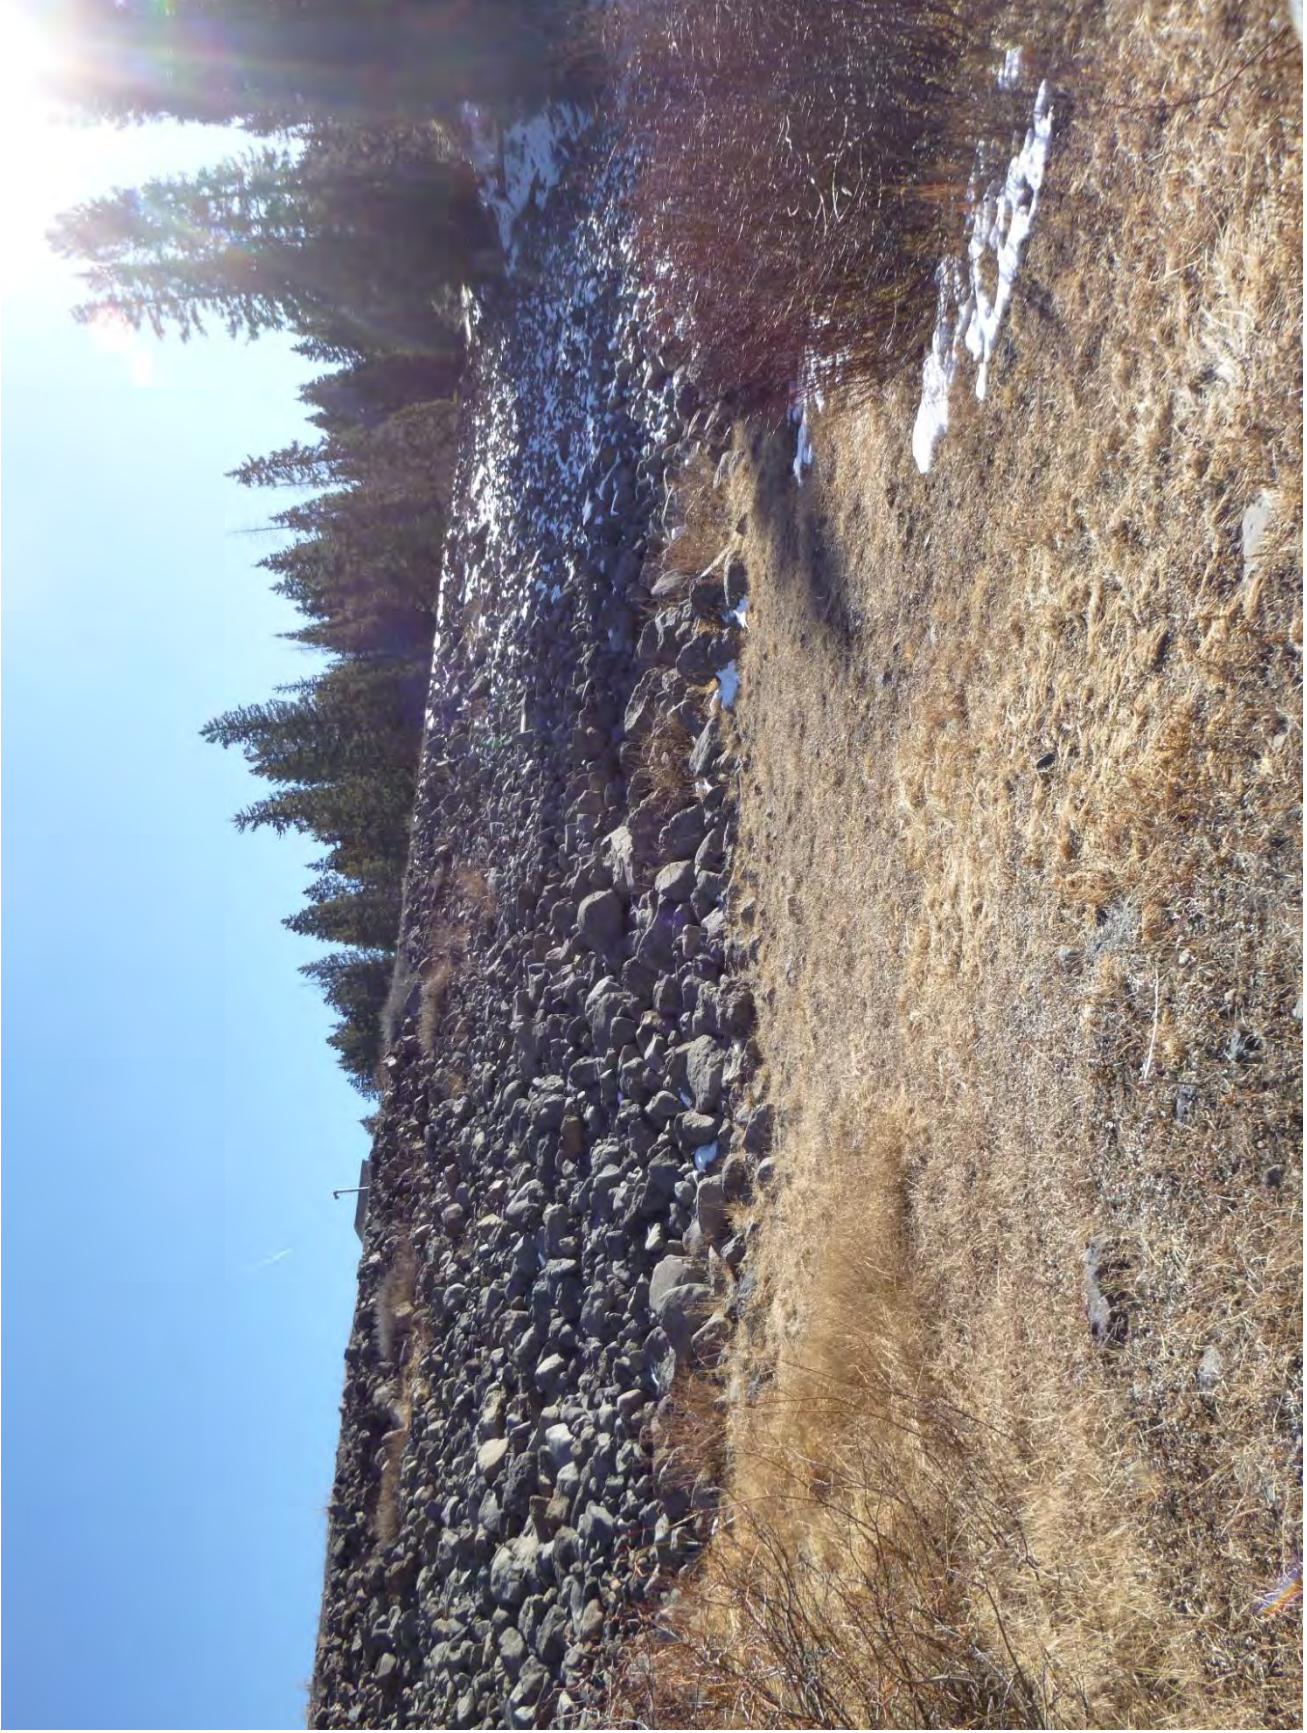
Photo 3: Downstream slope; Zone 2 material per C-454

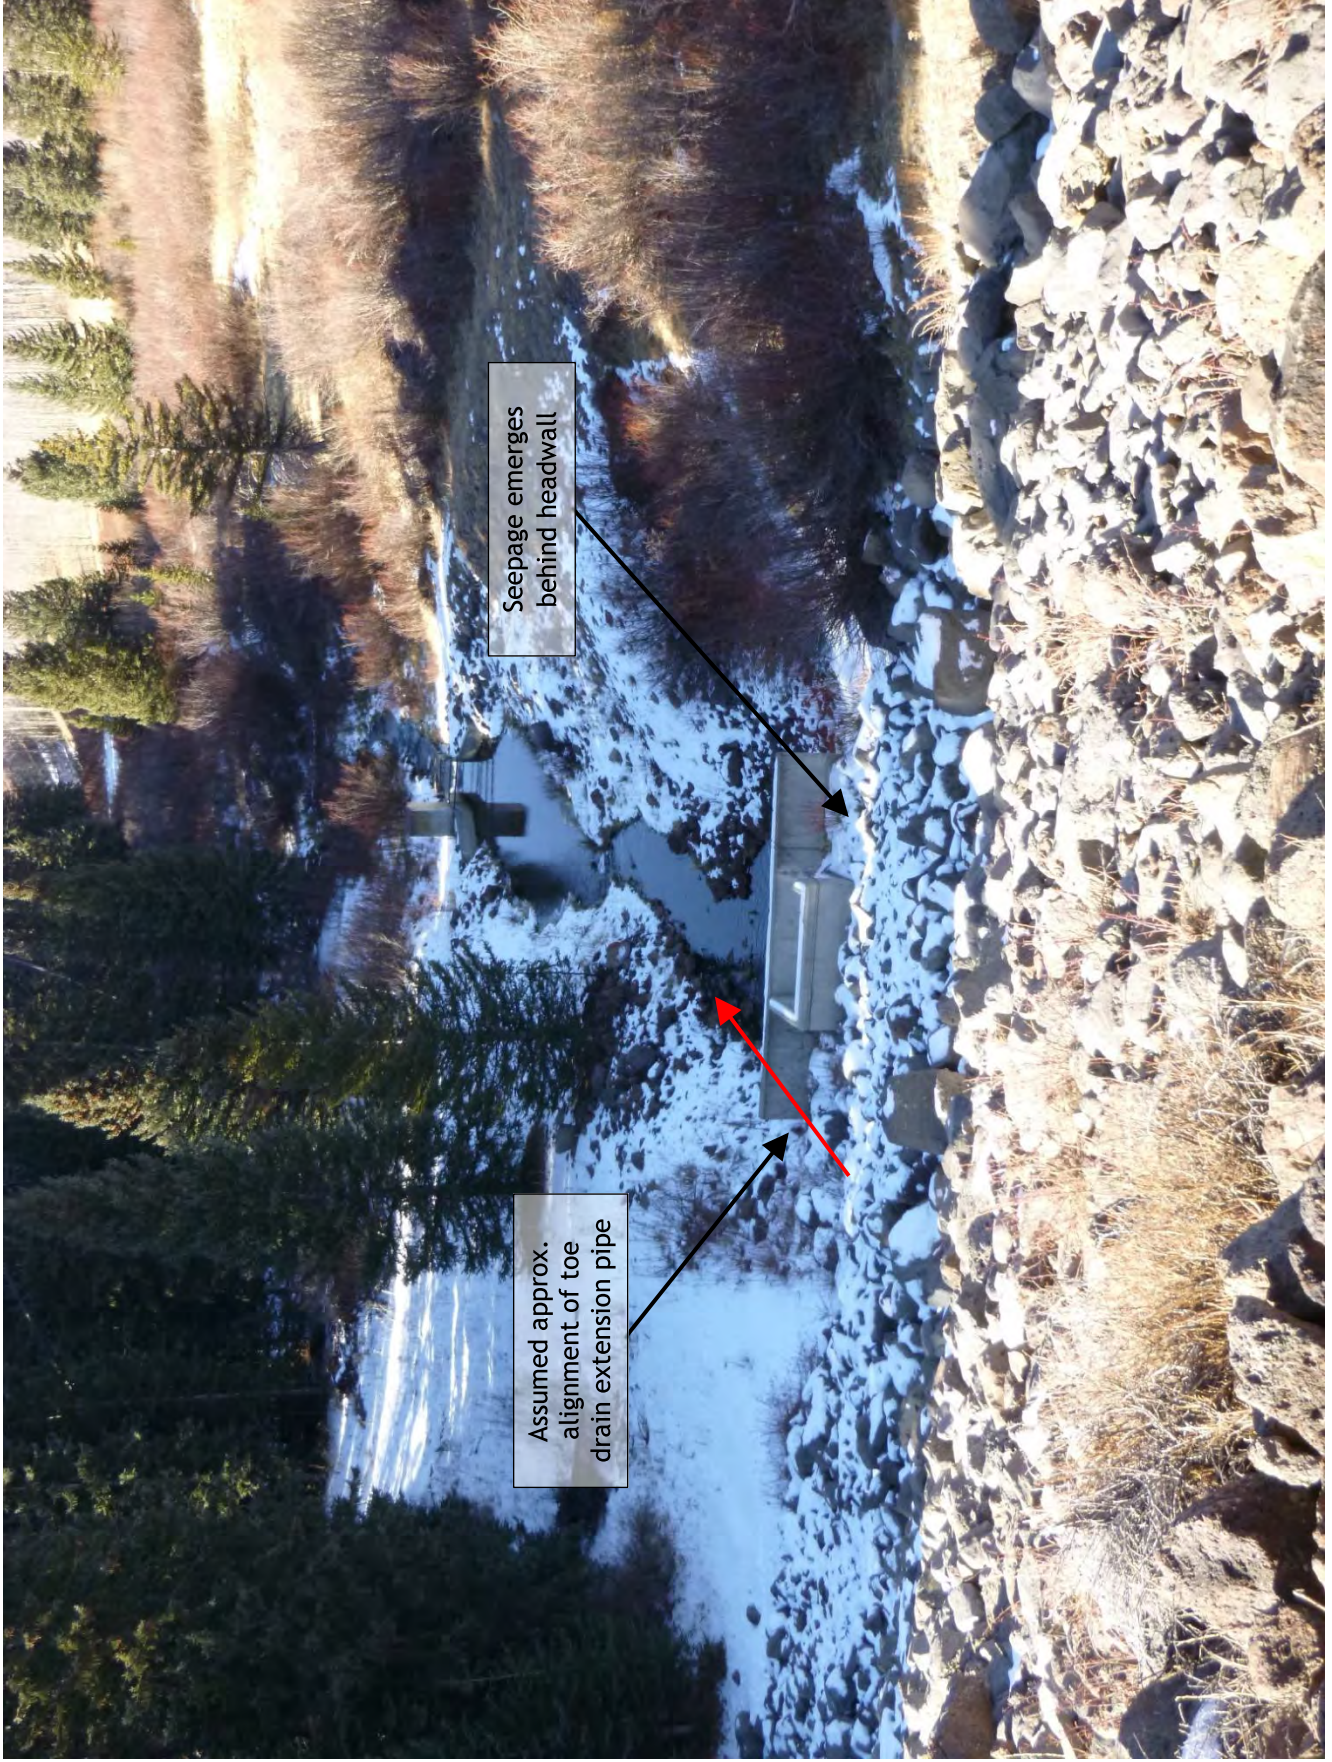
Seepage emerges behind headwall

Assumed approx. alignment of toe drain extension pipe

Photo 4: Downstream outlet headwall.

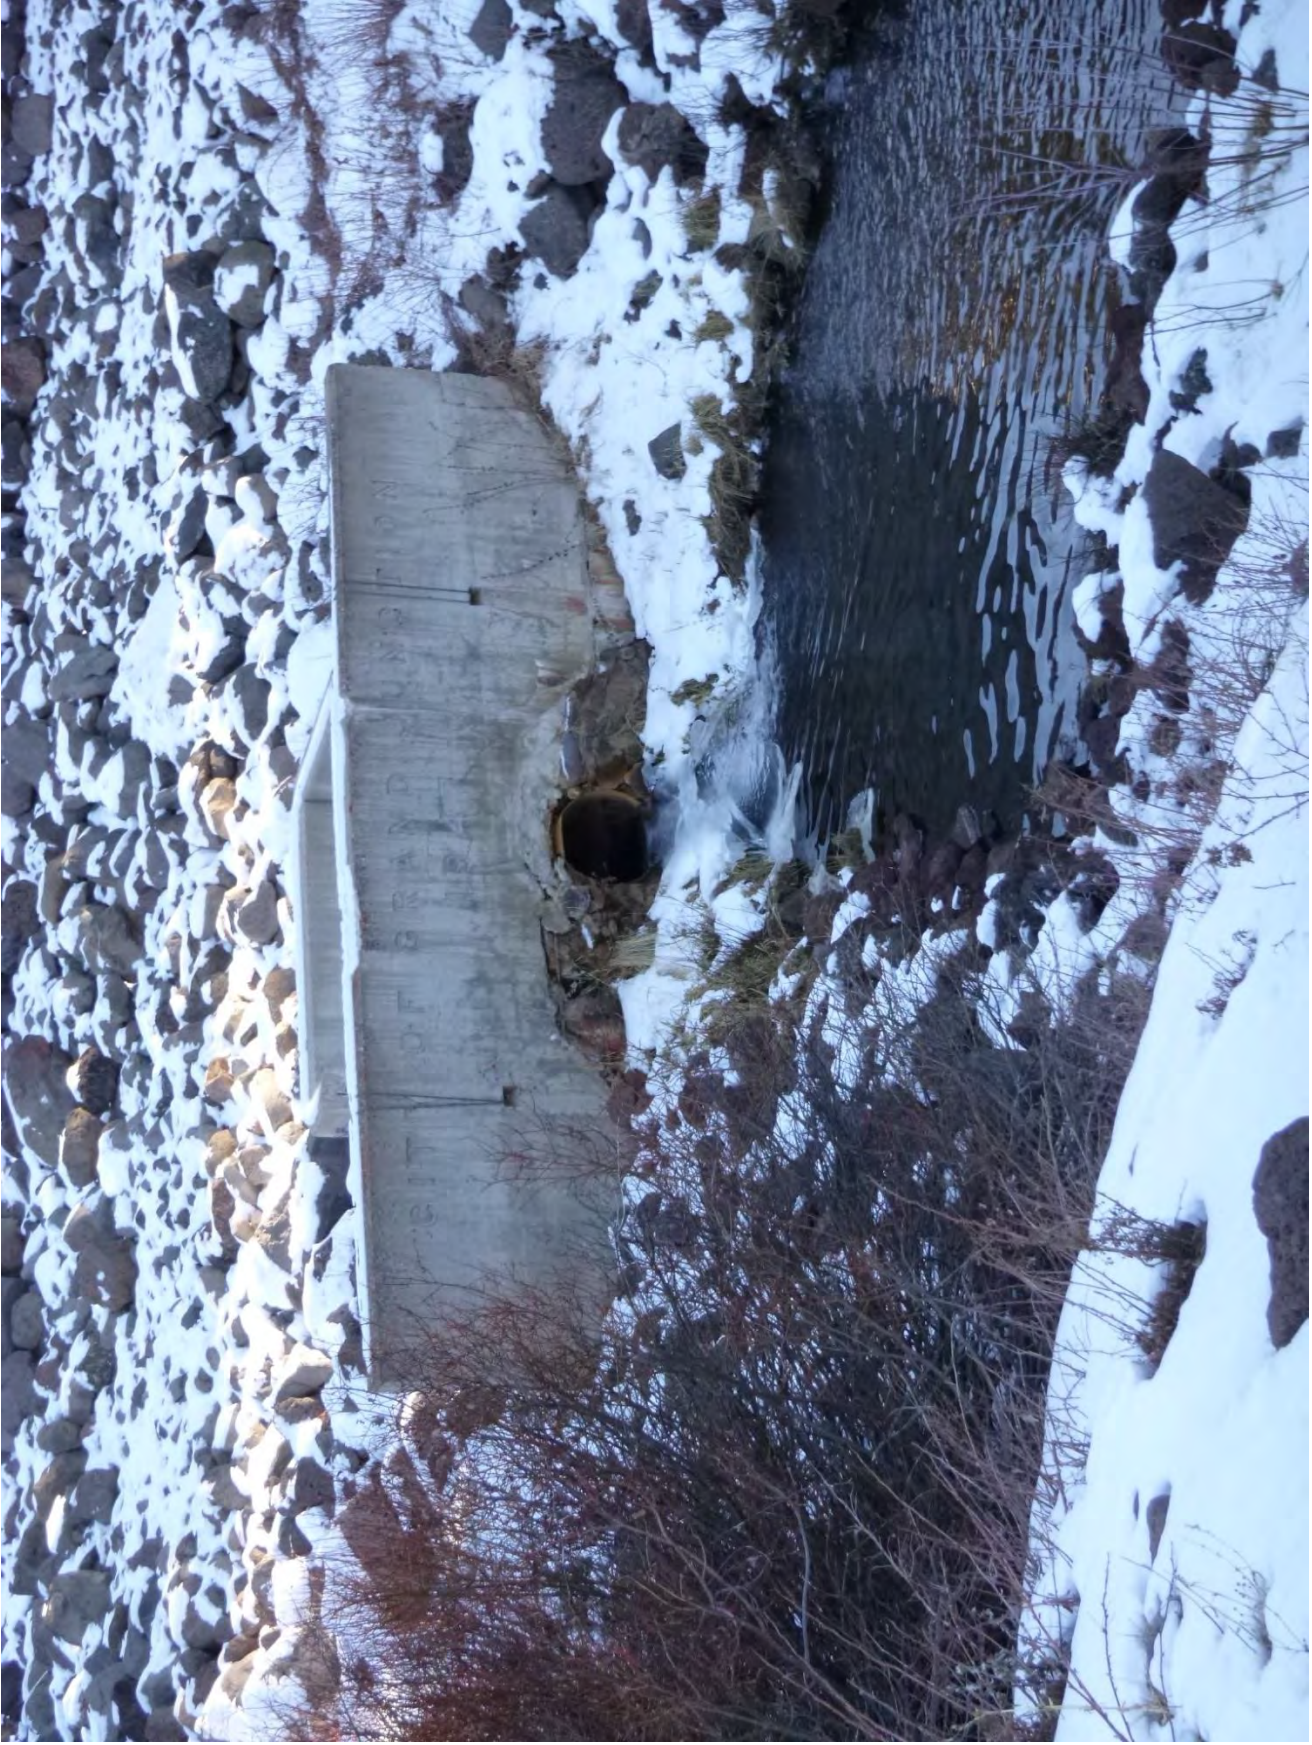
Photo 5: Downstream outlet pipe headwall.

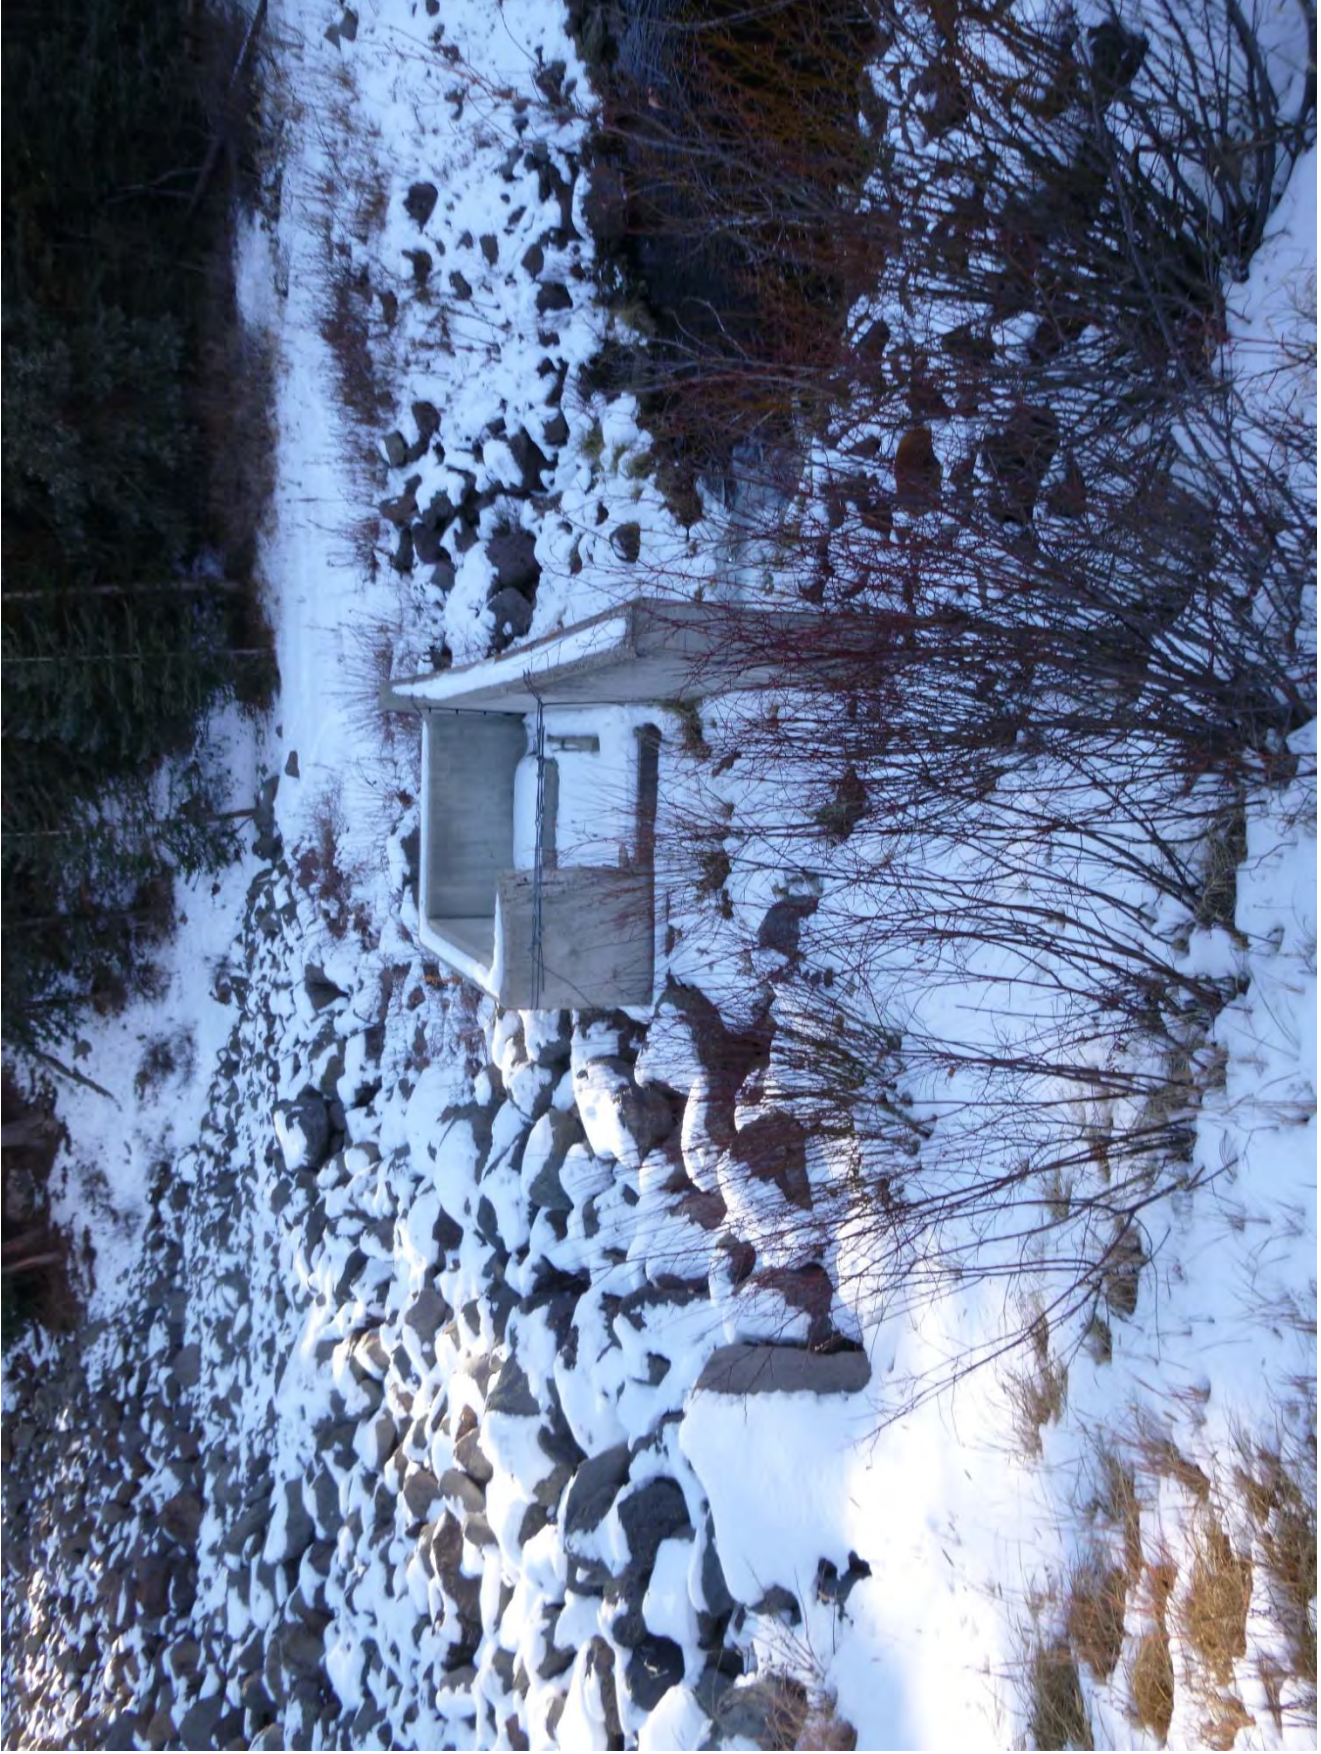
Photo 6: Abandoned outlet hydraulics control building foundation behind headwall.

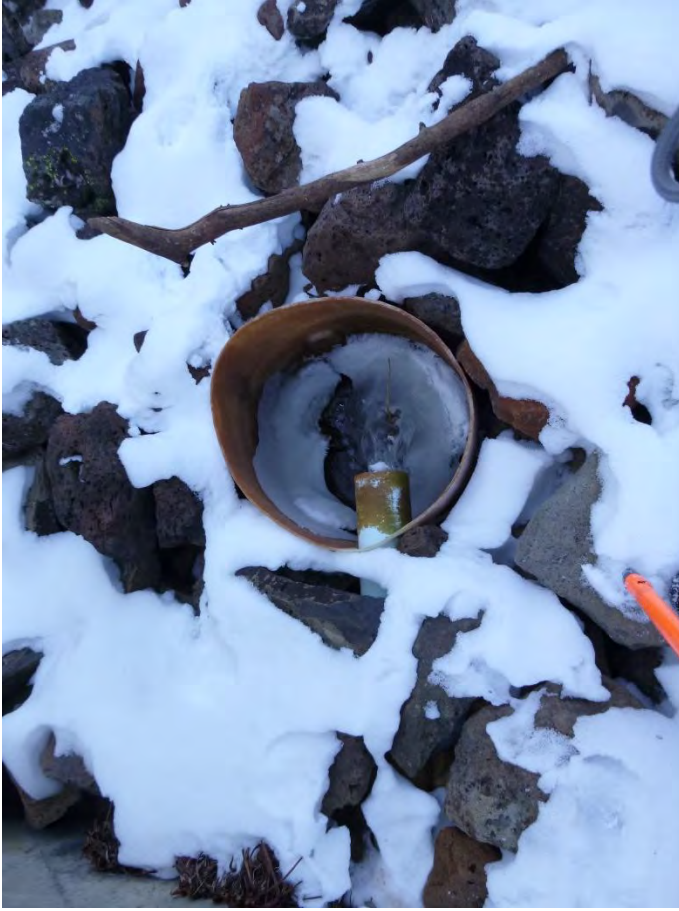
Photo 7: Collection and monitoring pipe from right side of outlet headwall.

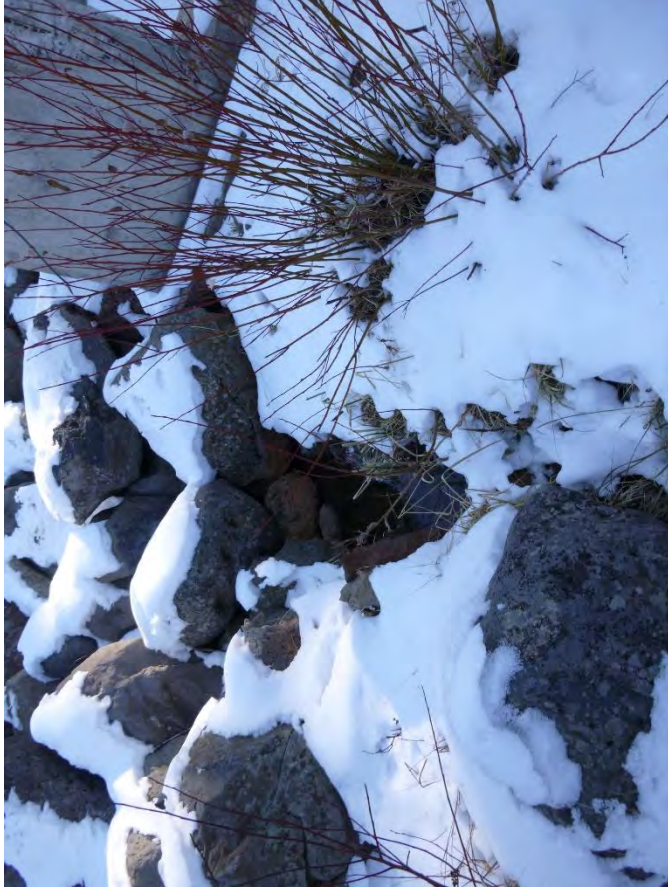
Photo 11: Seepage behind right side of outlet headwall.

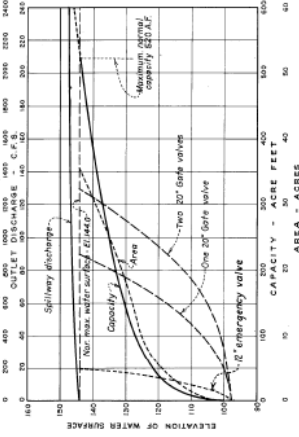
AREA, CAPACITY AND DISCHARGE CURVES

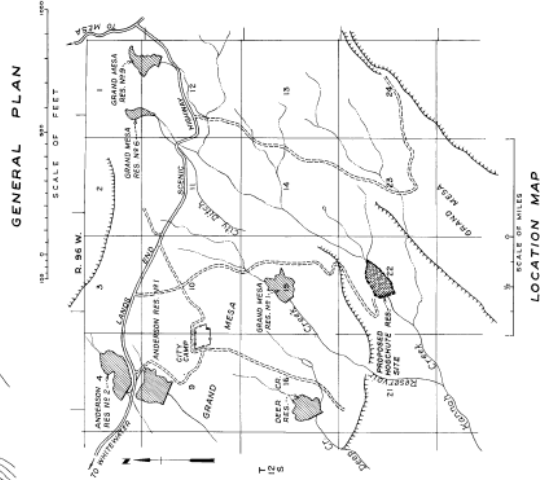
GENERAL PLAN

CITY OF GRAND JUNCTION
 AL J. TITTON, CIVIL ENGINEER
 GRAND JUNCTION, COLORADO
**IMPROVEMENTS TO WATER SUPPLY SYSTEM
 HOGCHUTE RESERVOIR
 VICINITY MAP AND GENERAL PLAN**
 DRAWN BY: [Signature]
 CHECKED BY: [Signature]
 APPROVED BY: [Signature] MAY 1967
 705-30
C-454

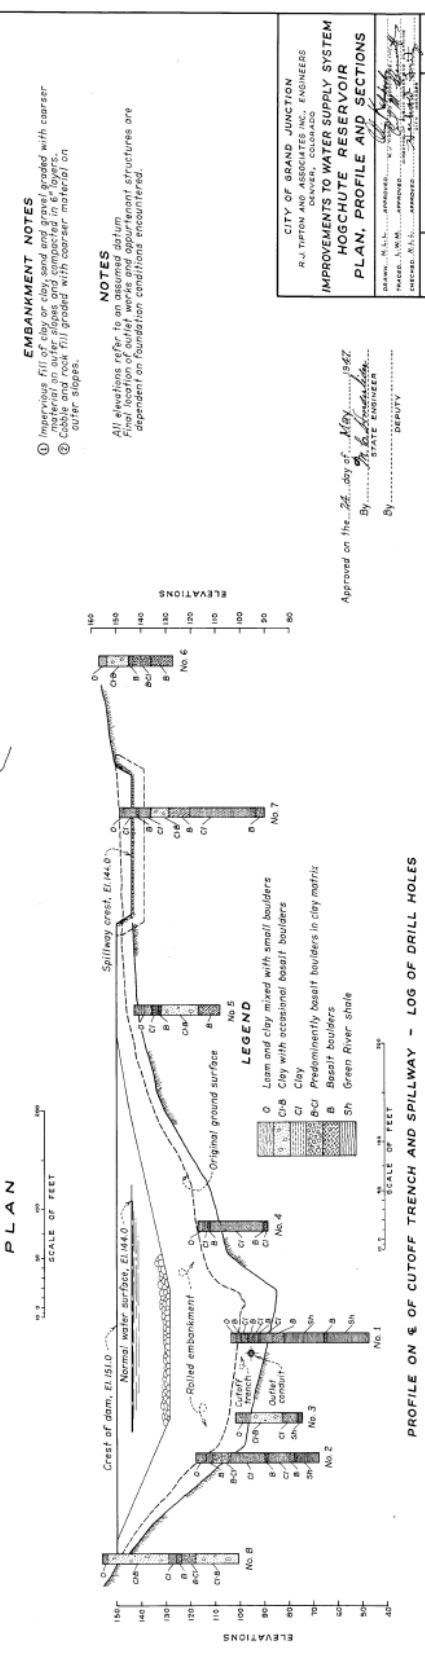
EMBAKMENT NOTES

- Impervious fill of clay or clay, sand and gravel graded with coarser material on outer slopes and compacted in 6" layers.
- Coarser fill graded with coarser material on outer slopes.

CITY OF GRAND JUNCTION
 R.J. Tipton and Associates Inc. ENGINEERS
 DENVER, COLORADO
HOGCHUTE WATER SUPPLY SYSTEM
HOGCHUTE RESERVOIR
PLAN, PROFILE AND SECTIONS
 SHEET NO. 105-31
 GRAND JUNCTION, COLORADO MAY 1947
