RE: TEDS Exception from Minimum Storage for Drive-up Banking Facilities for Branch Banks

DESIGN EXCEPTION #DE20-02

RE: Exception from Minimum Vehicle storage for Drive-up Banking Facility

SUBJECT: TEDS Exception for 1st National Bank of the Rockies at Redlands
Marketplace

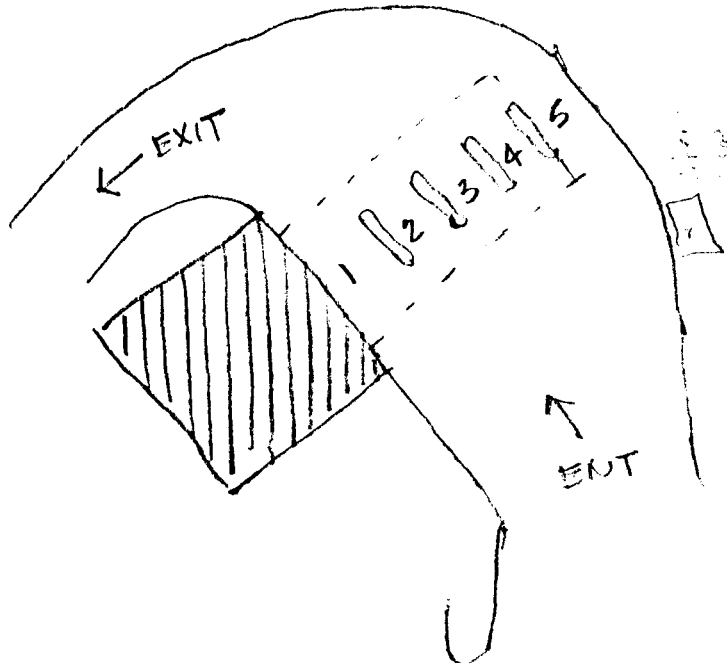
Diagram

Isle #1	Isle #2	Isle #3	Isle #4	+ATM Isle #5
4:00 - 4:04					
4:05 - 4:09					
4:10 - 4:14					
4:15 - 4:19					
4:20 - 4:24					
4:25 - 4:29					
4:30 - 4:34					
4:35 - 4:39					
4:40 - 4:44					
4:45 - 4:49					
4:50 - 4:54					
4:55 - 4:59					
5:00 - 5:04					
5:05 - 5:09					
5:10 - 5:14					
5:15 - 5:19					
5:20 - 5:24					
5:25 - 5:29					
5:30 - 5:34					
5:35 - 5:39					
5:40 - 5:44					
5:45 - 5:49					
5:50 - 5:54					
5:55 - 5:59					
	25	18	13	3	16

The banks were analyzed on the first Friday of the month, June 7, 2002, from 4:00 p.m. to 6:00 p.m. in the afternoon. This time period is recognized as the busiest period for the facilities. Each of the banks had a person counting the queues for each of the drive-up teller windows. The peak number of queued vehicles in each lane was recorded in 5-minute increments. A summary of the results of the data collected is found in Table A. Using the collected data, a summary of observations can be found in Table B. The raw data can be found in the Appendix.

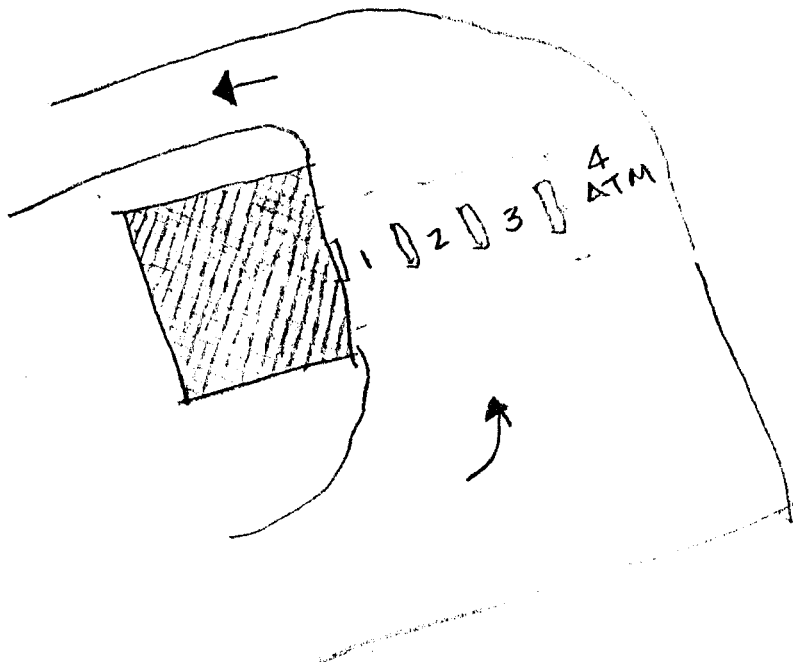
Diagram

ALPINE BANK
2424 F ROAD
Rick Elmer
6-7-03

Isle #1	Isle #2	Isle #3	+ ATM Isle #4	Isle #5
4:00 - 4:04	1	1	1	1	
4:05 - 4:09	2	1	2	0	
4:10 - 4:14	1	1	2	0	
4:15 - 4:19	1	1	0	1	
4:20 - 4:24	1	0	0	0	
4:25 - 4:29	2	1	1	0	
4:30 - 4:34	1	1	1	1	
4:35 - 4:39	1	2	1	1	
4:40 - 4:44	1	1	1	1	
4:45 - 4:49	1	1	0	1	
4:50 - 4:54	2	1	1	1	
4:55 - 4:59	1	1	0	1	
5:00 - 5:04	0	1	1	0	
5:05 - 5:09	0	1	1	1	
5:10 - 5:14	1	1	0	1	
5:15 - 5:19	1	1	1	2	
5:20 - 5:24	0	0	0	0	
5:25 - 5:29	1	1	0	1	
5:30 - 5:34	1	1	0	1	
5:35 - 5:39	1	1	0	1	
5:40 - 5:44	1	0	0	1	
5:45 - 5:49	1	0	0	0	
5:50 - 5:54	1	0	0	0	
5:55 - 5:59	0	0	0	0	
	25	19	13	16

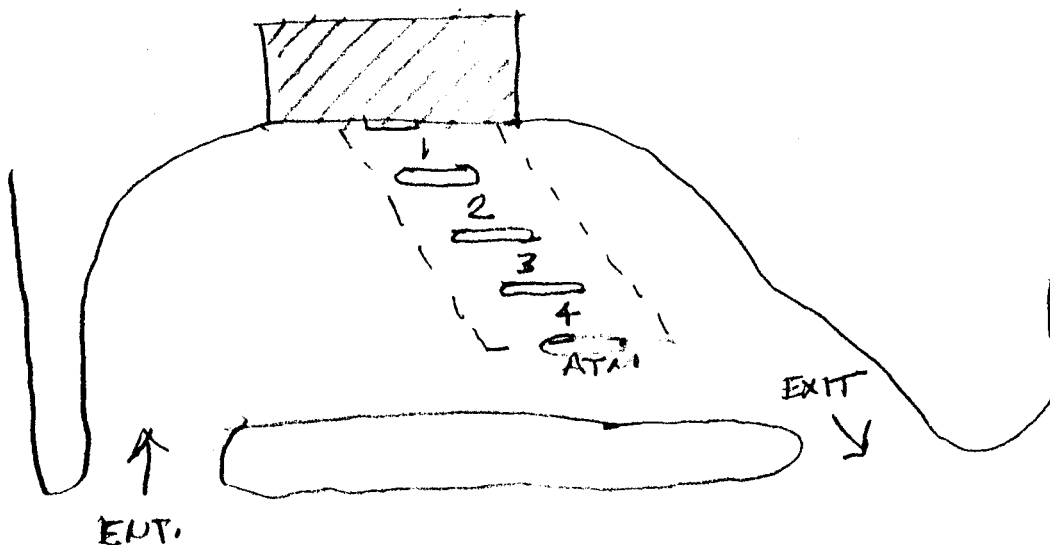
Diagram

BANK OF GRAND ST.
BROADWAY & REPLANTS PKWY
Mark Flmer
6-7-02

Isle #1	Isle #2	Isle #3	ATM Isle #4	Isle #5
4:00 - 4:04	1	0	0	0	
4:05 - 4:09	0	0	0	1	
4:10 - 4:14	1	0	0	0	
4:15 - 4:19		0	0	0	
4:20 - 4:24	0	0	0	0	
4:25 - 4:29	1	0	0	0	
4:30 - 4:34	1	1	0	0	
4:35 - 4:39	0	1	0	0	
4:40 - 4:44	1	2	0	0	
4:45 - 4:49	1	1	0	0	
4:50 - 4:54	1	0	1	0	
4:55 - 4:59	0	0	1	0	
5:00 - 5:04	1	0	1	0	
5:05 - 5:09	0	0	0	1	
5:10 - 5:14	0	0	0	0	
5:15 - 5:19	1	0	0	0	
5:20 - 5:24	0	0	0	0	
5:25 - 5:29	0	1	0	0	
5:30 - 5:34	0	1	0	0	
5:35 - 5:39	1	0	0	0	
5:40 - 5:44	0	0	0	0	
5:45 - 5:49	0	0	0	0	
5:50 - 5:54	0	0	0	0	
5:55 - 5:59	0	0	0	0	
	[12]	[8]	[3]	[2]

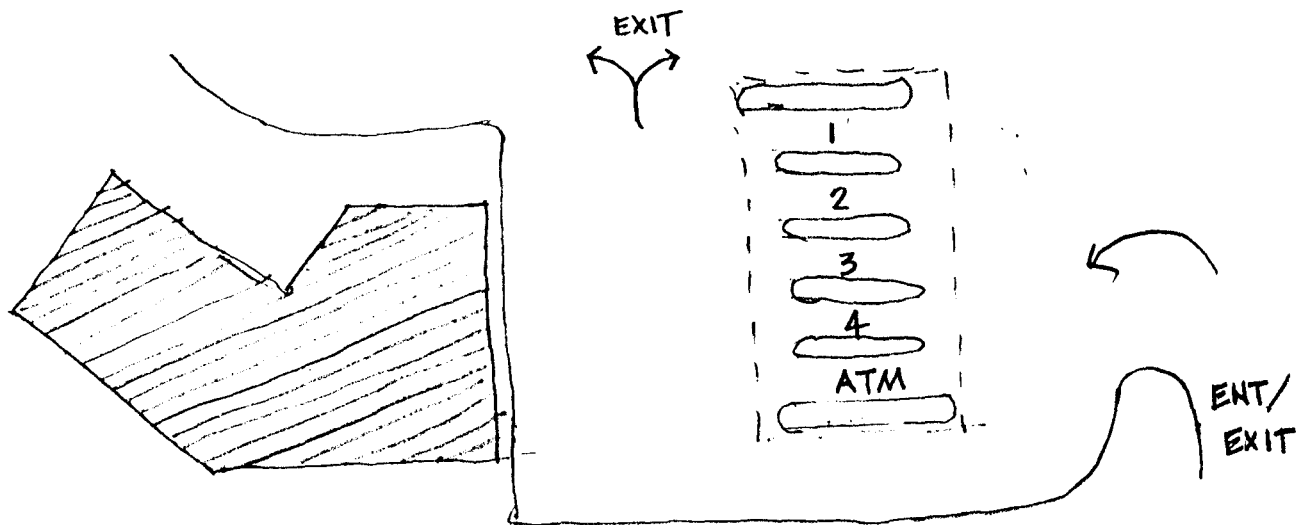
Diagram

1ST NATIONAL BANK OF ROCKIES
2452 HWY 6 & 50
Sean Pany
6/7/02

ATM				
	Isle #1	Isle #2	Isle #3	Isle #4	Isle #5
4:00 - 4:04	0	1	0	0	0
4:05 - 4:09	0	1	1	1	0
4:10 - 4:14	1	1	1	1	0
4:15 - 4:19	1	1	1	1	0
4:20 - 4:24	1	1	1	1	0
4:25 - 4:29	0	1	0	1	0
4:30 - 4:34	1	2	2	1	0
4:35 - 4:39	0	2	1	1	0
4:40 - 4:44	0	1	1	1	0
4:45 - 4:49	0	1	1	1	0
4:50 - 4:54	0	1	0	0	0
4:55 - 4:59	0	0	1	0	0
5:00 - 5:04	0	0	1	0	0
5:05 - 5:09	0	0	1	0	0
5:10 - 5:14	0	0	1	0	0
5:15 - 5:19	0	1	0	0	0
5:20 - 5:24	0	1	0	0	0
5:25 - 5:29	0	1	1	1	0
5:30 - 5:34	0	1	1	1	0
5:35 - 5:39					
5:40 - 5:44					
5:45 - 5:49					
5:50 - 5:54					
5:55 - 5:59					
	4	18	14	10	0

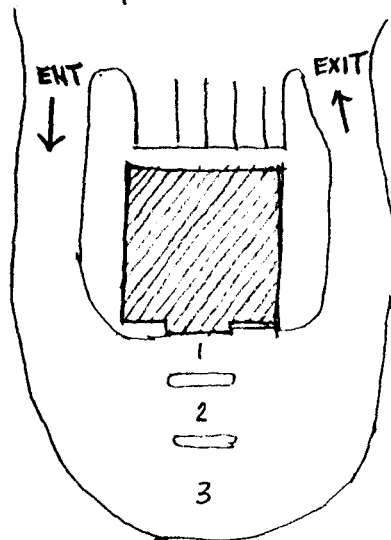
Diagram

WESTSTAR BANK
2448 F ROAD
Anton
05/07/00

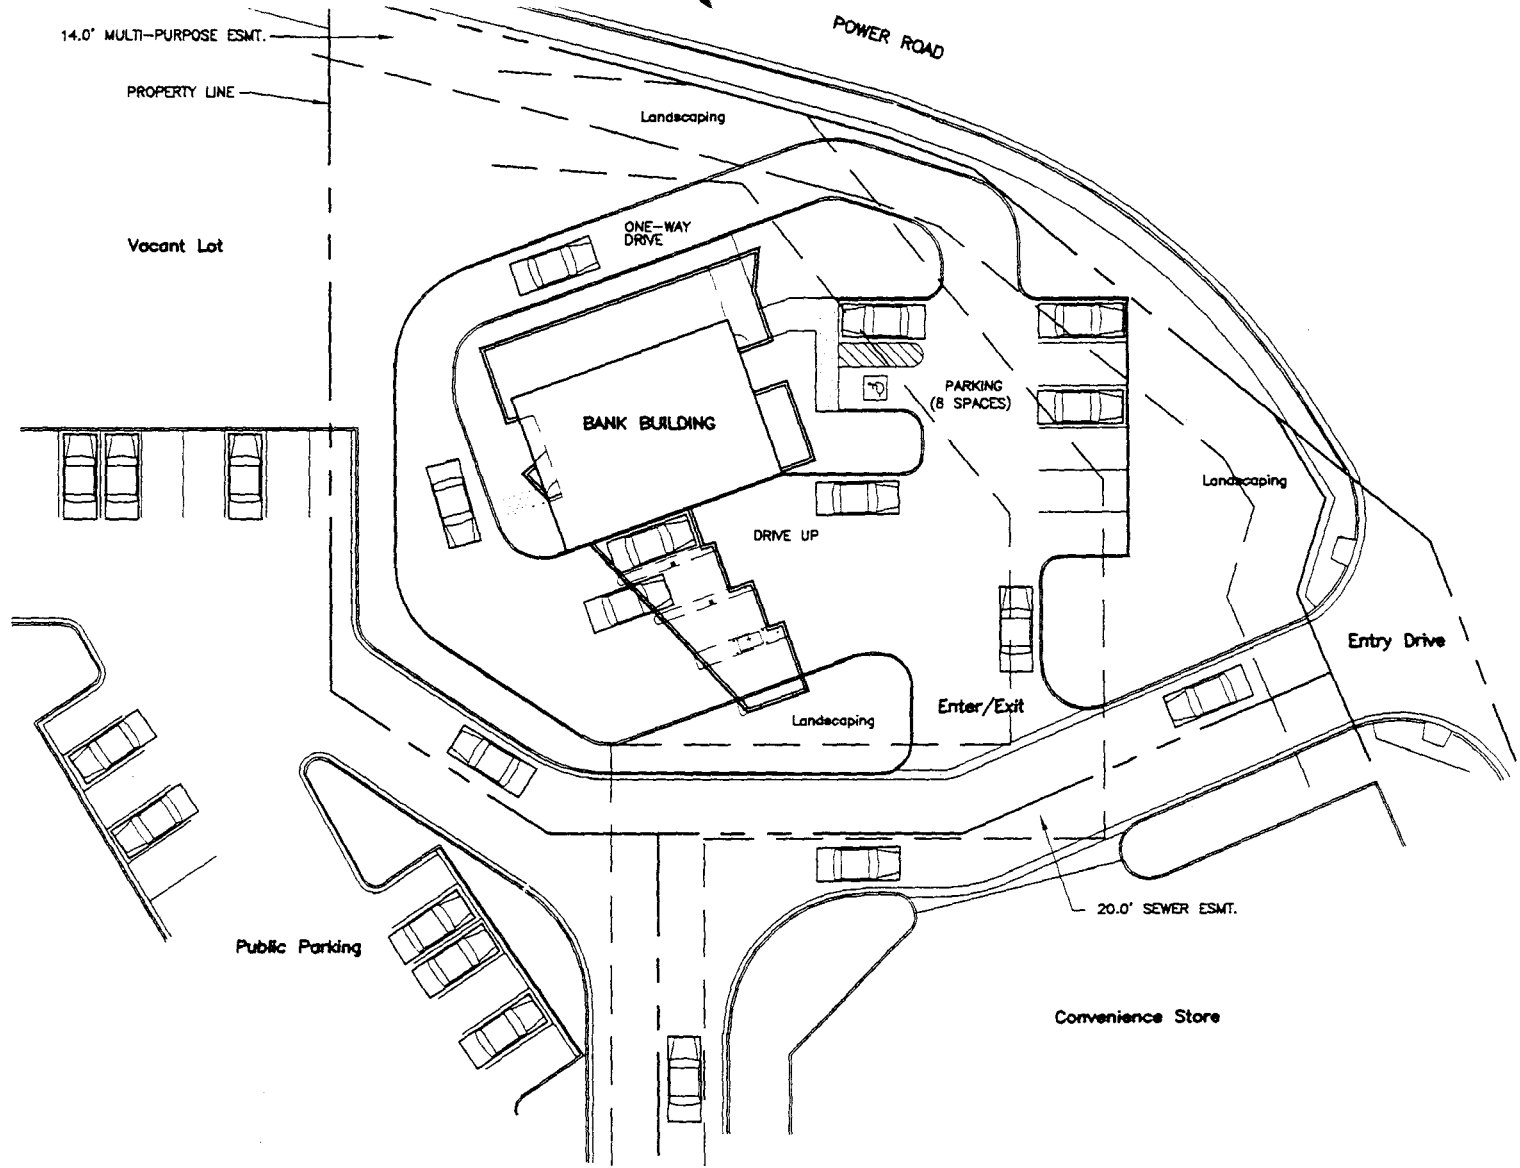
PROPOSED SITE PLAN

Lot 5, Redlands Marketplace

Proposed Design – The proposed design is to provide for (4) Drive-up Teller Windows (1 being a ATM) with a one-way loop road around the proposed building. Each Teller Window will be able to queue (2) cars together. The loop road will be able to queue (9) additional cars. Proposed site plan is attached in the Appendix.
