RE: TEDS Exception No. 37-03, from Minimum Vehicle Storage for a Drive-up Branch
Banking Facility

DESIGN EXCEPTION #DE37-03

To: Mark Relph, Director of Public Works & Utilities
Thru: Tim Moore, Public Works Manager
Copy to: Laura Lamberty, Development Engineer
From: Mike McDill, City Engineer
Date: September 12, 2003
RE: Exception from Minimum Vehicle Storage for Drive-up Branch Banking Facility

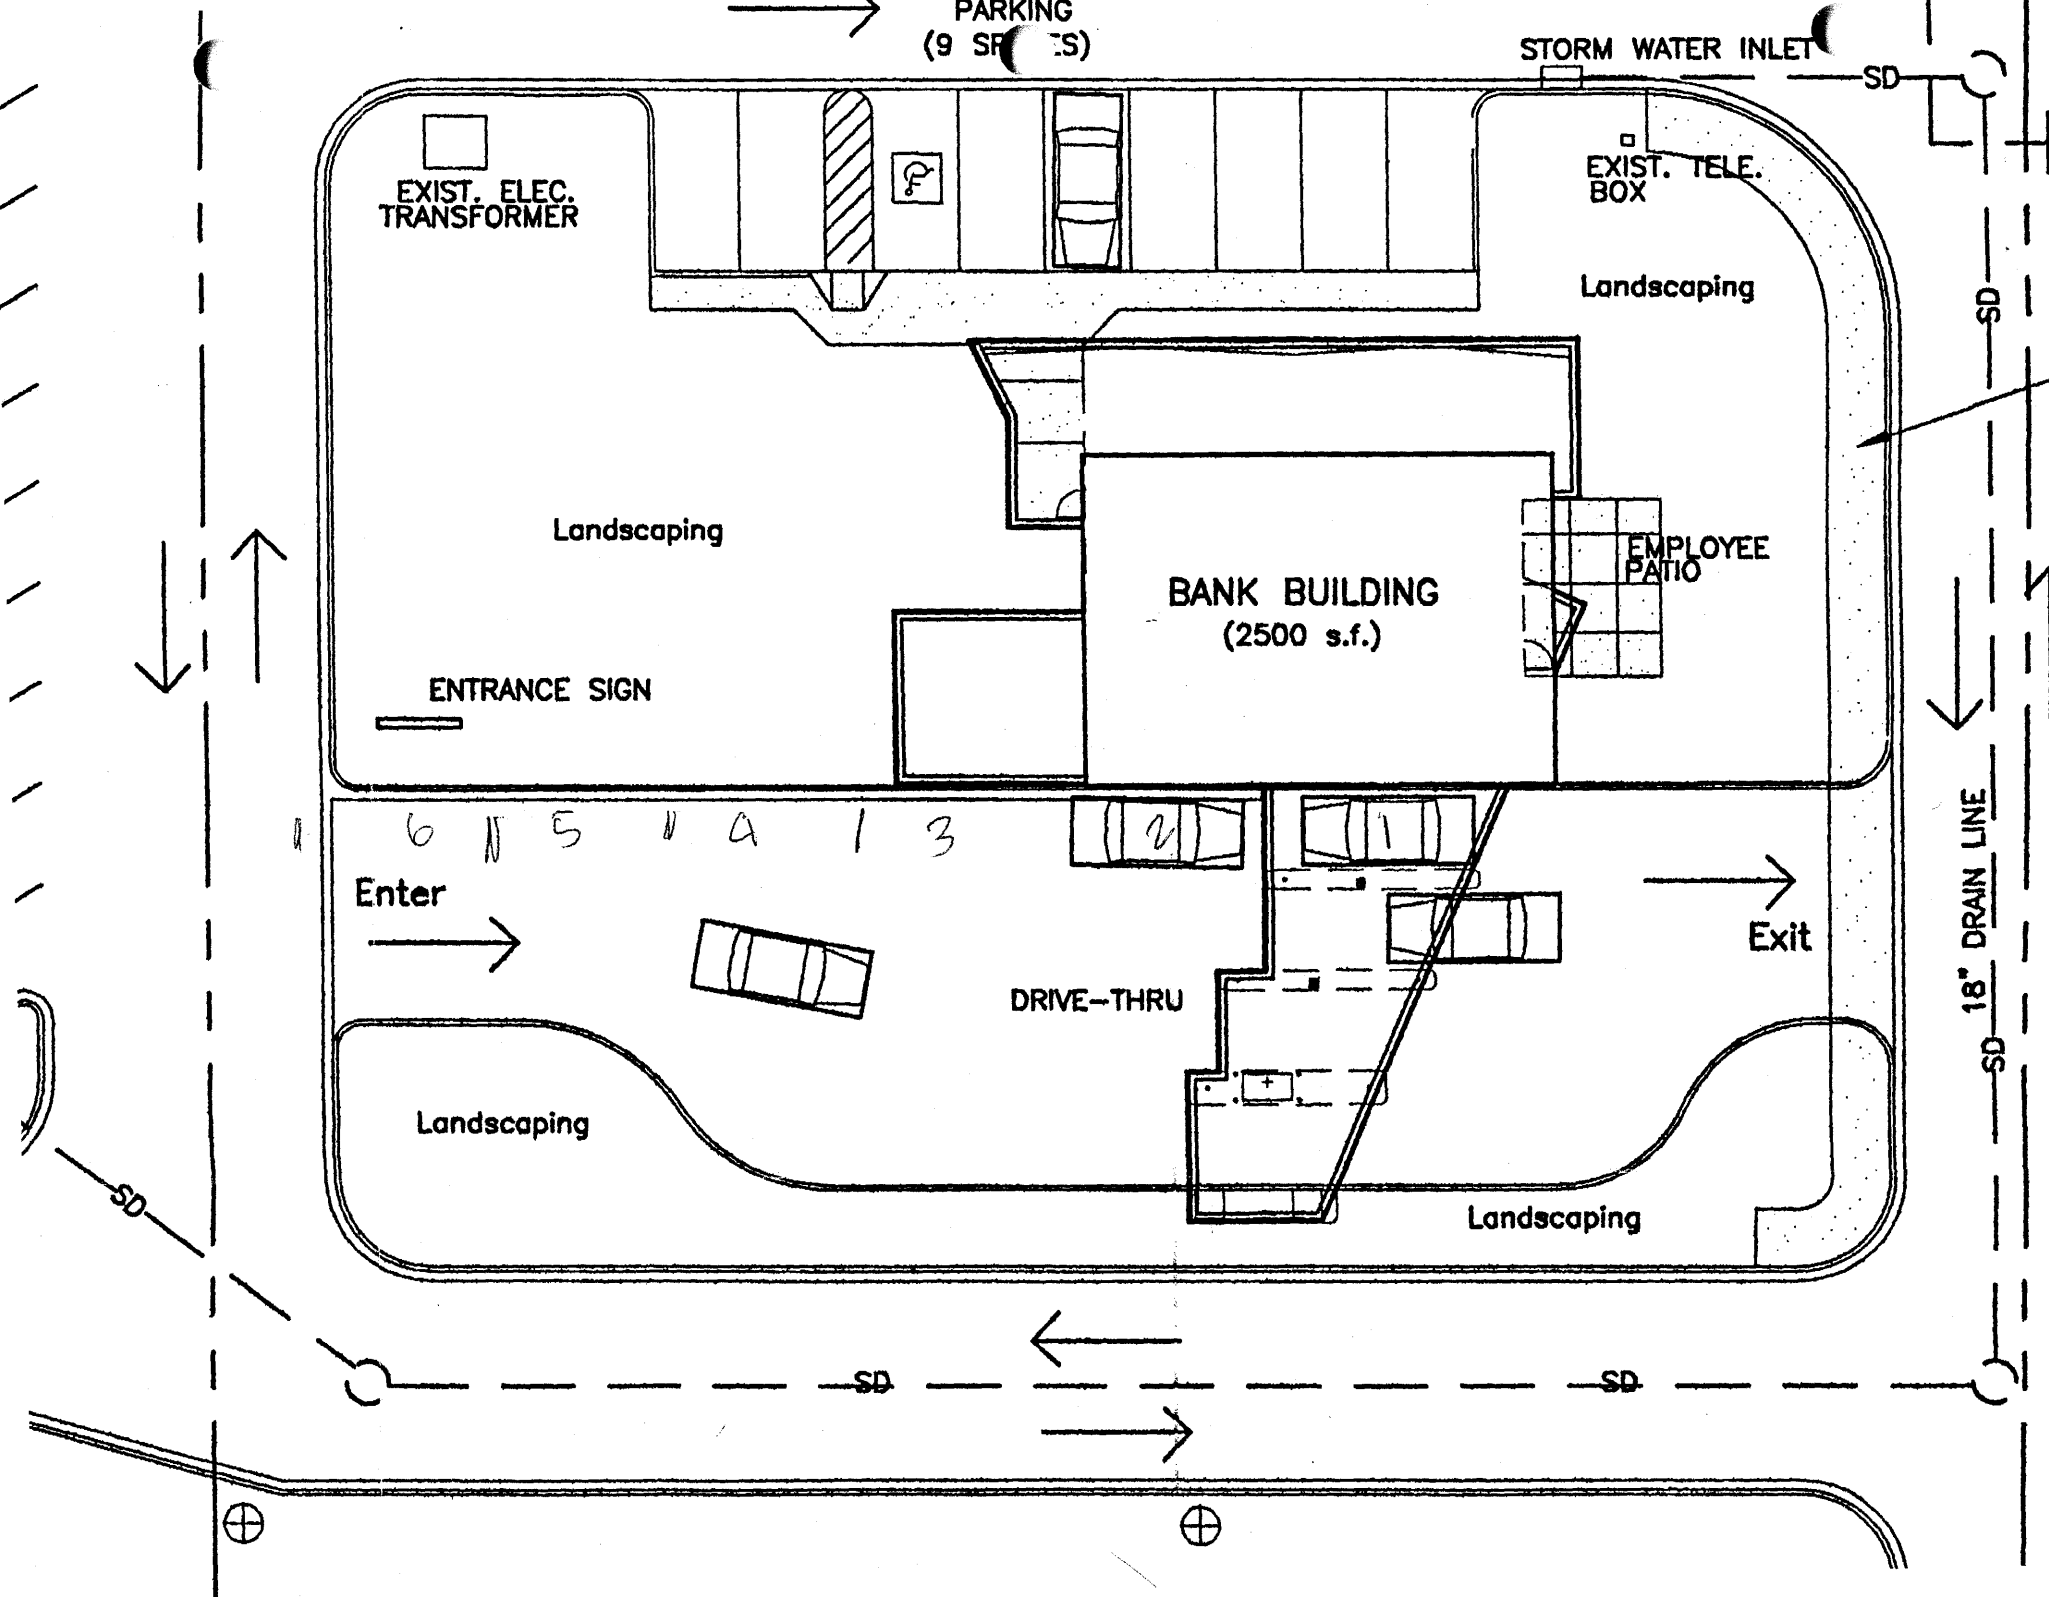
PARKING
(9 SPACES)

STORM WATER INLET

The site plan indicates four drive-up lanes, with adequate queue length for 6 vehicles in Lane 1, 5 vehicles in Lane 2, 4 vehicles in Lane 3, and 3 vehicles for Lane 4. Inadequate storage capacity would result in blocking an interior drive aisle for the Safeway Plaza, but no obstructions to major drive aisles, or public right-of-way. The building could be shifted to the east somewhat to increase the stacking area available.
