SUBJECT: TEDS Exception for 1st National Bank of the Rockies

at Meridian Park Subdivision on Orchard Mesa

DESIGN EXCEPTION #DE 4-05

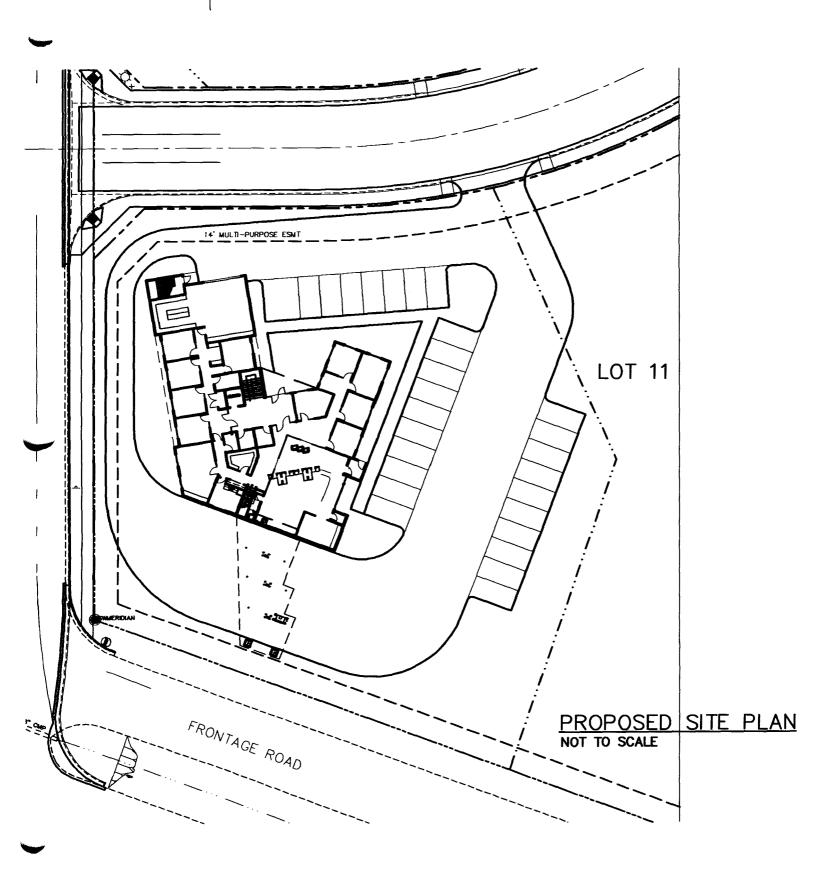
TABLE B SUMMARY OF OBSERVATIONS

- 9 times out of 120 / 5-minute intervals did all aisles become occupied.
- 22 times out of 120 / 5-minute intervals did 2 cars queue the same aisle.
- 1 time out of 120 / 5-minute intervals did 3 cars queue the same aisle (this was to use the ATM machine).
- The average queue for all aisles for all drive-ups were a high of 0.58 cars to a low of 0.319 cars.
- 27 times out of 120 / 5-minute intervals did all aisles become unoccupied.
- In all cases, where the aisles extended out from the building, the maximum number of queues occurred at the drive-up window closest to the building and descended in numbers the further away the aisles were (exception – the ATM machine use in the furthermost aisle).
- As can be seen in table A, the average queue in each lane was less than one vehicle.

The banks were analyzed on the first Friday of the month, June 7, 2002, from 4:00 p.m. to 6:00 p.m. in the afternoon. This time period is recognized as the busiest period for the facilities. Each of the banks had a person counting the queues for each of the drive-up teller windows. The peak number of queued vehicles in each lane was recorded in 5-minute increments. A summary of the results of the data collected is found in Table A. Using the collected data, a summary of observations can be found in Table B. The raw data can be found in the Appendix.

Standards for a minimum of 6 queued vehicles is in excess of what is actually observed at the branch bank facilities. Branch banks can be designed to accommodate queuing equal to approximately $2-2\ 1/2$ vehicles for each lane at any given time.
