Parks and Recreation Advisory Board Agenda HOSPITALITY SUITE ~ Lincoln Park Tower

ORCHARD MESA POOL FACILITY RENOVATION FINAL REPORT

Orchard Mesa Recreational Facility – Renovation Option Analysis

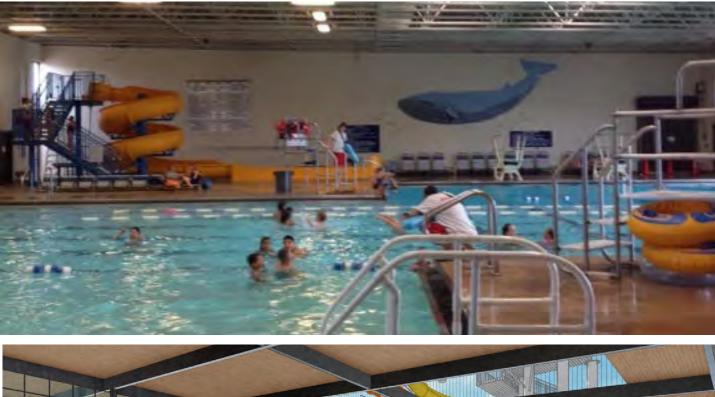
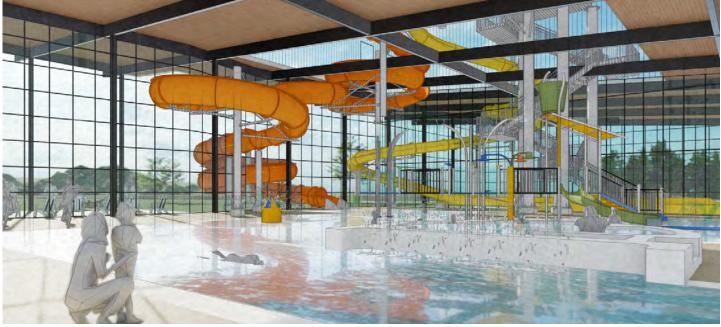
Drive Times to New CRC

Community Recreation Center

1,100 Projected

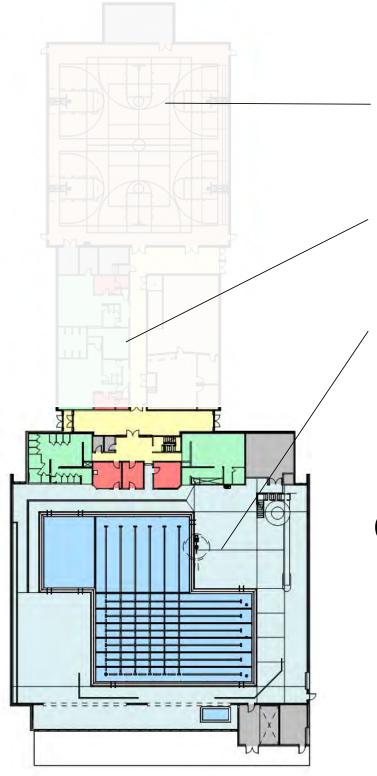
Option 2: Basic Pool Modernization

Demolish Existing

Modify Entry

New Spa, Upgrades to Existing Pool, Replacement of Mech/Elec Equipment

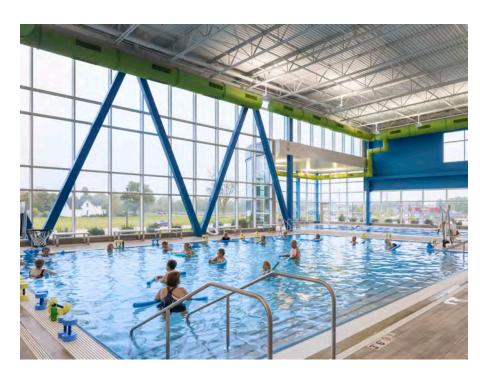
Capital Cost = \$5.7M - \$6.2M

- Subsidy = \$455,000
- Annual Visits = 26,250

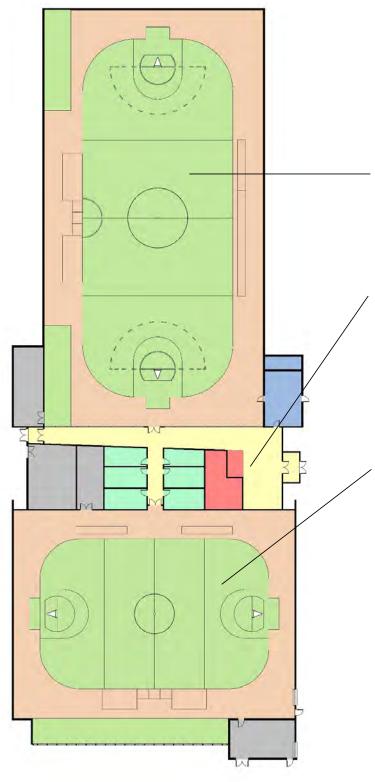
Option 4: Convert Pool / Add Turf

Demo Gym / Add Indoor Turf Field

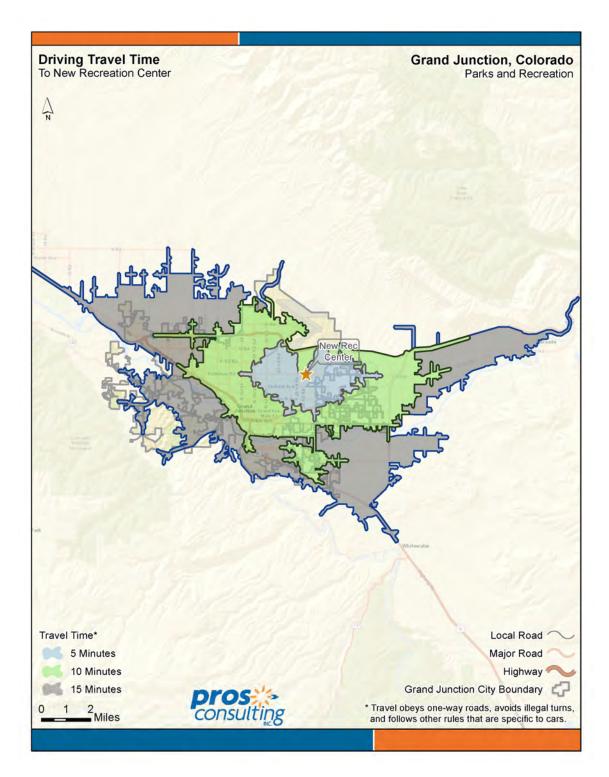
1.3.2.1 VEHICLE SERVICE AREA

As shown in the map below, the entire City of Grand Junction and some neighboring communities are within a 15 minute drive time by personal vehicle of the new CRC. PLEASE NOTE: The Orchard Mesa neighborhood is within a 10 minute drive time to the future facility.

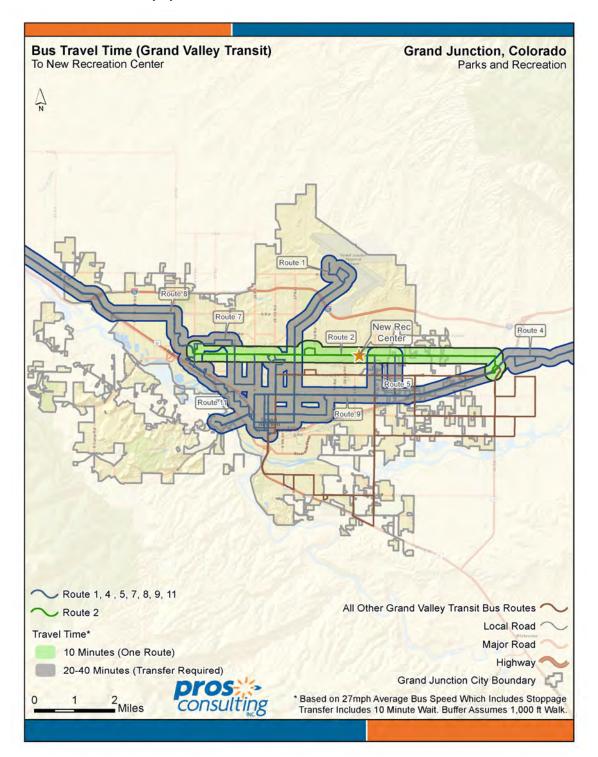
1.3.2.2 GRAND VALLEY PUBLIC TRANSIT (BUS) SERVICE AREA

As shown in the map below, some of the City of Grand Junction and neighboring communities will be able to access the new CRC by Grand Valley Transit. Future expansion of bus routes will be necessary to provide an increased level of accessibility by bus to the new CRC.

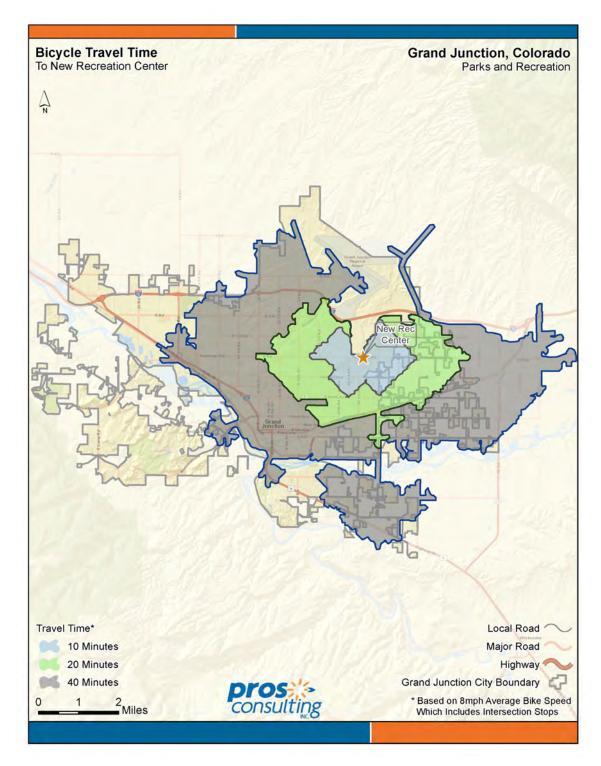
1.3.2.3 BICYCLE SERVICE AREA

As shown in the map below, much of the City of Grand Junction, including the Orchard Mesa neighborhood, as well as some neighboring communities to the east will be within a one-way, 40-minute bike ride, to the new CRC. Future expansion of bike lanes and paved trails will be necessary to provide an increased level of accessibility by bicycle to the new CRC.

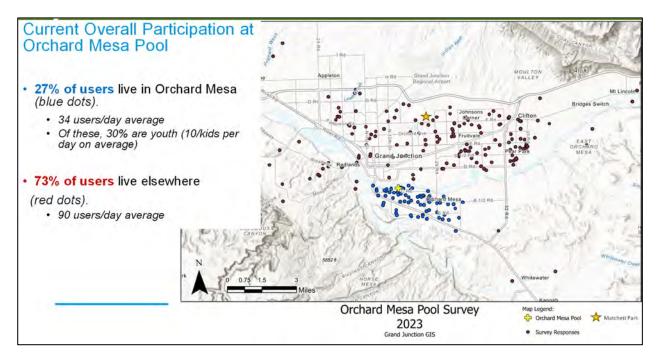
1.3.3.1 OVERALL USER PARTICIPATION

As noted in the map below, users of the Orchard Mesa Indoor Swimming Pool come from all corners of the City of Grand Junction as well as some neighboring communities. It must be noted that nearly three out of every four users of the Orchard Mesa Indoor Swimming Pool reside outside of the Orchard Mesa neighborhood, with a vast majority of these users living closer in proximity to Matchett Park, the site of the future CRC. It naturally can be assumed that - given their proximity to a newer, more robust aquatic center - a majority of these current Orchard Mesa Indoor Swimming Pool visitors will become users of the future CRC when it opens in 2025.

- 27% of users live in Orchard Mesa (blue dots). 34 users/day average
 ◊ Of these, 30% are youth (10/kids per day on average)
- 73% of users live elsewhere (red dots). 90 users/day average

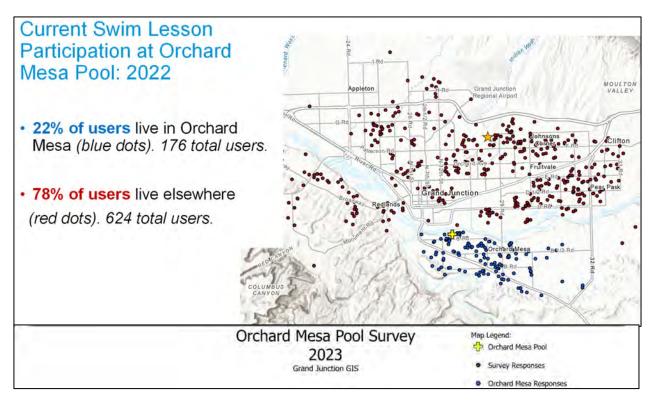
1.3.3.2 SWIM LESSON PARTICIPATION

As noted in the map below, participants in the swim lesson program currently offered at the Orchard Mesa Indoor Swimming Pool come from all corners of the City of Grand Junction as well as some neighboring communities. It must be noted that nearly four out of every five users of the Orchard Mesa Indoor Swimming Pool reside outside of the Orchard Mesa neighborhood, with a vast majority of these users living closer in proximity to Matchett Park, the site of the future CRC. It naturally can be assumed that - given their proximity to a newer, more robust aquatic center - a majority of these current Orchard Mesa Indoor Swimming Pool swim lesson participants will take swim lessons at the future CRC when it opens in 2025.

- 22% of users live in Orchard Mesa (blue dots). 176 total users.
- **78%** of users live elsewhere (red dots). 624 total users.

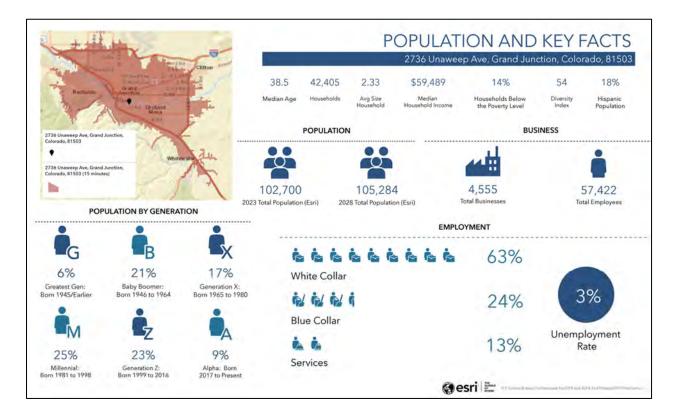
1.4.1.1 SERVICE AREA – OPTION #1

It is expected that the primary drive time service area of the Orchard Mesa Recreational Facility under renovation option #1 will be 15 minutes. The following graphic provides a snapshot of geographical area and the demographics of the population within the 15-minute drive time service area.

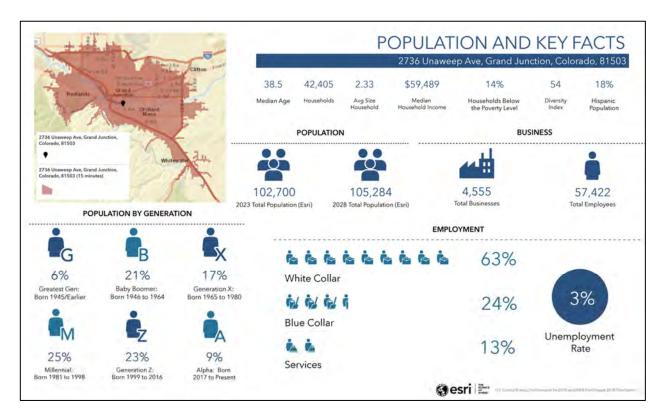
1.4.2.1 SERVICE AREA – OPTION #2

It is expected that the primary drive time service area of the Orchard Mesa Recreational Facility under renovation option #2 will be 15 minutes. The following graphic provides a snapshot of geographical area and the demographics of the population within the 15-minute drive time service area.

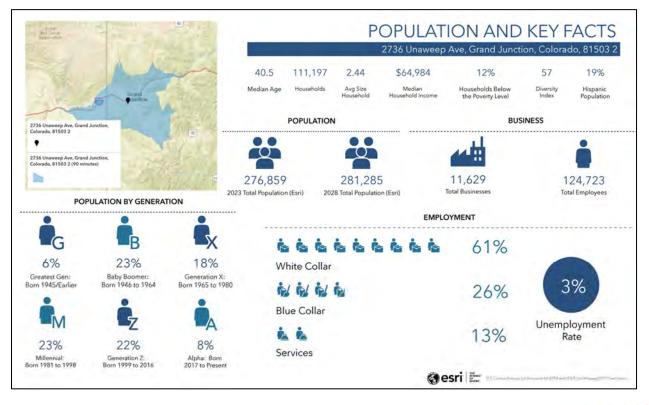
1.4.5.1 SERVICE AREA – OPTION #5

It is expected that the primary drive time service area of the Orchard Mesa Recreational Facility under renovation option #5 will be 90 minutes. The following graphic provides a snapshot of geographical area and the demographics of the population within the 90-minute drive time service area.

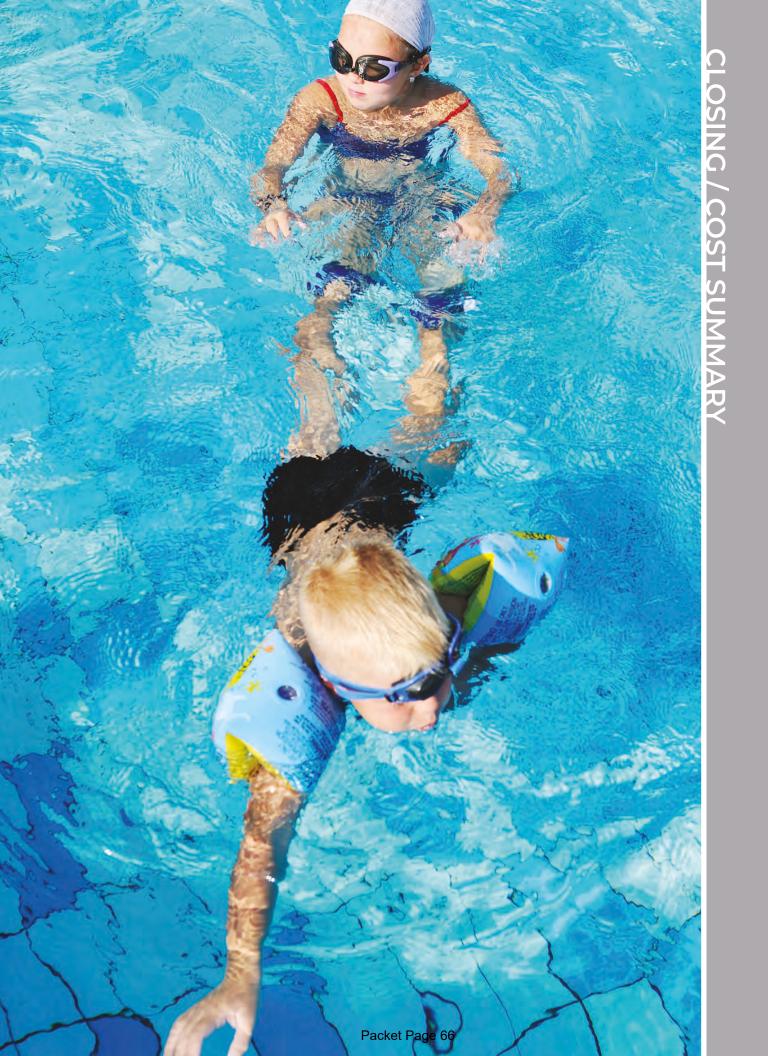
Floor Plan Option	Capital Cost	Service Area	Service Area Population	Projected Annual Visitation	Annual Operating Cost	Annual Operating Revenue	Annual Cost Recovery	Annual Operating Subsidy	Subsidy per Visit
Option 1: Status Quo	<\$800,000	15 minute drive time	102,700	14,000	\$525,000	\$125,000	24%	\$400,000	\$28.57
Option 2: Basic Modernization of Pool	\$5.7M - \$6.2M	15 minute drive time	102,700	26,250	\$650,000	\$195,000	30%	\$455,000	\$17.33
Option 3: Full Facility Renovation	\$12.6M - \$13.5M	15 minute drive time	102,700	52,500	\$650,000	\$260,000	40%	\$390,000	\$7.43
Option 4: Convert Pool/ Add Turf	\$27.5M -\$29M	60 minute drive time	183,670	78,750	\$540,000	\$378,000	70%	\$162,000	\$2.06
Option 5: New Fieldhouse	\$30M - \$33M	90 minute drive time	276,859	98,000	\$630,000	\$504,000	80%	\$126,000	\$1.29
New CRC	\$70M	60 minute drive time	183,670	396,000	\$3,533,000	\$2,204,000	62%	\$1,329,000	\$3.36

The Options that we've just described are summarized in the table in Figure 4, and also compared to the new CRC which is the gold row at the bottom. You can see that the capital cost investment, the construction cost, increases significantly for each one of the Options, but we also see projected annual visitation to increase substantially running from Option One to Five, annual cost recovery would grow substantially as well from about 24% projected for Option One and growing all the way up to 80% for Option Five. Inversely, if the cost recovery rate is lower the annual operational subsidy of taxpayer dollars would be higher so the highest level of subsidies really are around each one of the first three Options and very much driven by the expense just in operating indoor Aquatics. Options Four and Five certainly see a reduction in that overall subsidy.

The last column is an interesting piece of analysis that is important to understand. Based on projected annual visitation, the operational subsidy per visit is the amount of taxpayer dollars that are going to offset every visit that somebody makes to a facility. Whether this is the new CRC at \$3.36 of taxpayer money going to offset every visit or looking at Option One at a significant amount of money, \$27.78 per visit being supported by taxpayer dollars. Looking at capital cost or debt service it's important to note that debt service is pretty much a fixed cost over a 20, 25, and sometimes a 30-year span, but operational costs over time go up, as facilities get older, and expenses increase. So, although Option Five costs a lot more to invest in upfront, the operational subsidy is a lot less on an annual basis, so the total cost of ownership over time will not be all that different from the other Options. We expect that to be true for each one of these Options going forward. In other words, we're not necessarily looking at a long-term total cost of ownership investment in Option One being significantly less than what we would look at for Option 5, however, the number of people the facility serves over that time will certainly be significantly higher in Option 5.

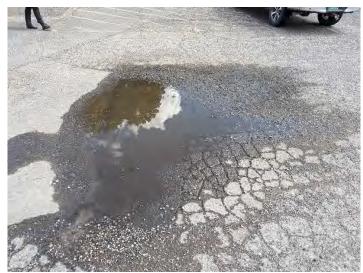
Picture 1, Pavement failure near northern area inlet

The parking lot sits well below the street grades of 27 3/8 Road. The parking lot is entirely curbed and shaped to move stormwater runoff to two area inlet drains which tie to the City's storm drain system. The inlets were dry and had no debris accumulation. Of note were several low-lying areas where water pooled and degraded the asphalt surface. One such area is located just south of the northernmost area inlet; the other is on the south side of the south entrance. The asphalt damage in both locations is significant. It strongly suggests that subgrade at each location is comprised, necessitating deep repairs, not just patching is needed to provide an enduring solution. Also, the curb and gutter along the west frontage of the parking area wasn't correctly conceived. The existing curb and gutter traps and holds water as the curbing has little or no slope. We recommend consideration of replacing the curb and gutter with a spill curb and replacing a portion of the parking lot asphalt to create a positive grade toward the area inlets.
