COLORADO CULTURAL RESOURCE SURVEY

**Architectural Inventory
Form**
1 of 4

1. Resource number: 5ME.14614
2. Temporary resource number: 1700.SEVT
3. County: Mesa
4. City: Grand Junction
5. Historic building name: n/a
6. Current building name: n/a
7. Building address: 1700 N. 17th Street
8. Owner name and address: Mary E Baker
1700 N 17th St Grand Junction, CO 81501-6318

48. Report title: Grand Junction Phase 3 Survey 49. Date(s): March 2005

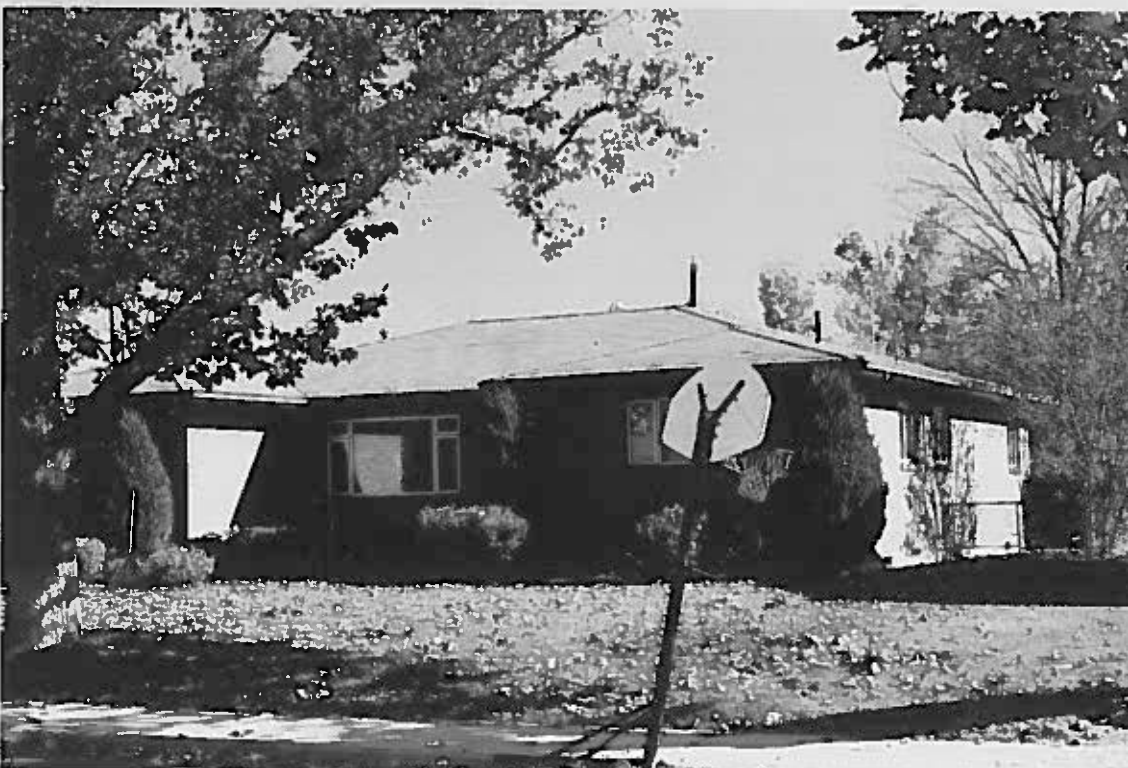
5ME.14614

21. General architectural description: This is a horizontally proportioned brick house with a main hipped roof shape. The main ridge runs north/south and the principal façade faces west. Two lower hipped wings are located at either end of the main roof, sharing the north and south facing roof planes respectively. The north wing projects furthest toward the street, with a single car garage door centered on the wall. The south wing has a single horizontally proportioned window opening containing a central picture window with a casement style window on each side. The central recessed area has a large picture window group on the left and the entry door on the right. The open end of the 'U' is bordered by a low brick wall that extends from the face of the garage and opens at the pathway to the door. The south side has three sets of paired casement along the length. The brick has a textured surface and quoins on the corners.

1700 N. 17th Street

Roll # 5 Frame # 16

Looking northeast
