COLORADO CULTURAL RESOURCE SURVEY

Architectural Inventory Form

1. Resource number: 5ME.14735
2. Temporary resource number: 2045.SEV
3. County: Mesa
4. City: Grand Junction
5. Historic building name: n/a
6. Current building name: n/a
7. Building address: 2045 N. 7th Street
8. Owner name and address: Cynthia C Cyphers
2045 N 7th St Grand Junction, CO 81501-7419

2045 N. 7th Street

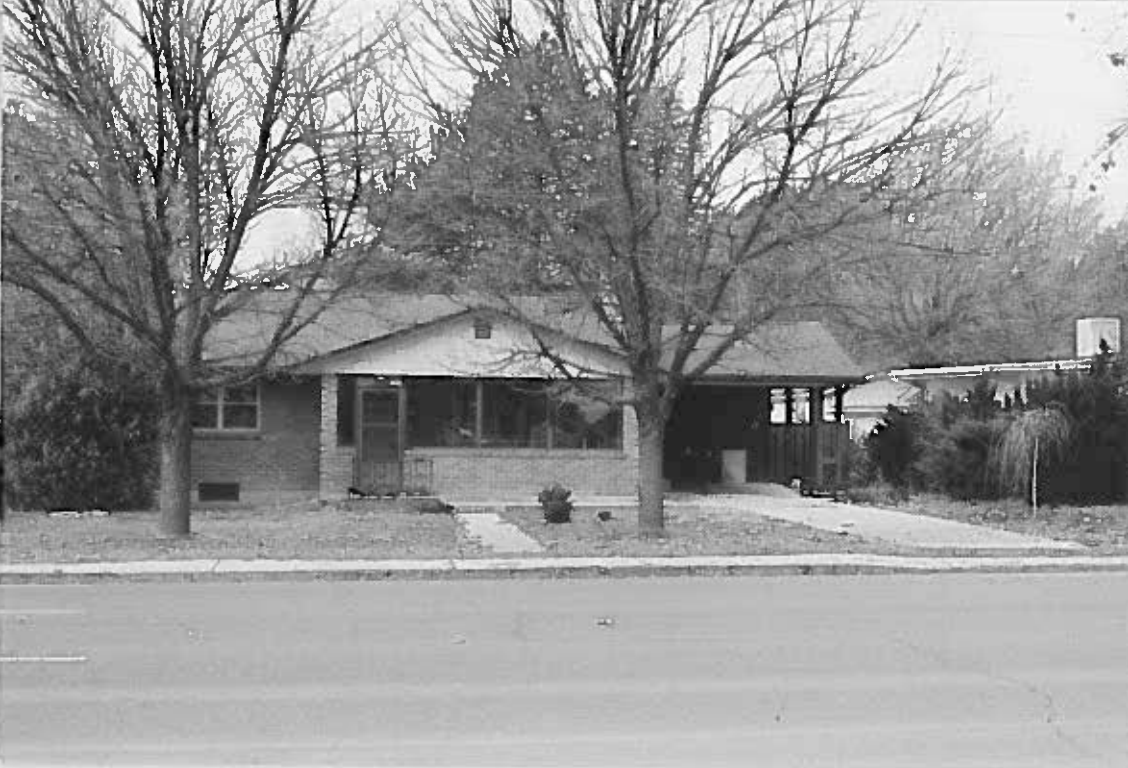
Roll # 10 Frame # 3

21. General architectural description: This is a horizontally proportioned, masonry building with several additive volumes. The main ridge runs north/south and the principal façade faces east. A low pitched front gable is applied to the north end of the main façade, a lower side gable carport extends off the north side of the main volume, and shed roof addition extends off the rear of the house. The carport is open on the north and east sides and the roof is supported by simple wood posts, with a pair at the northeast corner. The front gable projection has the main entry door on the left side and three large glass panes across the remainder of the façade. Brick piers support the front gable roof on the corners and a low brick wall runs across the front at the height of the window sills. Contrasting siding infills the gable end. A pair of double hungs is centered on the remainder of the main wall to the south. The south side has two groups of three double hung windows on each end with a single double hung in the center of the gable. On this wall the brick runs all the way up to the peak of the roof.

43. Assessment of historic physical integrity related to significance: Alterations have had a considerable impact on the integrity of the building. The primary façade is uncharacteristically altered.
