COLORADO CULTURAL RESOURCE SURVEY

Architectural Inventory Form 1 of 4

I. I	lden	tification		
	1.	Resource number:	5ME.14848	
	2.	Temporary resource number:_	1803.FOR	
	3.	County:	Mesa	
	4.	City:	Grand Junction	
	5.	Historic building name:	n/a

10.	. UTM reference		
		Zone 1 2; 7 1 0 4 8 6 mE 4 3 2 8 8 8 7 mN		
11. USGS quad name: Grand Junction Quadrangle Year: 1962 rev.1973 Map scale: 7.5' X 15' Attach photo copy of appropria 12. Lot(s): 5 & 6 Block: 2			unction Quadrangle	
			ale: 7.5'_X 15' Attach photo copy of appropriate map section	
			2	
		Addition: Sherwood Addition	Year of Addition: 1950

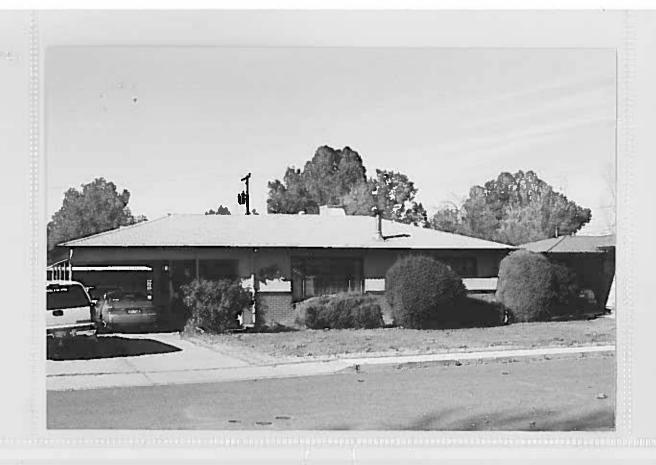
Roll # 14 Frame # 23

21.	. General architectural desc	ription: This is a simple rectangular wood frame house with a		
		moderately pitched hipped	d roof. The ridge runs north/south and the principal façade		
		faces east. The principal f	açade has a large picture window, flanked by casements,		
		generally centered on the	façade. To the right is a single horizontally proportioned		
		window also flanked by ca	sements. To the left is a large void area that creates a carport		
		under the main roof form.	The roof is supported by five pipe columns along the south		
		side. The main entry is lo	cated in a recess along side the carport area. Three steps run		
		from grade up to the porch	area, which begins at the main wall plane. The concrete		
		porch runs along the wall t	to the back of the recessed area. A pair of casements sit on the		
		street facing wall and the r	main entry door faces south in the recess. The principal facade

has a brick wainscoting the	at engages the large picture window. The wall above the brick		
		is infilled with plywood sid	ling with vertical lines. An enclosed porch extends off the rear		
		of the house.	0.323

Looking west
