COLORADO CULTURAL RESOURCE SURVEY

**Architectural Inventory
Form**
1 of 4

1. Resource number: 5ME.14694
2. Temporary resource number: 1309.TEX
3. County: Mesa
4. City: Grand Junction
5. Historic building name: n/a
6. Current building name: n/a
7. Building address: 1309 Texas Ave.
8. Owner name and address: Jerome Van Cleave
271 Arlington Dr Grand Junction, CO 81503-2122

48. Report title: Grand Junction Phase 3 Survey 49. Date(s): March 2005

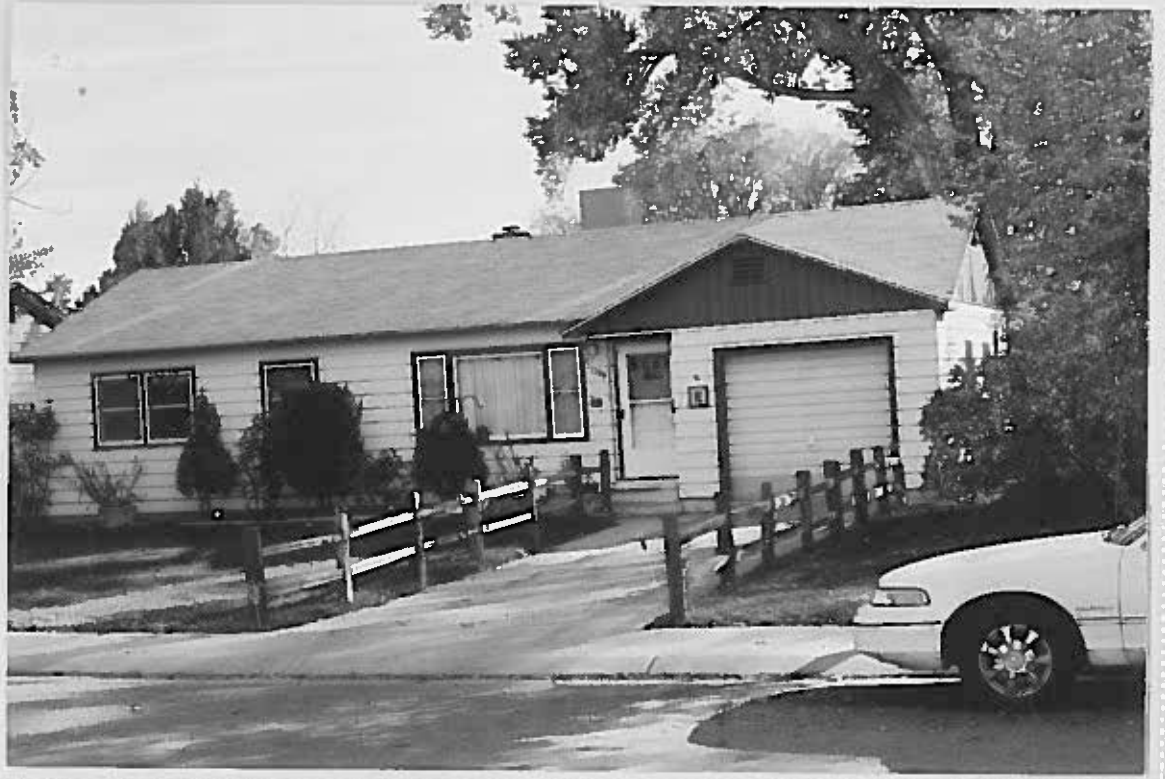
Roll # 3 Frame # 28

21. General architectural description: This is a rectangular wood frame house with a side gable roof. The main ridge runs east/west and the principal façade faces north. The roof has small overhangs on the eave ends and a deeper overhang on the principal façade. At the west side the wall projects forward of the main façade and has a low front gable which covers the projection and the area of the entry door. The main entry door sits on the face of the main side gable. A single car garage door is located on the wall of the projection. A picture window, flanked by double hungs, sits to the east of the entry door and a single window is centered between the picture window and a pair of double hungs near the east side. The double hung windows have a single horizontal muntin in each sash. Two small horizontally proportioned windows are located on the west side, and two slightly larger units are located on the east. The gable ends are infilled with a vertical siding with small rectangular vents at the peak.

Looking south
