# Architectural Inventory Form

1. Resource number: 5ME.14780
2. Temporary resource number: 565.PIN
3. County: Mesa
4. City: Grand Junction
5. Historic building name: n/a
6. Current building name: n/a
7. Building address: 565 Pinyon Ave.
8. Owner name and address: Wallace D Powell  
565 Pinyon Ave Grand Junction, CO 81501-7431

48. Report title: Grand Junction Phase 3 Survey 49. Date(s): March 2005

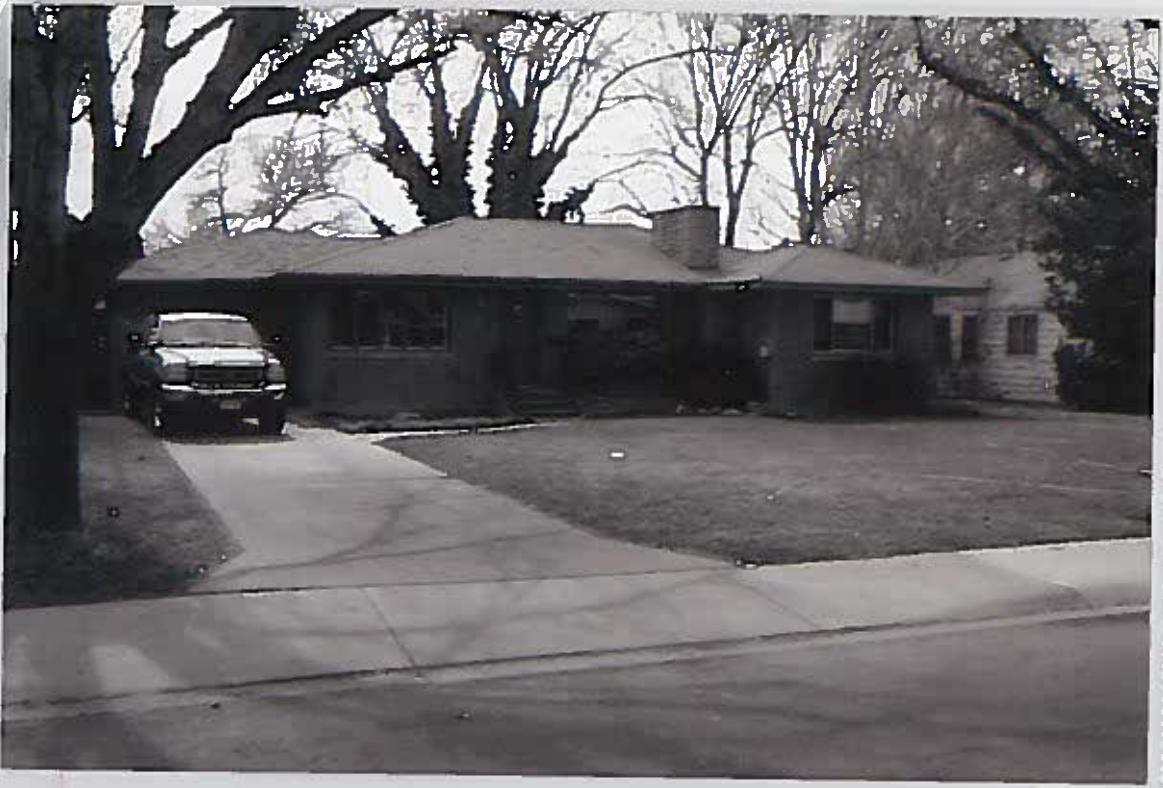
5ME.14780  
565 Pinyon Ave.  
Roll # 8 Frame # 22  
Looking southeast  
Grand Junction, Mesa County, CO

21. General architectural description: This is a masonry house with several additive volumes and a low pitched hipped roof. The main volume has a ridge which runs east/west and the principal façade faces north. The west side of the main façade has a small projecting volume, which shares its west wall and roof plane with the main volume. The projection has a picture window, flanked by casements, in the center of the north wall plane. A large rectangular rusticated brick chimney sits in the ell created by the projection and the main volume. The entry door is centered on the remainder of the main wall with a picture window to the right and a large series of casements to the left. The five casements have thin horizontal muntins in each unit. A single car garage door is located on the south face of another projecting volume on the east side. The projection has a small peak along the east side of the ridge. Three concrete steps and a small landing front the entry door with light metal rails. The west side has a series of small individual horizontally proportioned windows along the length.

43. Assessment of historic physical integrity related to significance: Window alterations have somewhat impacted the integrity. The house continues to contribute to the character of the neighborhood.
