COLORADO CULTURAL RESOURCE SURVEY

Architectural Inventory Form

1 of 4	Contributes to eligible NR District Noncontributing to eligible NR District			
1. [den	tification				
	1.	Resource number:	5ME.14895			
	2.	Temporary resource number:_	1520.ESER

48. Report title: Grand Junction Phase 3 Survey 49. Date(s): M	arch 2005					
50. Recorder(s): Suzannah Reid, Patrick Duffield and Lydia H	erron					
51. Organization: Reid Architects, Inc.

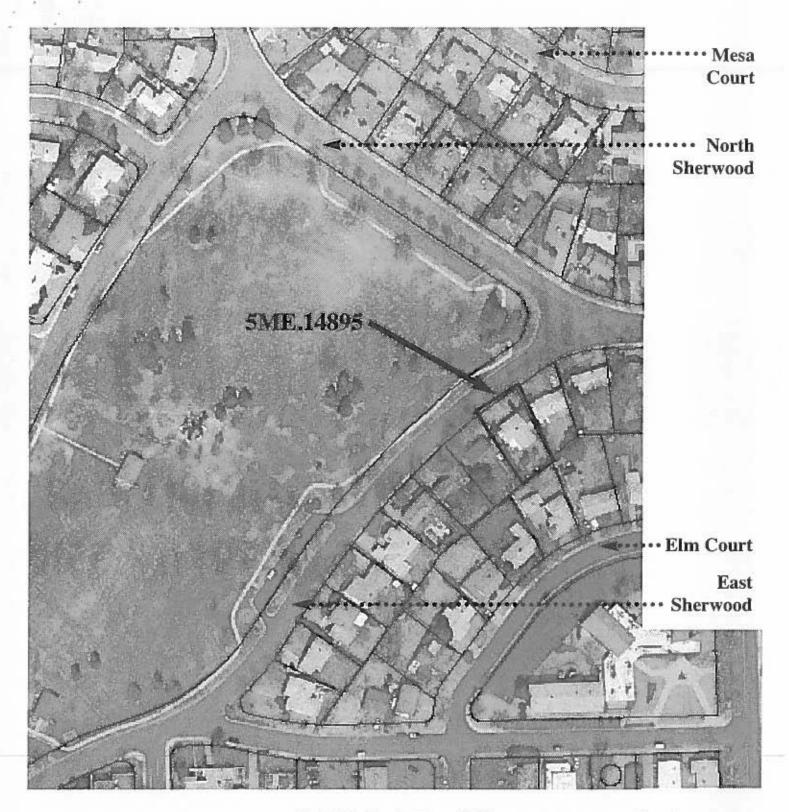
1520 E. Sherwood Ave.

Grand Junction, Colorado image from 2002 aerial map

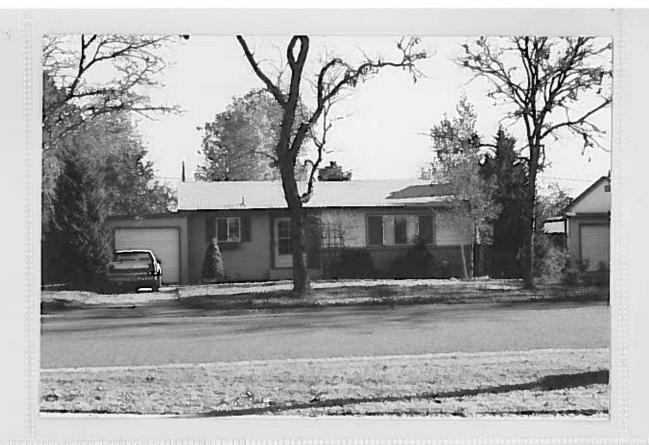
Roll # 13 Frame # 8 Looking southeast

21.	. General architectural desc	cription: This is a simple wood frame house with a moderately		
		pitched side gable roof. T	he ridge runs northeast/southwest and the principal façade		
		faces northwest. The mai	n entry is located in a shallow recess near the left side of the		
		façade. The main façade	to the left of the recess has a single sliding window unit		
		centered on the remaining	wall. The wall surface is vertical siding. To the right of the		
		entry recess is a single la	rge picture window, flanked by vertical units, centered on the		
		remaining wall. The wind	low sits on a brick sill, which continues across this section of		
		façade separating the brid	k field below and the horizontal siding above. A rectangular		
		brick chimney is applied t	o the southwest façade, in front of the ridge line. A flat roofed		
		garage is applied to the ne	ortheast façade and continues the plane of the main façade. A

single car garage door is	centered on its width. Horizontal siding infills the gable ends		
		above the eave line, and	a large addition extends off the rear of the house.

29.	Construction history (inclu	de description and dates of major additions, alterations, or		
		demolitions):	Window replacement, infill of original carport by new garage		
		dates unknown.

43. Assessment of historic physical integrity related to significance	e: Alterations have had a
					moderate impact on the integrity of the house.	,,
