COLORADO CULTURAL RESOURCE SURVEY

## Architectural Inventory Form

- 1. Resource number: <u>5ME.14684</u>
- 2. Temporary resource number: 1216.TEX
- 3. County: <u>Mesa</u>
- 4. City: Grand Junction
- 5. Historic building name: <u>n/a</u>
- Current building name: <u>n/a</u>
- 7. Building address: <u>1216 Texas Ave.</u>
- 8. Owner name and address: Howard R Perino

- 47. Photograph numbers: Roll # 4 Frame # 2 Negatives filed at: City of Grand Junction Planning Dept.
- 48. Report title: Grand Junction Phase 3 Survey 49. Date(s): March 2005
- 50. Recorder(s): Suzannah Reid, Patrick Duffield and Lydia Herron
- 51. Organization: Reid Architects, Inc.
- 52. Address: PO Box 1303 Aspen, Colorado 81612
- 53. Phone number(s): 970 920 9225

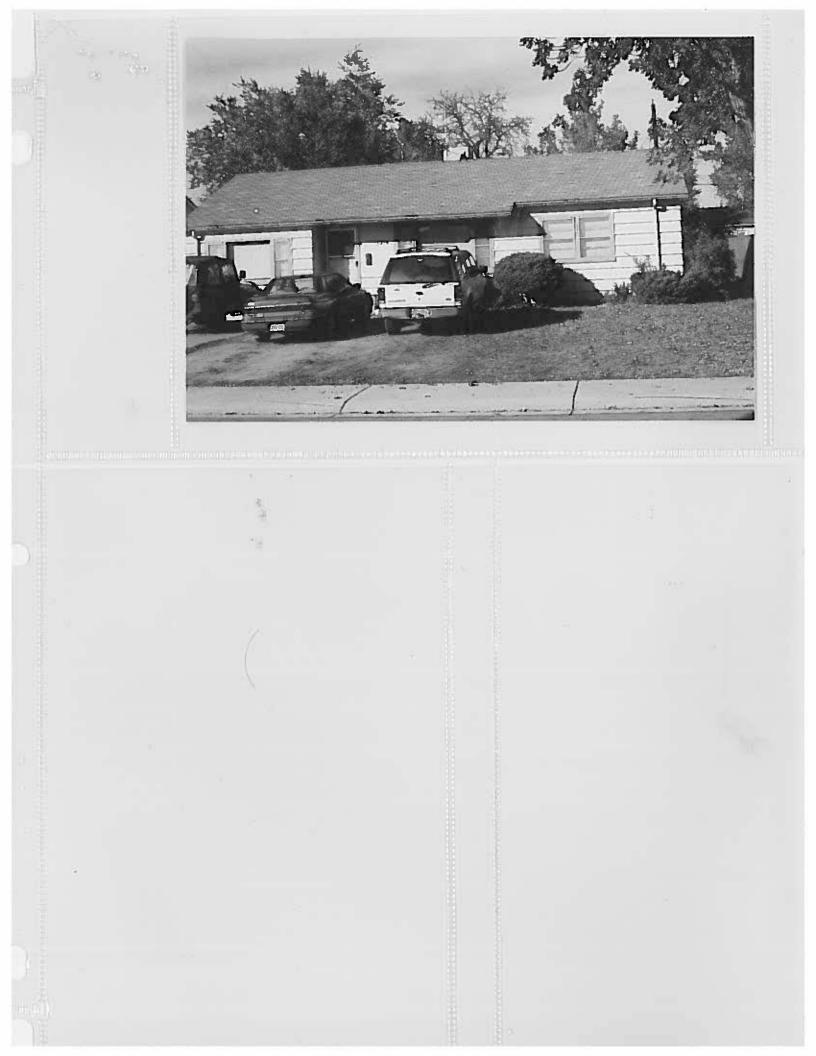
5ME.14684 1216 Texas Ave. Roll #4 Frame #2 Looking north Grand Junction, Mesa County, CO WHF BA010A1X0N NNN+ 1 5653 002916 54755 003 share

- 21. General architectural description: <u>This is a rectangular wood frame house with a side gable roof. The main ridge runs east/west and the principal façade faces south. The roof has minimal overhangs on the eave ends and a deeper variable overhang on the principal façade. The variation is a result of a combination of areas of extended roof plane and wall projections below. At the west side the wall projects forward of the main façade and has a large picture window, with flanking double hungs, centered on its length. The main entry door is located adjacent to the east side wall of the projection; the eave line remains continuous, creating a deep overhang at the door and adjacent picture window. The picture window to the east has a narrow double hung to each side; to the east of the window the roof returns to a smaller overhang. A pair of double hungs are centered on the remainder of the wall. The double hung windows have a single horizontal muntin in each sash. A covered porch extends off the rear on the west side.</u>
