COLORADO CULTURAL RESOURCE SURVEY

**Architectural Inventory  
Form**

1. Resource number: 5ME.14687
2. Temporary resource number: 1233.TEX
3. County: Mesa
4. City: Grand Junction
5. Historic building name: n/a
6. Current building name: n/a
7. Building address: 1233 Texas Ave.
8. Owner name and address: Brad J Standley  
1233 Texas Ave Grand Junction, CO 81501-7637

48. Report title: Grand Junction Phase 3 Survey 49. Date(s): March 2005

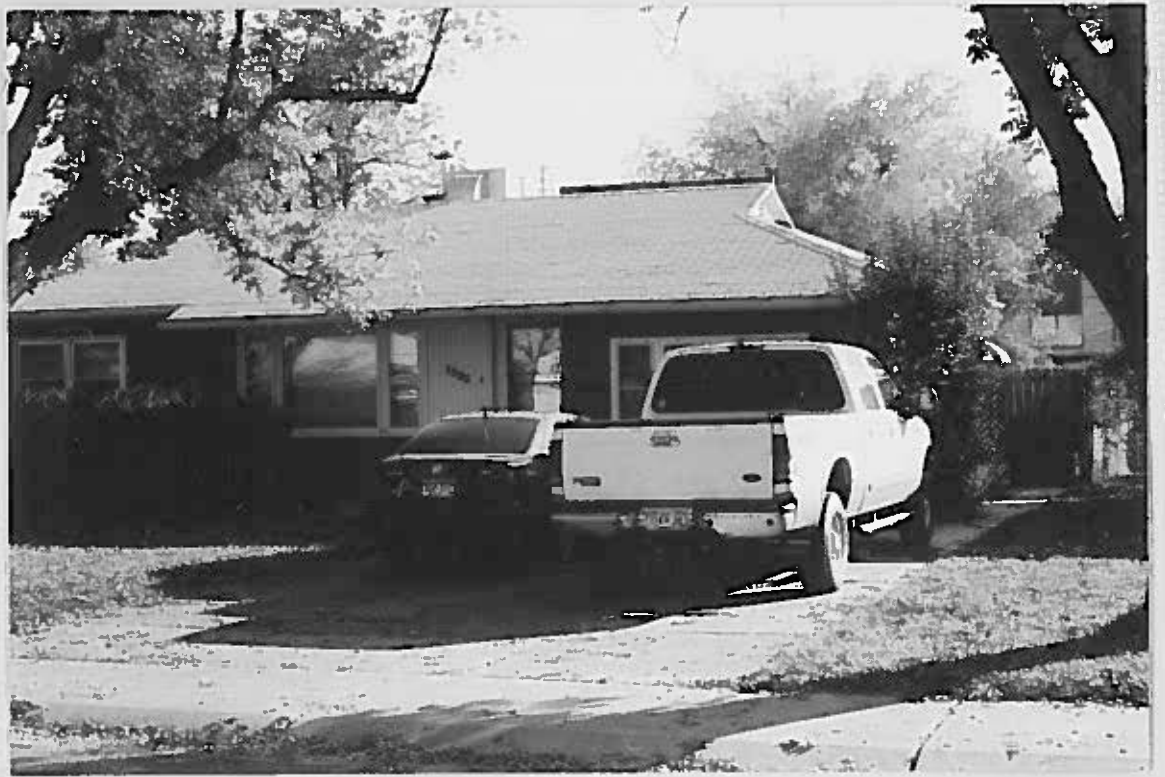
Roll # 3 Frame # 35

21. General architectural description: This is a rectangular wood frame house with a primarily hipped roof. The main ridge runs east/west with small gables exposed at the ends of the ridge. The principal façade faces north. The roof has moderate overhangs on all sides and a variable overhang on the principal façade. The variation is a result of a combination of areas of extended roof plane and wall projections below. At the west side the wall projects forward of the main façade and has a picture window with a double hung on each side, centered on its length. The main entry door is located adjacent to the east side wall of the projection; the eave line remains continuous, creating a deep overhang at the door and adjacent picture window. The picture window to the east has a narrow double hung to each side; to the east of the window the roof returns to a smaller overhang. A section of contrasting vertical siding fills the space between the picture window and the entry door, from the sill up to the soffit. A pair of double hungs are centered on the remainder of the wall. The double hung windows have a single horizontal muntin in each sash. A long addition extends off the eastern side of the rear of the house.

Looking south
