COLORADO CULTURAL RESOURCE SURVEY

Architectural Inventory Form

1. Resource number:
 5ME.14696

7. Building address:
 1316 Texas Ave.

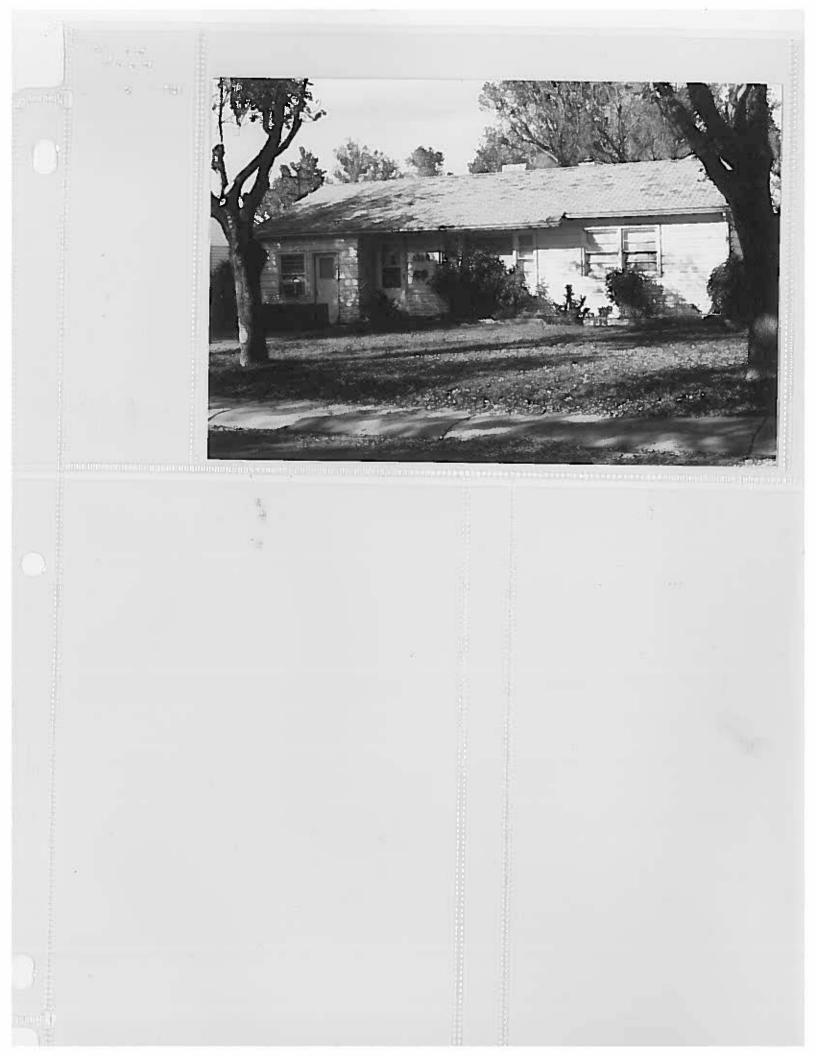
1316 Texas Ave. 5ME.14696 Roll #3 Frame #26 Looking northwest Grand Junction, Mesa County, CO WHF BA010A1X0N NNN 0 5871 002924 027 sharp 57604
