COLORADO CULTURAL RESOURCE SURVEY

Architectural Inventory Form

1. Resource number: 5ME.14790
2. Temporary resource number: 550.WAL
3. County: Mesa
4. City: Grand Junction
5. Historic building name: n/a
6. Current building name: n/a
7. Building address: 550 Walnut Ave.
8. Owner name and address: James C Fuller
550 Walnut Ave Grand Junction, CO 81501-7438

48. Report title: Grand Junction Phase 3 Survey 49. Date(s): March 2005

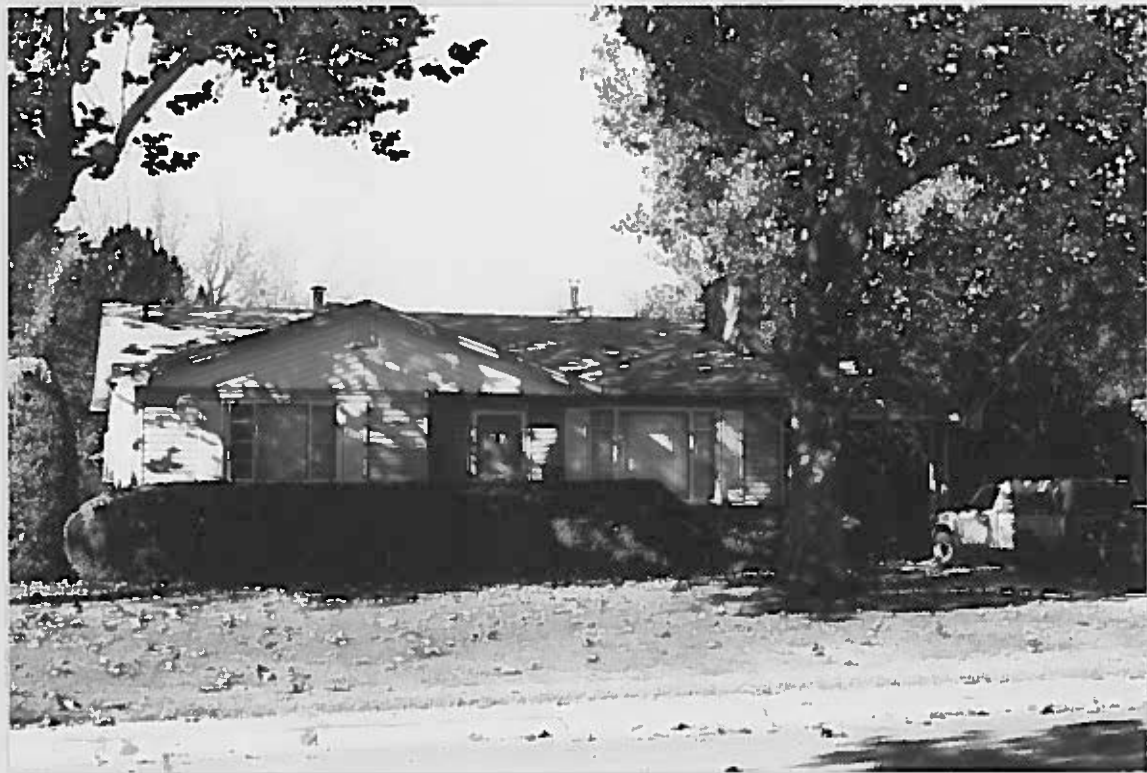
Roll # 7 Frame # 14

21. General architectural description: This is a small wood frame house with a low pitched gable roof. The main ridge runs generally east/west and the principal façade faces south. A shallow front gabled projection extends off the face of the side gabled form and occupies over half its width. A picture window, flanked by casements, sits off center to the left on the front gable. The right section of the front gable is recessed back to the main side gable wall. The entry door is located in the recess and a large picture window, flanked by casements, occupies the remainder of the side gable wall to the right. A side gable carport is applied to the east side and a rectangular brick chimney is applied to the east wall of the main side gable; it runs up through the overhang of the main roof. The front gable has diagonal siding which mimics the slope of the roof. A shed roof porch extends off the rear of the house.

Looking northwest
