COLORADO CULTURAL RESOURCE SURVEY

Architectural Inventory Form

1. 1	den	tification		
	1.	Resource number:	5ME.14834	
	2.	Temporary resource number:_	2030.KEN	
	3.	County:	Mesa	
	4. City:		Grand Junction	
	5.	Historic building name:	n/a

11.	Ged	ographic Information		
	9.	P.M. <u>Ute Principal Meridian</u>	Township 1 South Range 1 West	
		<u>NE</u> 1/4 of <u>NW</u> 1/4 of <u>SW</u> 1/	4 of <u>SE</u> 1/4 of section <u>12</u>

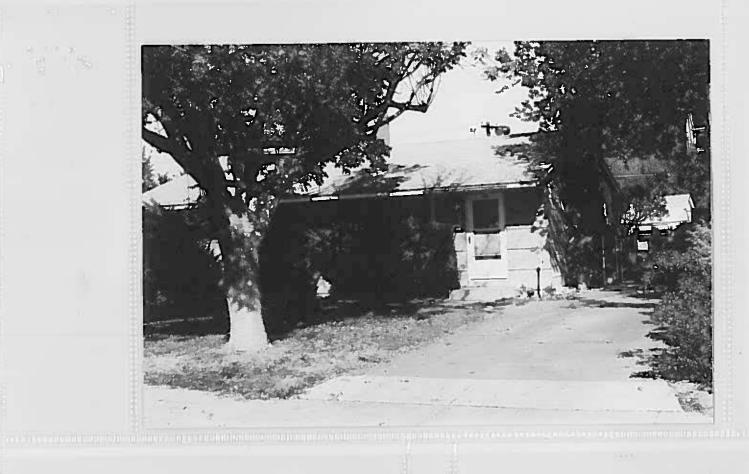
Roll #1 Frame #37

21.	1. General architectural description: This is a modest wood frame rectangular house with				
		the long side facing the street (south). The main façade has a veneer of brick on the				
		whole wall surface; the brick is running bond with a row of slightly projecting brick ever				
		several courses. This creates a series of horizontal lines across the façade. This is applied to the front only. The entry door sits on the far eastern side of the main faça				
		with a picture window flanked by a double hung on each side to the west. Two horizontally proportioned slider windows are located on the remainder of the façade.				
		Their sills are higher than t	the picture windo	ow and they are closer to the window and the		
		far corner than to each other	<u>er. The overhan</u>	g on the sides in minimal with a simple ogee		
		trim and the overhang on t	<u>he eaves is sligh</u>	tly larger to provide protection for the entry

door. The house sits on a	concrete foundat	ion and has composition shingles on the		
		surfaces without brick. The	ere are no windo	ws on the east side, but a stone chimney is		
		applied to the wall and con	tinues up throug	h the eave line.

Looking north
