HISTORIC BUILDING INVENTORY RECORD

| project name: | Grand Junction Downtown Survey | | | | |
| current building name: J. B. Hart Music Co. | | | | | |
| address: | 417 Main, Grand Junction | n, CO 8 | 1501 | | |

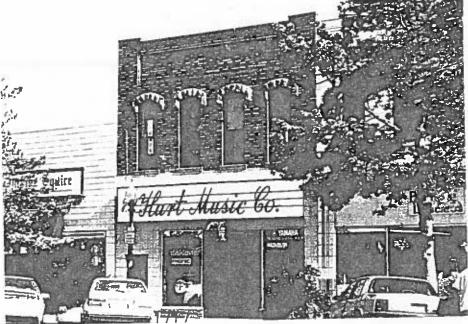
| describe: new recessed entry, display windows, signage, and tile covering at first floor. |
|--|
| architectural description: Two-story, commercial brick building with brick detailing on upper level and one-over-one double hung windows with rusticated stone voussoirs and stone sills. Lower level has recessed entry with display windows with signage and brick kickplates. The clerestory is covered and has a large sign. There is an offset door which is closed with wood. This area, clerestory, and along display window has been covered with pink tiling. There is a hanging drum over the entrance which serves as a sign. |

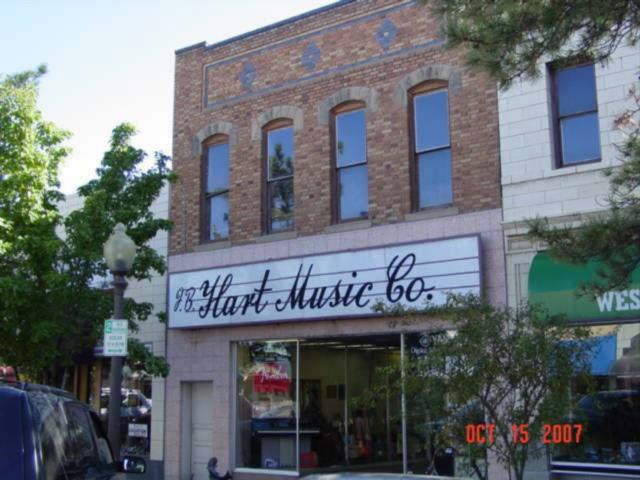
| project name: | Grand Junction Downtown Survey | | | | |
|---|---|---|---|---|--|
| negative nos.6942-25, 6942-29 | | | | | |

| describe: new recessed entry, display windows, signage, and tile covering at first floor. |
