HISTORIC BUILDING INVENTORY RECORD

project name: Grand Junction Downtown Survey city: Grand Junction Mesa county: state ID no. 5ME 4119 temporary no. current building name: Dinosaur Valley address: 362 Main, Grand Junction, CO 81501 owner: DYP, Denver, 1100 Umatilla St., Denver, CO 80204-3421 township: 1S range: 1W section: 14, NE 1/4, SW 1/4 historic name: Reed Building USGS quad name: Grand Jct., CO 1962 N3900-W10830 X 7.5' 15' district name: block: 102 lot(s) 17-21 addition: City yr. of addition film roll by: Marty Alexandroff no. negative nos. 5854-8, 5854-11, 6943-5; 6837-22 location of negatives: City of Grand Junction date of construction: _______ estimate _____actual source: 1981 Historic Survey of City signage on building above entry use: <u>commercial</u> present <u>commercial</u> historic condition: _____ excellent X good _____fair ____deteriorating extent of alterations: _____minor ____moderate _X__major describe: New windows on second level, new facade lower level, including display windows, recessed entrance, glass doors, and mental awning. style: Commercial

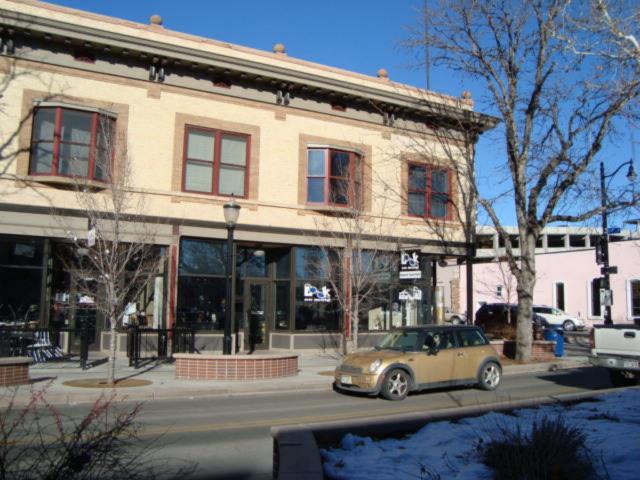
architectural description: Large, two story brick building. Eight windows on second level have three casement windows in the center; these are flanked with glass tiles in the clerestory and on either side of casements. Signage on second level over the entrance indicates "Reed Building AD 1908." Street level has large display windows with a recessed glass entry with two double doors of glass. White painted posts are at the center of the entry. A very large green metal awning is offset over the entry and on the east side of the building and is a later gabled alteration. A green canvas awning with white lettering is under the metal awning at the entrance. The window treatment on the east side of the building is the same as the front.

construction history: (description, names, dates, etc. relating major additions or alterations to original structure) New windows on second level, new facade lower level, including display windows, recessed entrance, glass doors, and mental awning; 1950s.
