COLORADO HISTORICAL SOCIETY Office of Archaeology and Historic Preservation 1300 Broadway Denver, CO 80203		SITE NO.: 5ME7518 Eligible for National Registeryesno
HISTORIC BL	JILDING INVENTORY	date initials CriteriaABCD Contributes to a potential National Register district yesno district name:
COUNTY: Mesa	Сіту: Grand Junction	Eligible for State Registeryesno date initials Criteriaabcde Areas of significance:
HISTORIC BUILDING NAME: Dickey, Josephine, House		Period of significance Needs data date initials
CURRENT BUILDING NAME: Dickey Residence Address: 1336 White Ave., Grand Junction, CO 81501-4538		LOCAL LANDMARK DESIGNATION: [] yes [X] no Date of designation: N/A Designating authority: N/A
		P.M.: UTE township: 1S range:1W NW ¼ of NE ¼ of NW¼ of SW¼ of section 13
OWNER NAME & ADDRESS: Josephine Dickey, 1336 White Ave., Grand Junction, CO 81501-4538		UTM REFERENCE-12 Easting: 712000 Northing: 4327130

USGS QUAD NAME: Grand Junction Year: 1962; photorevised 1973 [X] 7.5' [] 15'
STYLE: Bungalow BUILDING TYPE: MATERIALS: Concrete Foundation; Wood Frame; Asphalt Shingle Roof		Block: B Lot(s): 21-22 Addition: Keith Year of addition: 1890
		[X] original location [] moved
		Date of moves

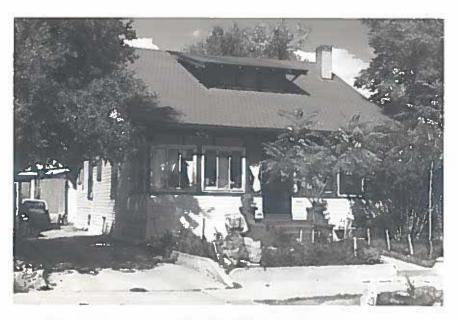
1336 White Ave. Grand Junction, Mesa Co, CO 2945-133-03-013 5ME7518 10/05/1995 Roll 4 Frame 14 View S Dir N/NE 5ME7518

steps with paneled concrete piers. Porch glaz hung, wood sash, one-over-one. Dormer with	ed as sunroom with wood casements and transor shed roof and three single pane windows. False	Full width front porch under principal roof. Broad concrete ns. Siding on porch half-wall. Windows primarily double bevel siding in buff; trim around doors, windows and lace chimney on east eave wall. Brick chimney on north
Landscaped with concrete retaining wall al	ong sidewalk and large lilacs on lawn. Sumacs or with false bevel siding, front gable, and garage do	n lawn and parking area. Jors boarded over.
PHOTOGRAPHS (include photographs showing e	ach side of building and any associated buildings)
Film roll no.: 4 Negative no.: 14	Photographer: Carolyn Howard Location of negatives: City Of Grand Junction	n
CONSTRUCTION HISTORY (include description an construction or modifications not noted in Asse	d dates of major additions, alterations, or demolitions as a second second second second second second second s	ons): Porch enclosed, date undetermined. Additional
