COLORADO HISTORICAL SOCIETY Office of Archaeology and Historic Preservation		SITE NO.: 5ME7450
1300 Broadway Denver, CO 80203 HISTORIC BUILDING INVENTORY		Eligible for National Registeryesno dateinitials CriteriaABCD Contributes to a potential National Register districtyesno district name:
County: Mesa	Спу: Grand Junction	Eligible for State Register
HISTORIC BUILDING NAME: Biggs, Clyde, House		Period of significance Needs data date initials
CURRENT BUILDING NAME: Beckner Residence		LOCAL LANDMARK DESIGNATION: [] yes [X] no
ADDRESS: 1241 Gunnison Ave., Grand Junction, CO 81501-4438		Date of designation: N/A Designating authority: N/A
		P.M.: UTE township: 1S range:1W NW ¼ of NW ¼ of SW¼ of NW¼ of section 13
OWNER NAME & ADDRESS: Larry B. Beckner, PO Box 220, Grand Junction, CO 81502-0220		UTM REFERENCE-12 Easting: 711850 Northing: 4327570
		USGS QUAD NAME: Grand Junction
		Year: 1962; photorevised 1973 [X] 7.5' [] 15'

PROJECT NAME: Grand Junction Historic Resources Survey, Phase 2

1241 Gunnison Ave. Grand Junction, Mesa Co, CO 2945-132-08-002 5ME7450

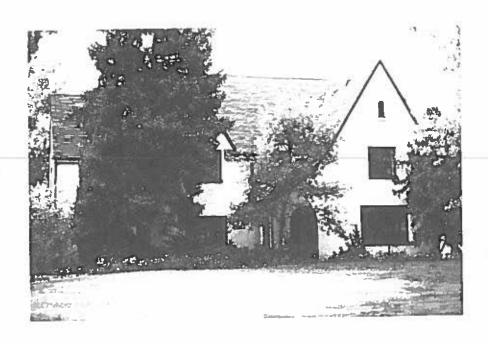
ARCHITECTURAL DESCRIPTION: Irregular plan with concrete foundation and buff, stucco walls. Main body of house is two story rectangle. Two story gabled wing on the east. One and a half story gabled wing on the west, with a two car garage. Eaves of main body of house have wall dormers over second story windows. Large cross gable on the west half of facade has a cat slide that continues down to the one story level, ending with a flared eave. Under the eave, an archway opens to a small integral entry porch and an arched batten door with small, four pane light. French doors, under small shingled hood, on west gable wall open to the driveway. Steel casement windows, generally five panes high on first story and four panes high on second story, without window surrounds, have red brick rowlock sills. Brown composition shingle roofs are steeply pitched with close to the wall eaves. Rakeboards. Gables have narrow, louvered ventilators with round arch heads. Fireplace chimney on east gable walt, and chimney on south stope are buff stucco, with red brick coping.

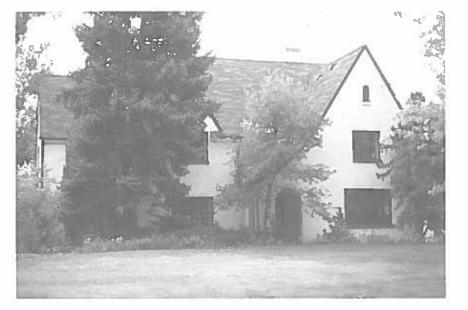
1241 Gunnison Ave. Grand Junction, Mesa Co, CO 2945-132-08-002 5ME7450 10/05/1995 Roll 1 Frame 9

View N Dir SW
