<b>COLORADO HISTORICAL SOCIETY</b> Office of Archaeology and Historic Preservation 1300 Broadway Denver, CO 80203		SITE NO.: 5ME7559
<b>HISTORIC BUILDING INVENTORY</b>		Eligible for National Register <input type="checkbox"/> yes <input type="checkbox"/> no date _____ initials _____ Criteria <input type="checkbox"/> A <input type="checkbox"/> B <input type="checkbox"/> C <input type="checkbox"/> D Contributes to a potential National Register district <input type="checkbox"/> yes <input type="checkbox"/> no district name: _____
COUNTY: Mesa	CITY: Grand Junction	Eligible for State Register <input type="checkbox"/> yes <input type="checkbox"/> no date _____ initials _____ Criteria <input type="checkbox"/> a <input type="checkbox"/> b <input type="checkbox"/> c <input type="checkbox"/> d <input type="checkbox"/> e Areas of significance: _____
HISTORIC BUILDING NAME: Helman, John, House		Period of significance _____ Needs data <input type="checkbox"/> date _____ initials _____

CURRENT BUILDING NAME: Kock Residence		LOCAL LANDMARK DESIGNATION: [ ] yes [X] no Date of designation: N/A Designating authority: N/A
ADDRESS: 1330 Main St., Grand Junction, CO 81501-4639		P.M.: UTE township: 1S r

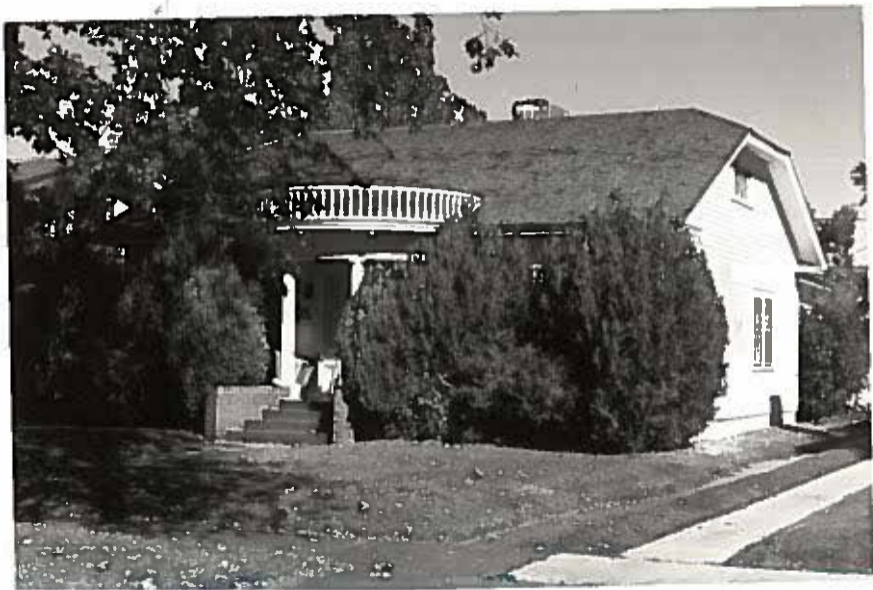
10/05/1995  
Roll 6 Frame 12  
View S Dir N/NW  
5ME7559

**ARCHITECTURAL DESCRIPTION:** One story, with side hip on gables and concrete foundation. Concrete steps with wire cut brick piers lead up to semi-circular portico with two Tuscan columns. Architrave of portico has dentil course. Shaped brackets under portico roof. Balustrade with turned spindles on top of portico. Paneled front door, flanked by eight light sidelights. Cutaway bay on west elevation with hip roof. Windows are double hung wood sash, six-over-six, with green louvered shutters on front windows. White narrow lapped siding. Red painted cedar shingled roof. Fascia on gables with cornice returns. Full height brick fireplace chimney on west gable wall.
