PROJECT NAME: Grand Junction Historic Resources Survey, Phase 2

1048 Main St.,
Grand Junction, Mesa Co, CO
2945-144-14-013
5ME7694

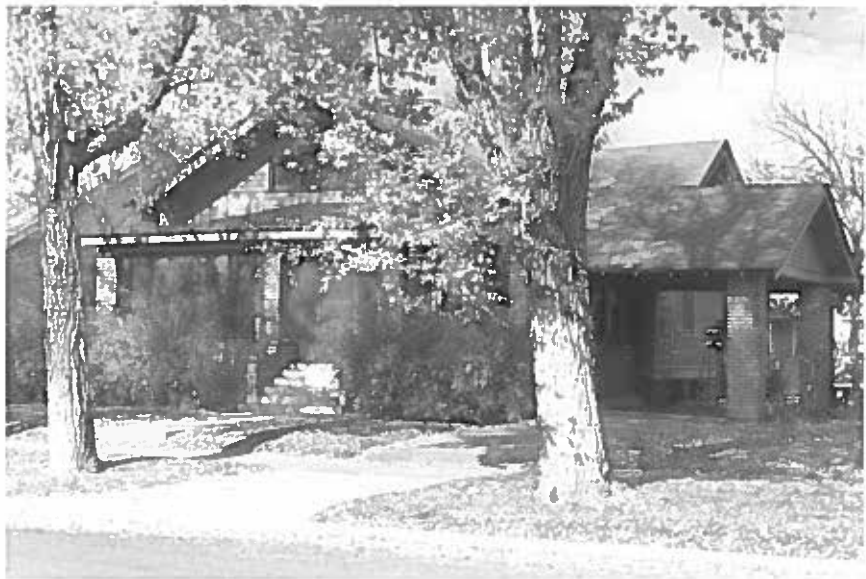
11/07/1995
Roll 12 Frame 21
View S Dir NW
5ME7694

ARCHITECTURAL DESCRIPTION: One story with hip roof with cross gables. Concrete block foundation. Concrete steps with piers of yellow, wire cut brick. Screened porch across facade has hip roof. Paneled door has three vertical lights of multi-colored stained glass with large amber side light of hammered glass. Brick half-walls and four brick columns across porch. Porte cochere on east facade has a side gable roof with two brick columns at each outer corner. All brick is yellow, wire cut. Windows are double hung wood sash, one-over-one. Some windows with leaded glass in lozenge pattern. Projecting bay window with shed roof on west elevation. Ocher narrow lapped siding with brown door and window surrounds. Gables have ocher wood shingles and flared eaves. Red composition shingle roof with exposed rafter ends. Bargeboards are notched. Wide eaves. Weathervane with copper whale on front gable ridge.
