PROJECT NAME: Grand Junction Historic Resources Survey, Phase 2

806 Ute Ave.,
Grand Junction, Mesa Co, CO
2945-144-28-010
5ME7711

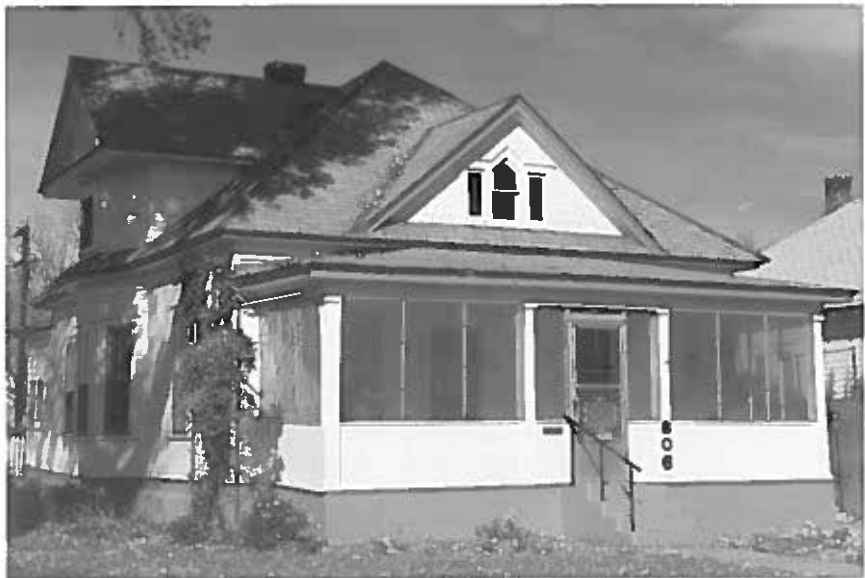
11/07/1995
Roll 13 Frame 21
View S Dir N/NE
5ME7711

ARCHITECTURAL DESCRIPTION: One and a half story with cross gables. Concrete front steps with pipe rail lead to nearly full width screened porch with hip roof. Vertical siding on half-wall. Four full height squared columns across porch. Front door is paneled with large light. On west elevation is a two story cutaway bay with a pent roof and pedimented gable. Windows are double hung wood sash, one-over-one. White narrow simple drop siding with white trim. Foundation, cornices and narrow frames of porch screens are coral. Composition shingle roof. Boxed eaves. Cornices. Gables on south and west roof are shingled with wood shingles cut in the reverse of fishscale. Brick chimney on north slope.

One car garage by alley with front gable, false bevel siding, and composition shingle roof. Siding indicates that garage was built later than house.
