COLORADO HISTORICAL SOCIETY		SITE NO.: 5ME7852
Office of Archaeology and Historic Preservation 1300 Broadway Denver, CO 80203 HISTORIC BUILDING INVENTORY		Eligible for National Registeryesno date initials CriteriaABCD Contributes to a potential National Register districtyesno district name:
County: Mesa	Crry: Grand Junction	Eligible for State Registeryesno dateinitials Criteriaabcde Areas of significance:
HISTORIC BUILDING NAME: The house at 1127 Ouray Avenue		Period of significance inklials
CURRENT BUILDING NAME: Magraw Residence		LOCAL LANDMARK DESIGNATION: [] yes [X] no Date of designation: N/A Designating authority: N/A
ADDRESS: 1127 Ouray Ave., Grand Junction, CO 81501-3333		
		P.M.: UTE township: 1S range:1W SE ¼ of SE ¼ of SE¼ of NE¼ of section 14
OWNER NAME & ADDRESS: Bronwen Magraw, 1127 Ouray Ave., Grand Junction, CO 81501-3333		UTM REFERENCE-12 Easting: 711660 Northing: 4327340
		USGS QUAD NAME: Grand Junction

INVENTORY COMPLETED BY: Museum Group Staff	DATE: 3/29/96
Affiliation: Museum of Western Colorado	PHONE: (970) 241-9117
ADDRESS: PO Box 20000-5020, Grand Junction, Colorado 81502-5020	PROJECT NAME: Grand Junction Historic Resources Survey, Phase 2

1127 Ouray Ave.

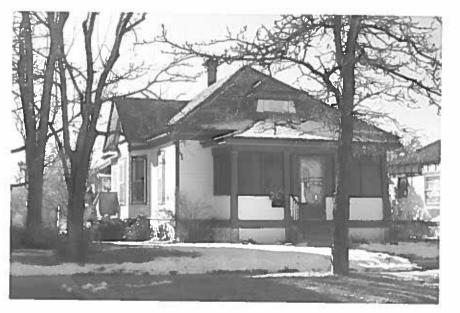
Roll 18 Frame 23 View N Dir SW

ARCHITECTURAL DESCRIPTION: One story with hip roof. Concrete block foundation. Concrete steps with wrought iron railings lead up to screened porch on center three-fifths of facade. Hip roof is continuous with principal roof. Porch has half-wall with wainscoting and four full height, squared columns around porch. Storm door. Front door inside porch is paneled and has a very large light, Porch base has siding. Windows are double hung wood sash, one-over-one. Cutaway bay on east elevation has gabled roof. White narrow lapped siding. Door and window surrounds, columns, water table, corner boards, friezes, and cornices are blue. Green composition shingle roof with flared boxed eaves. Small hip roof dormer on north slope. Battered wood shingle siding. Louvers on facade. Gable on east elevation has return cornices. Brick chimney on south slope.
